Ecological Conditions Update

Governing Board Meeting
May 9, 2013

Kissimmee River (Pool C)

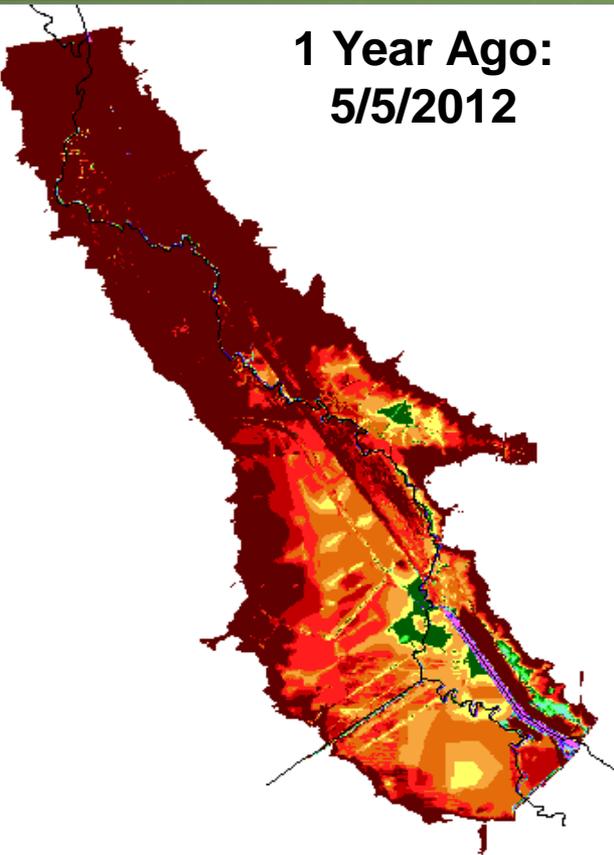
1 Year Ago:
5/5/2012

Monthly Water Depth Maps

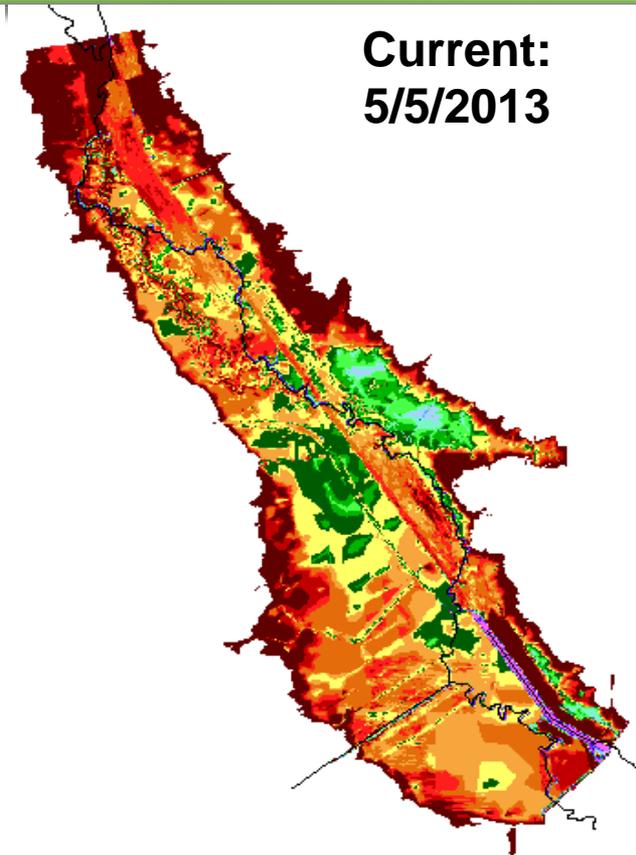
Current:
5/5/2013

Water Depth (feet)

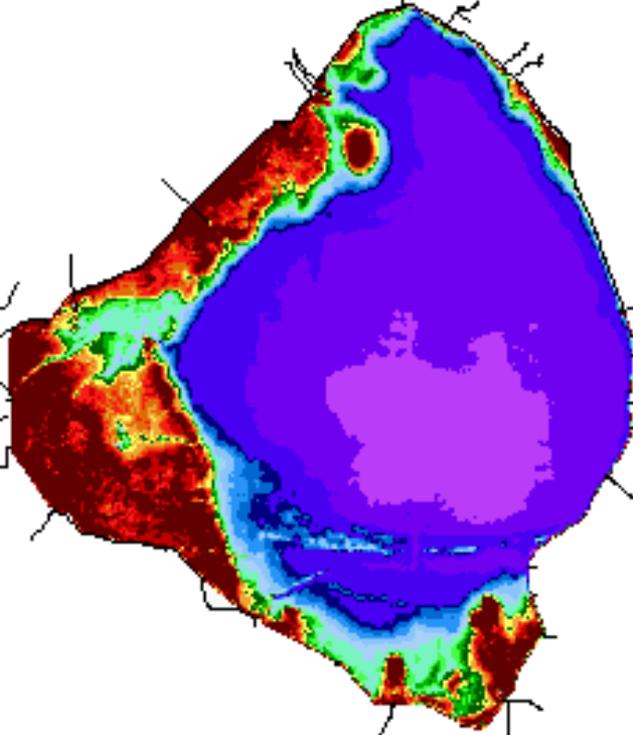
1 Year Ago: 5/6/2012

Lake Okeechobee Water Depth Timeseries Maps

(11.61 ft NGVD29)

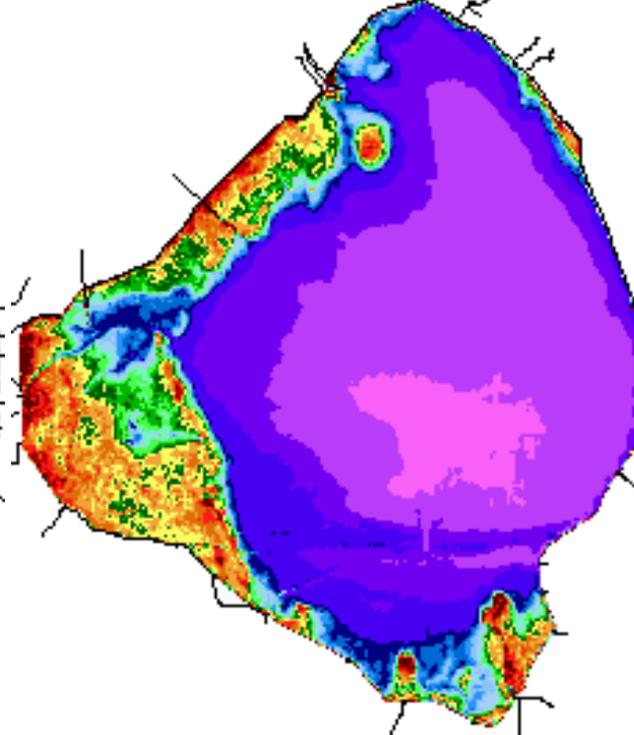
1 Month Ago: 4/6/2013

(13.73 ft NGVD29)

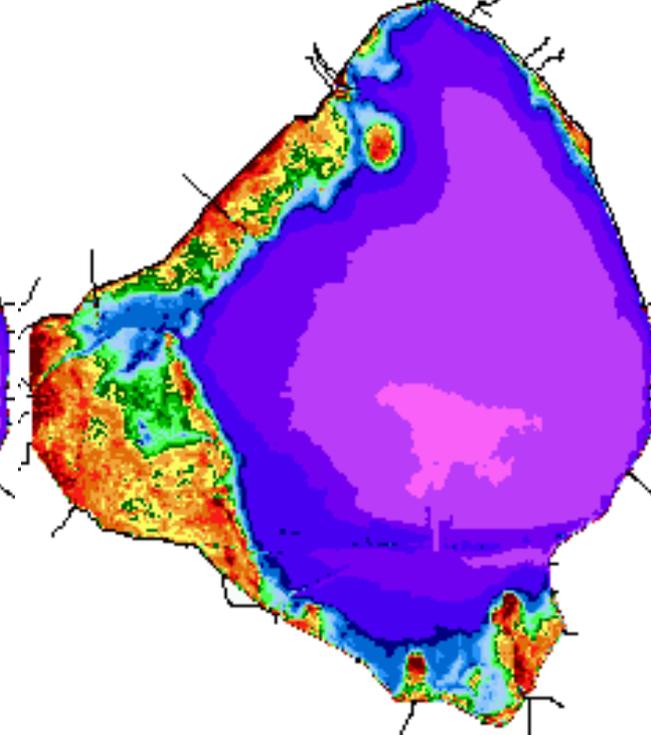
Current: 5/6/2013

(13.58 ft NGVD29)

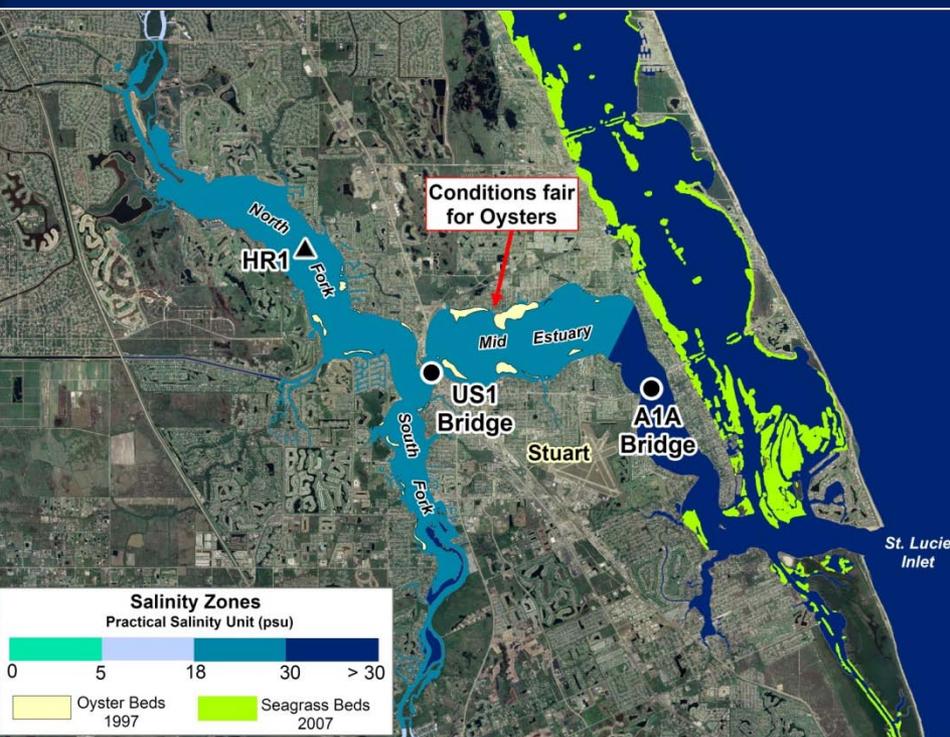
April 8, 2013

St. Lucie Estuary

Salinity Conditions

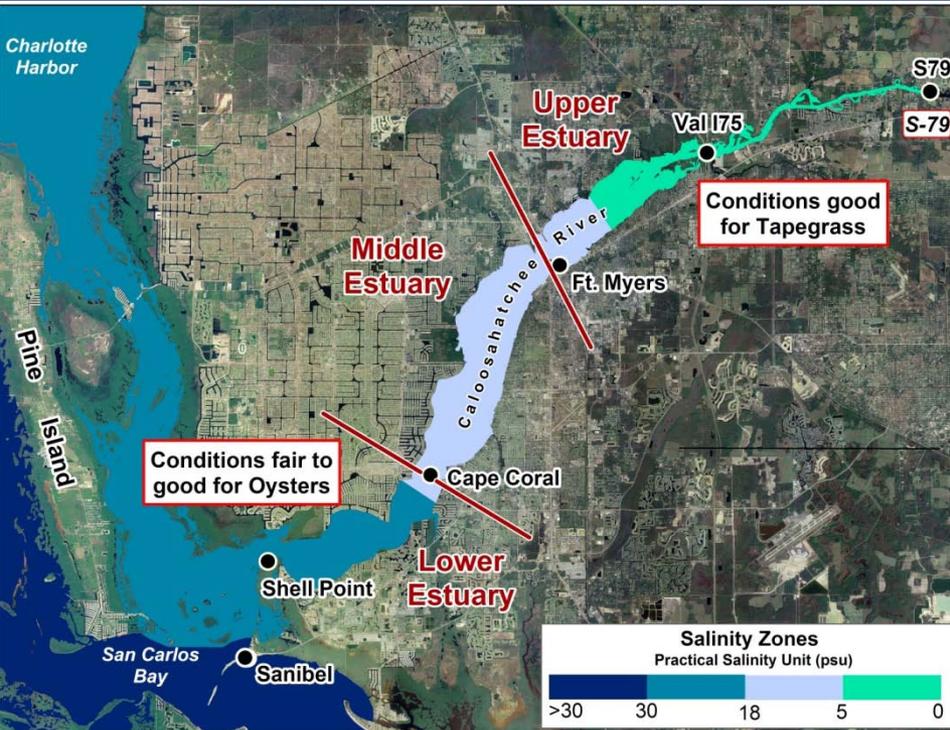
April 8, 2013

Caloosahatchee Estuary

Salinity Conditions

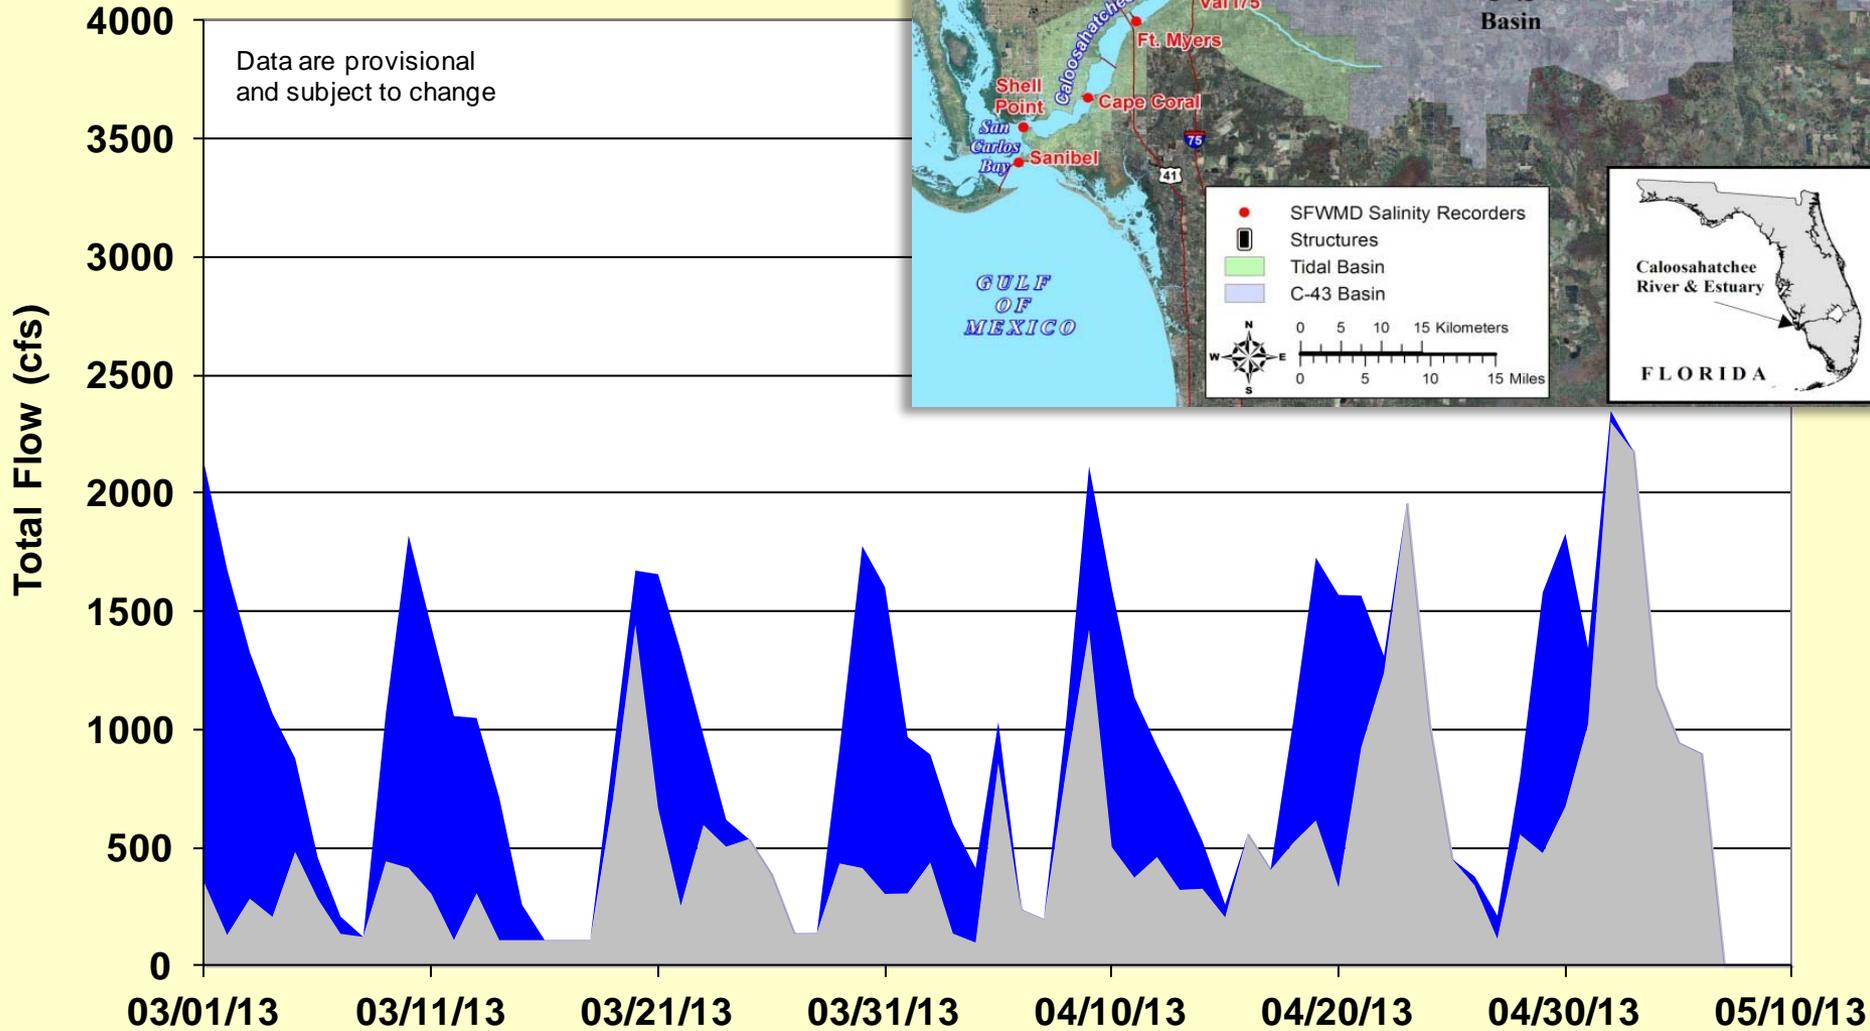
■ Inflow from Basins: C-43 (upstream) and Tidal Basins* (downstream) ■ Inflow from Lake

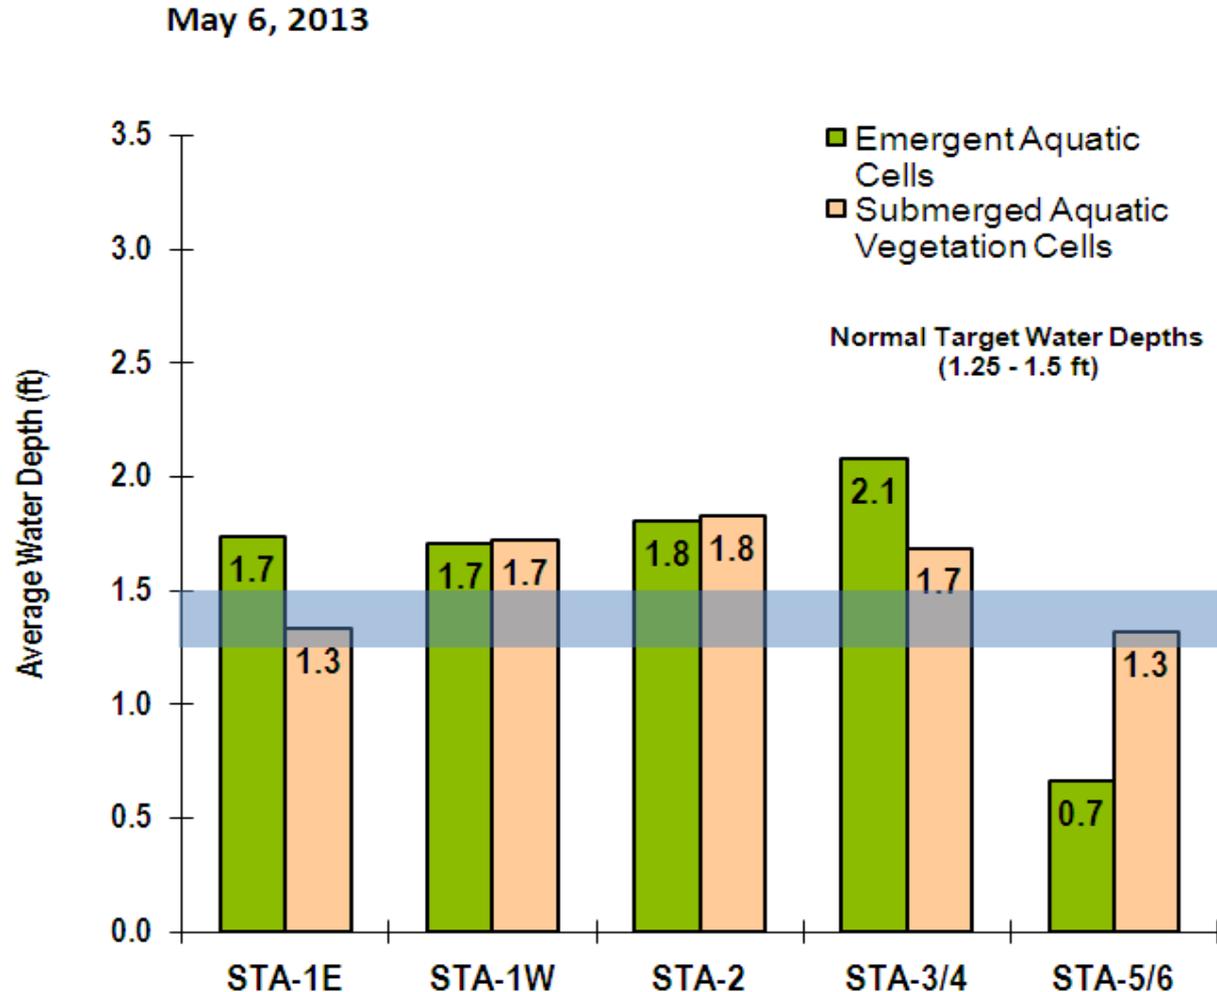
Stormwater Treatment Areas Water Depths

- Most STA water depths at or near target
 - Some Cells in STA-5/6 below target
- Newly constructed STA-2 Cells 7 & 8 hydrated for start-up monitoring

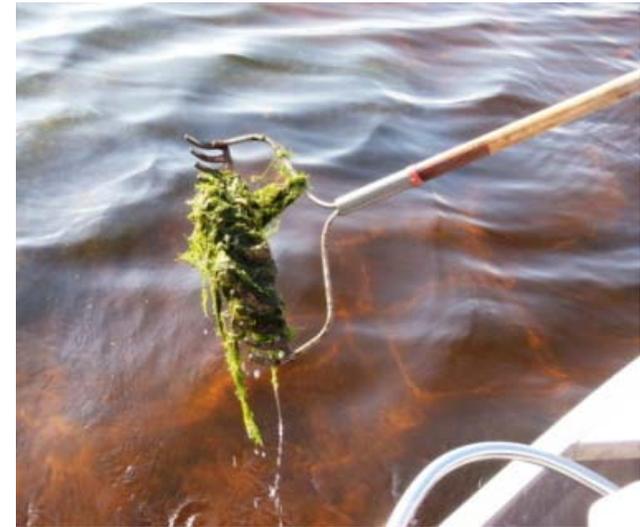
- Water depths reduced to benefit vegetation communities
 - STA-1E Cell 6, STA-3/4 Cell 2A & STA-5/6 Cells 5-1B and 5-2B
- Vegetation in newly constructed STA-5/6 Cell 4B well established
- Decline observed in submerged aquatic vegetation (SAV)
 - STA-1E, STA-1W, STA-3/4
 - Winter die-back and herbivore possible causes
 - Research is being conducted to further investigate

Sparse SAV in the STA

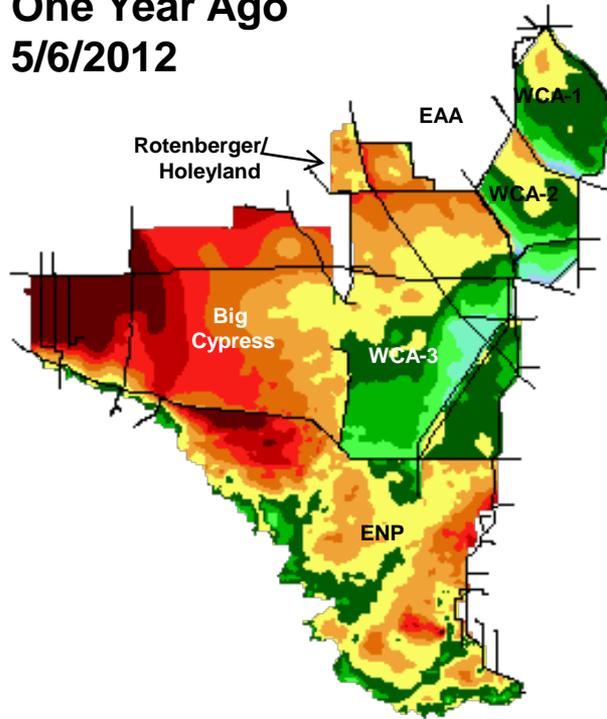
**One Year Ago
5/6/2012**

Greater Everglades Water Depth Monthly Snapshots

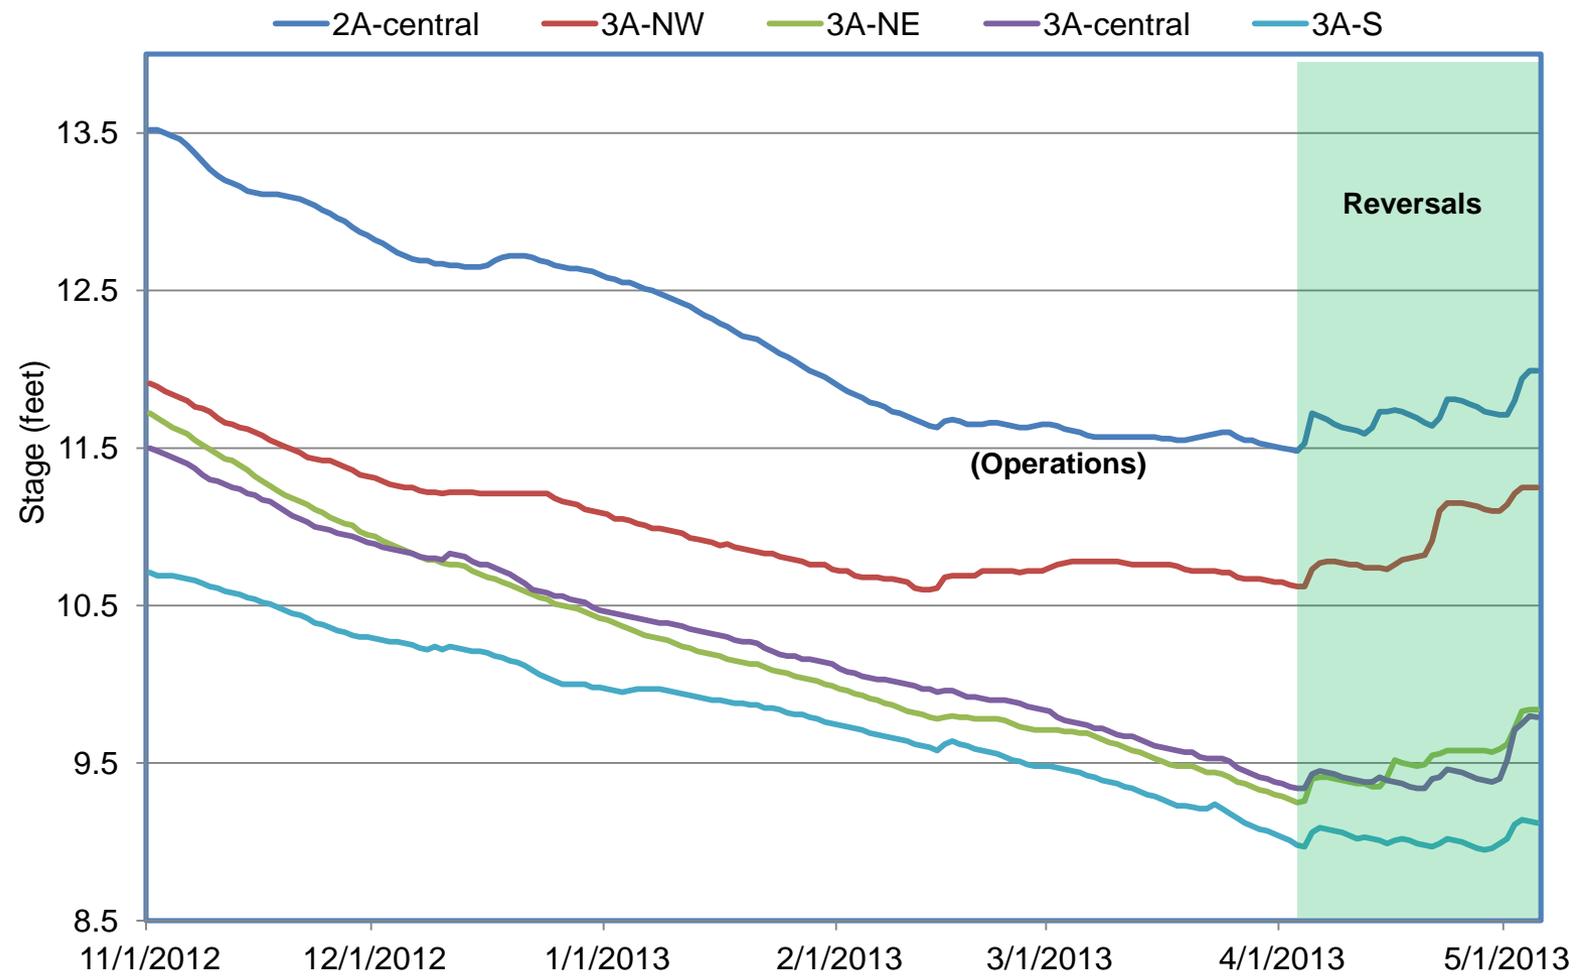
Water Conservation Areas
Dry season water levels, 2012-2013

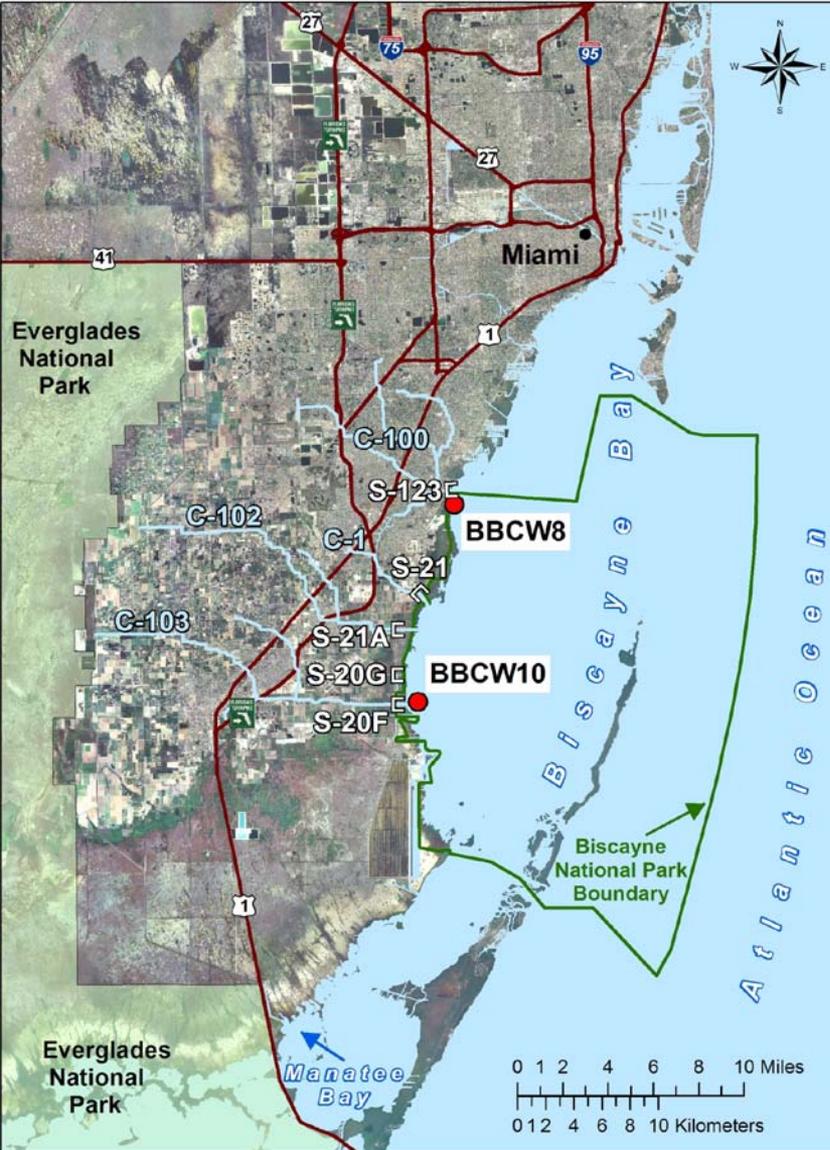
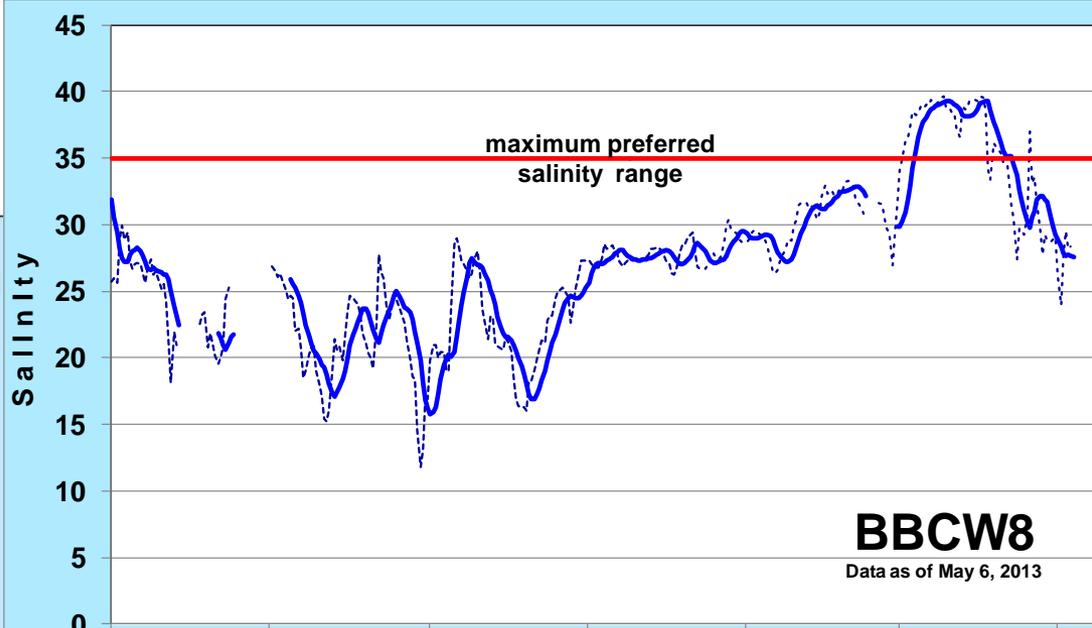
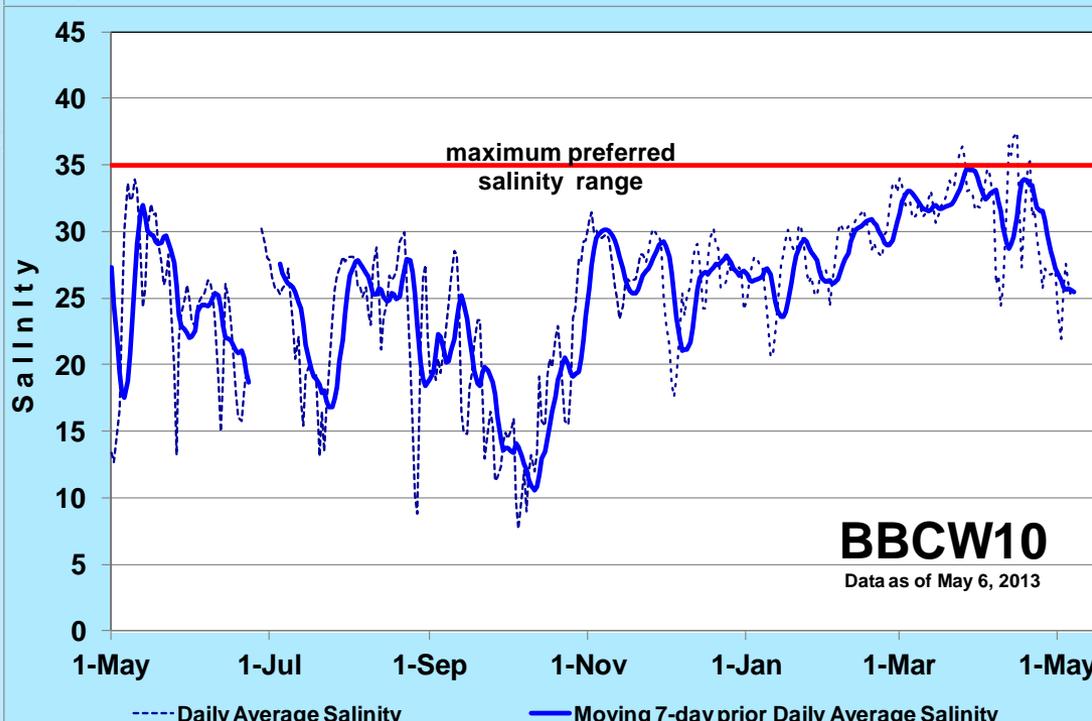
Biscayne Bay Salinity

--- Daily Average Salinity — Moving 7-day prior Daily Average Salinity

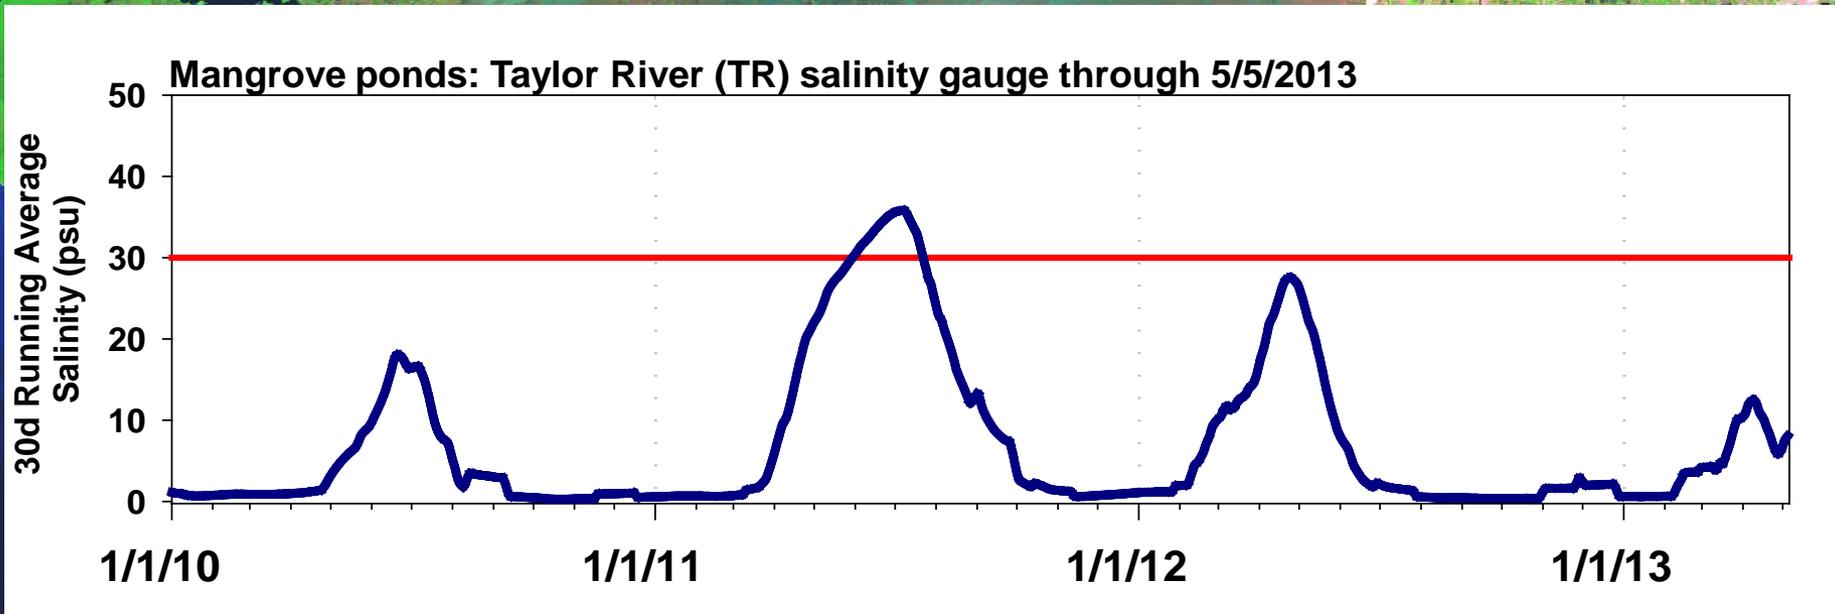
Tracking Salinity in Florida Bay

Florida Bay MFL salinity threshold was exceeded in late June of 2011
