Governing Board Meeting

September 8, 2011

Ecological Conditions Update

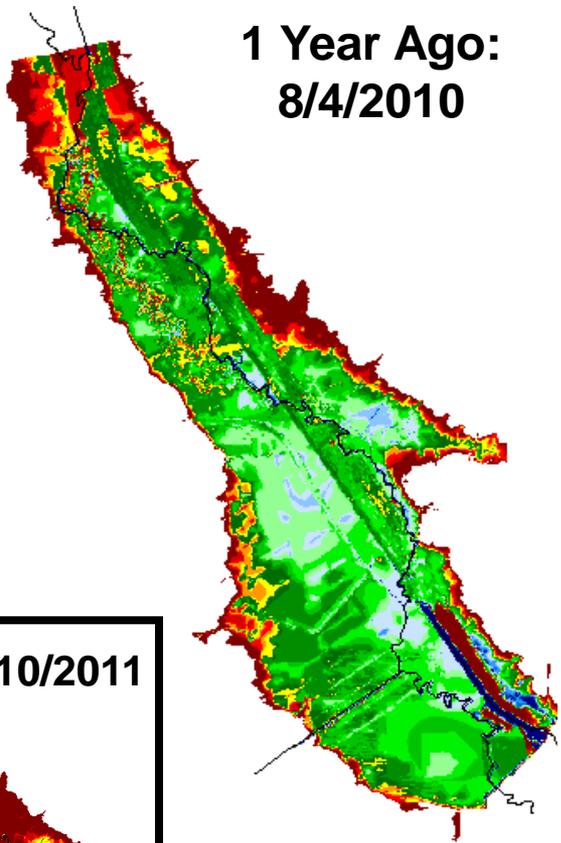
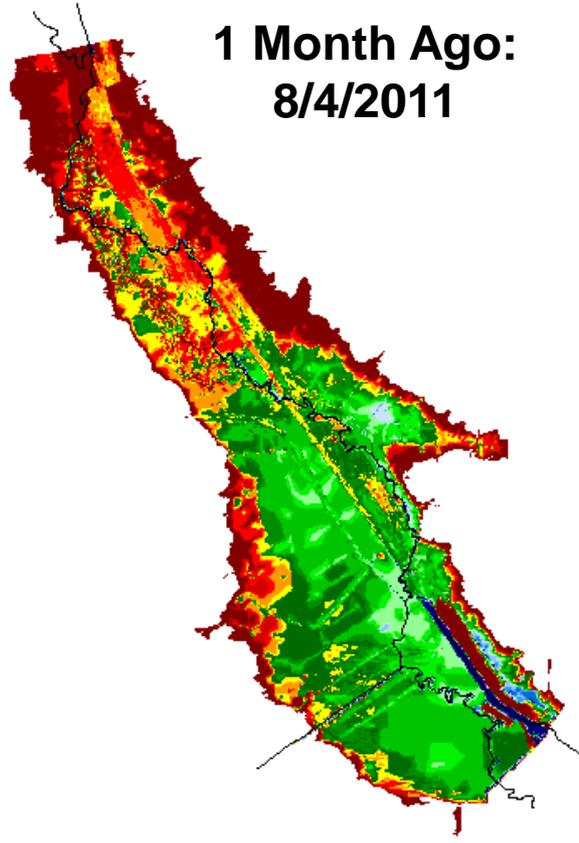
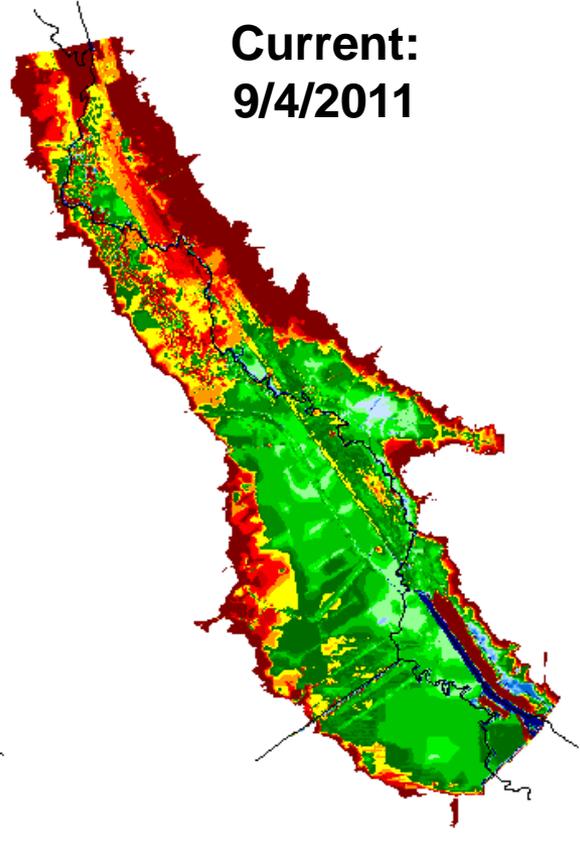
Kissimmee River Floodplain Water Depth Maps

1 Year Ago:
8/4/2010

1 Month Ago:
8/4/2011

Current:
9/4/2011

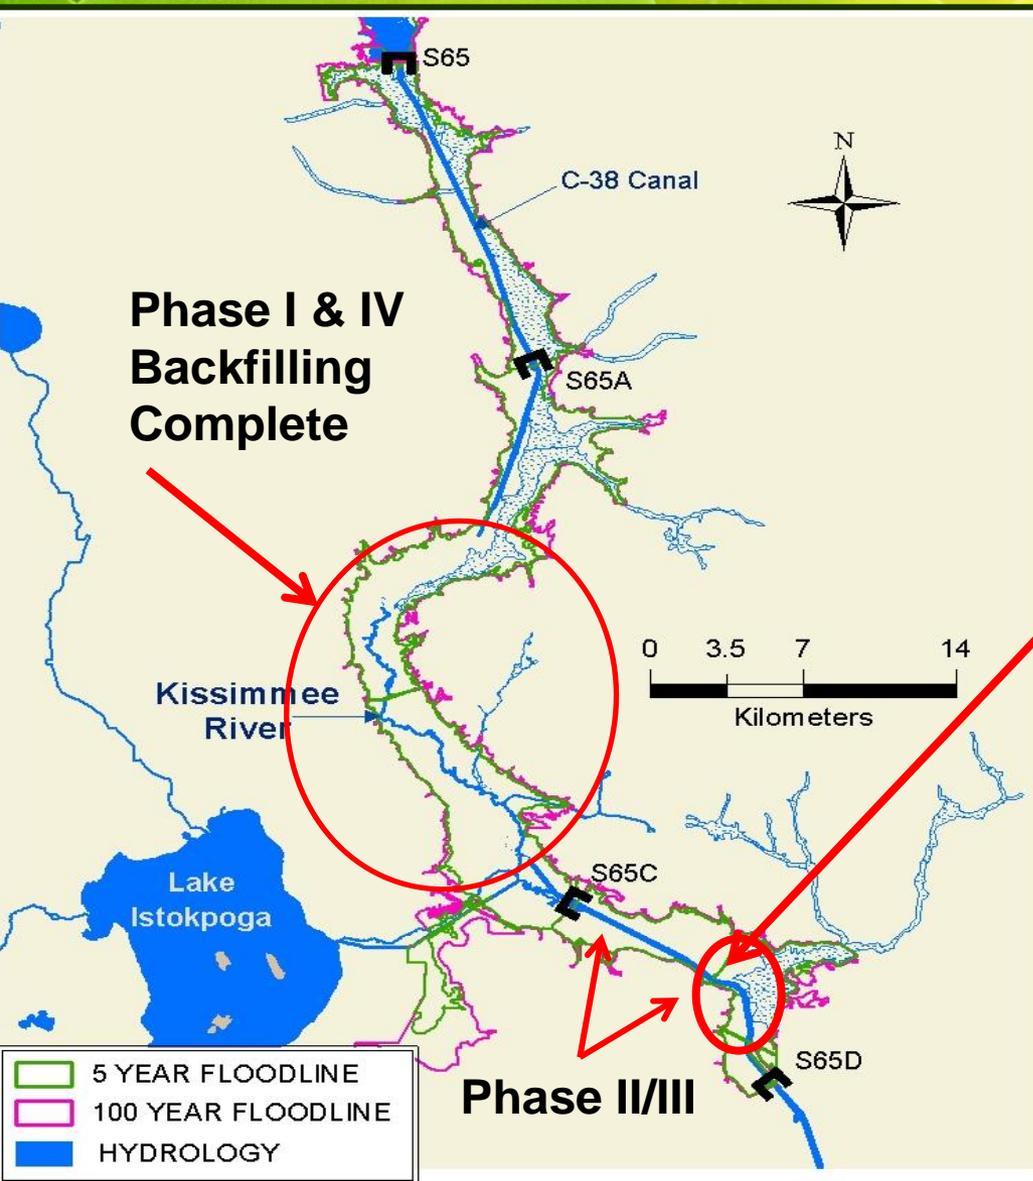
Pool D Construction Features

Most Pool D Features are located at the bottom of the Pool

- River Acres Flood Reduction
- CSX Railroad Bridge
- U-Shaped Weir
- Tie-back levee
- Recarved River Reaches

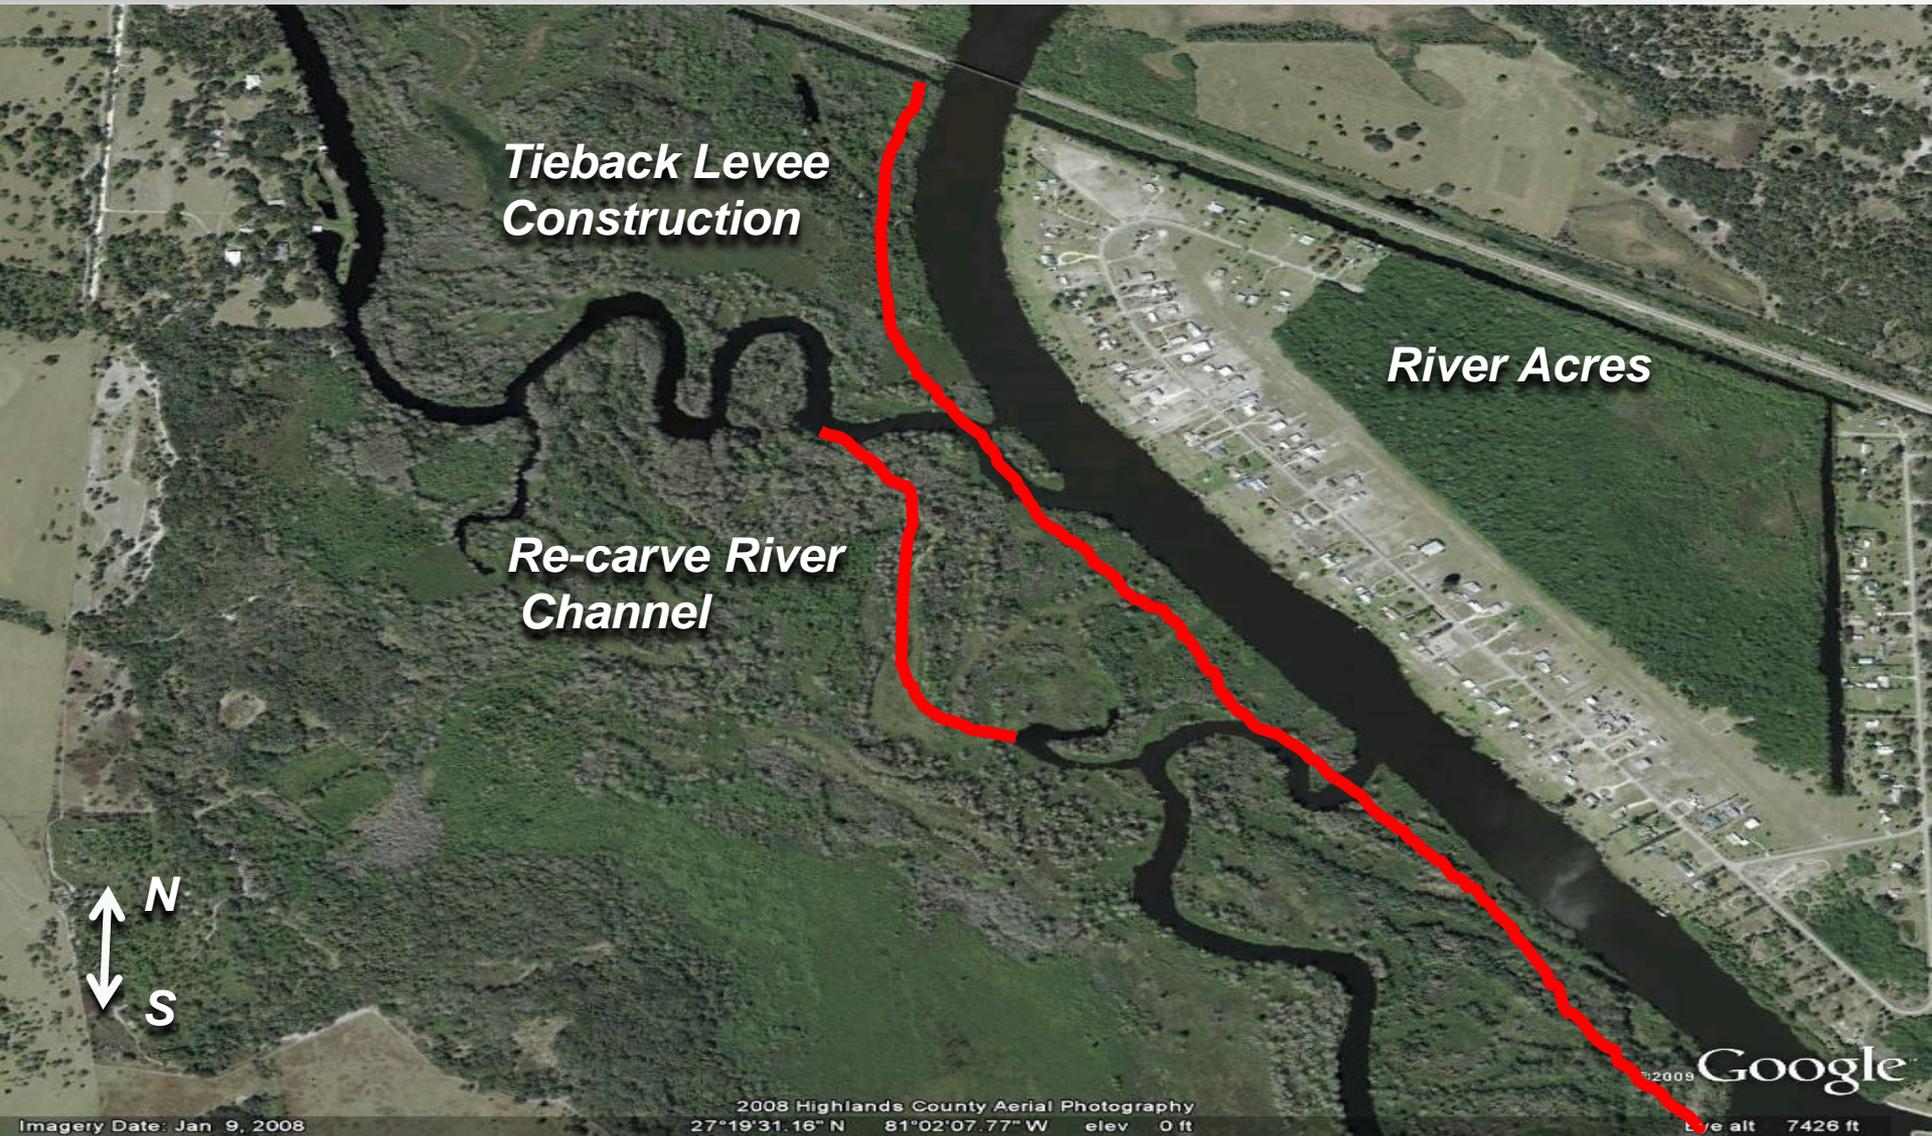
Kissimmee Basin **Phase II/III Tie Back Levee**

Tieback Levee Construction

River Acres

Re-carve River Channel

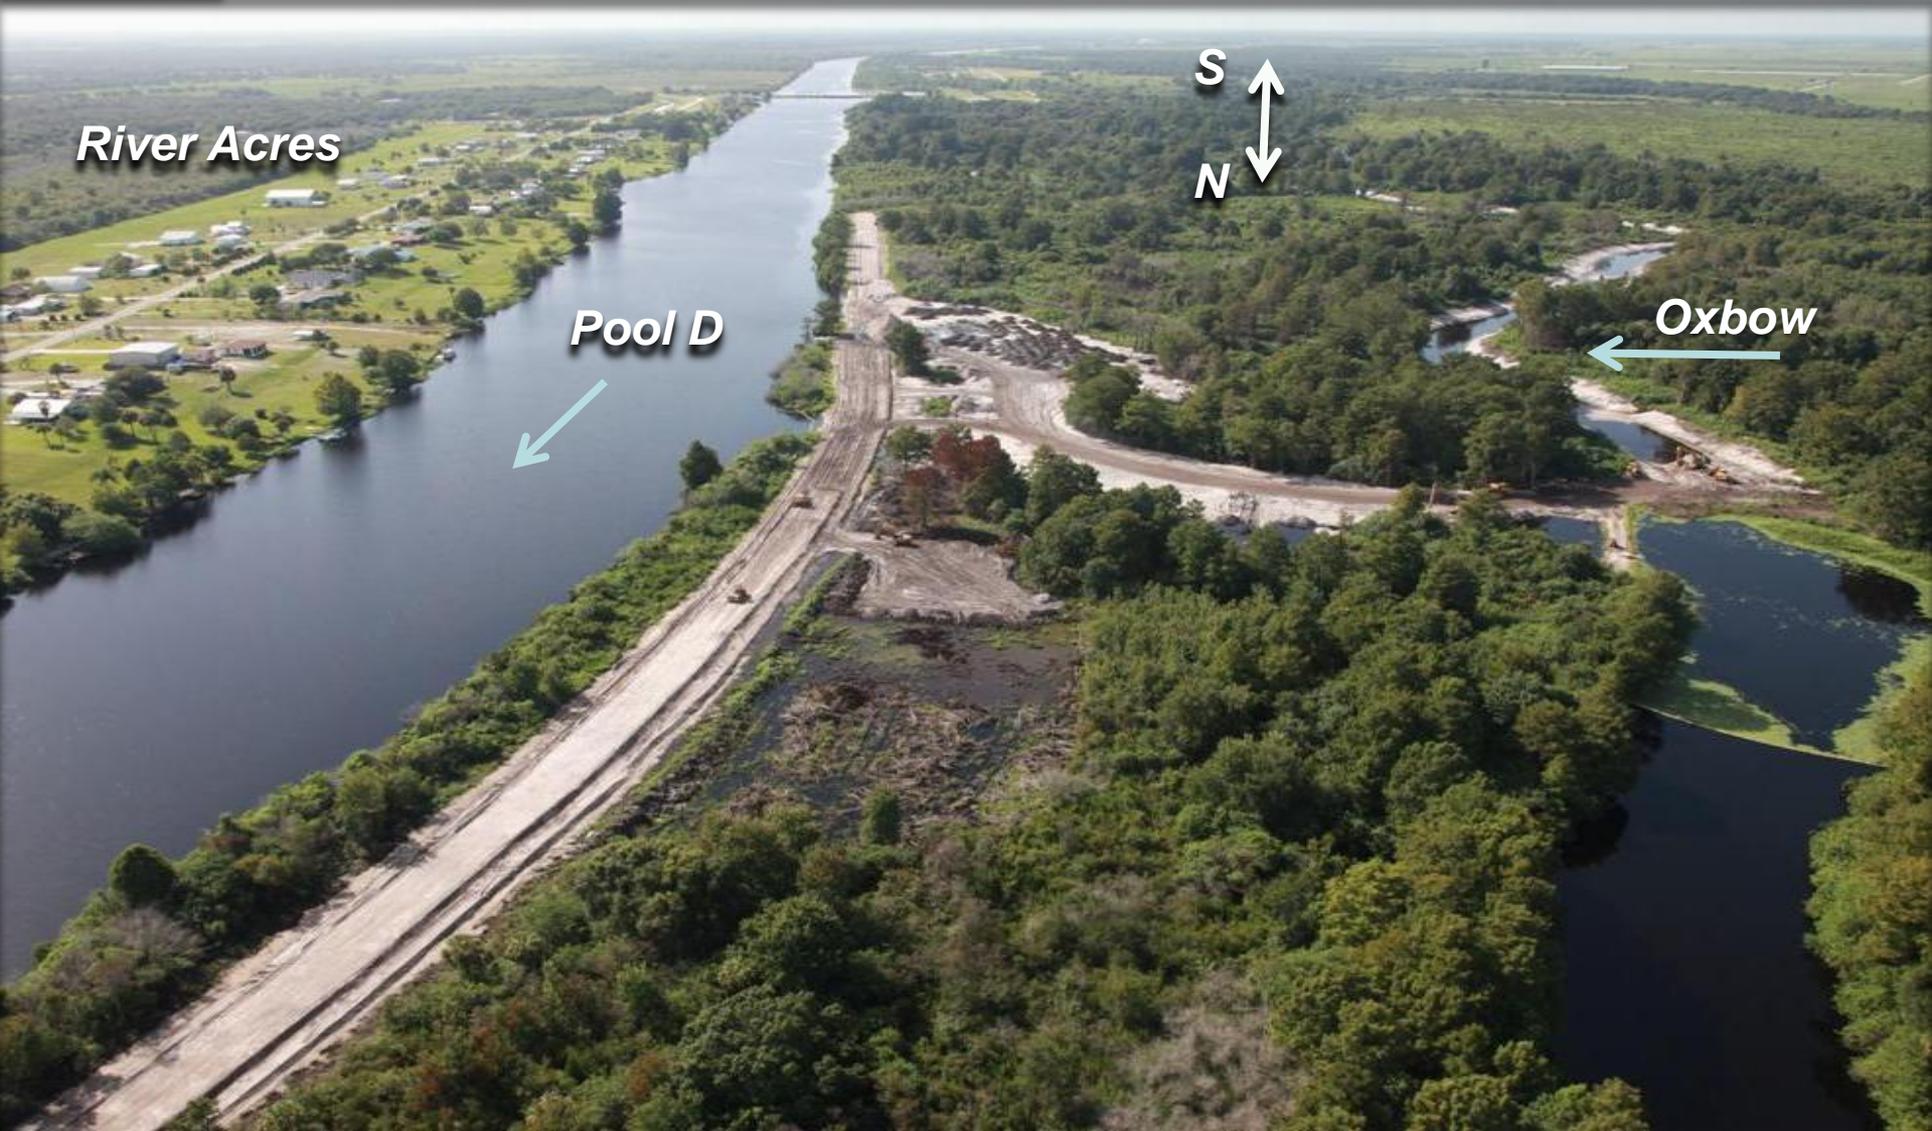
Kissimmee River Restoration Project Construction

River Acres

Pool D

Oxbow

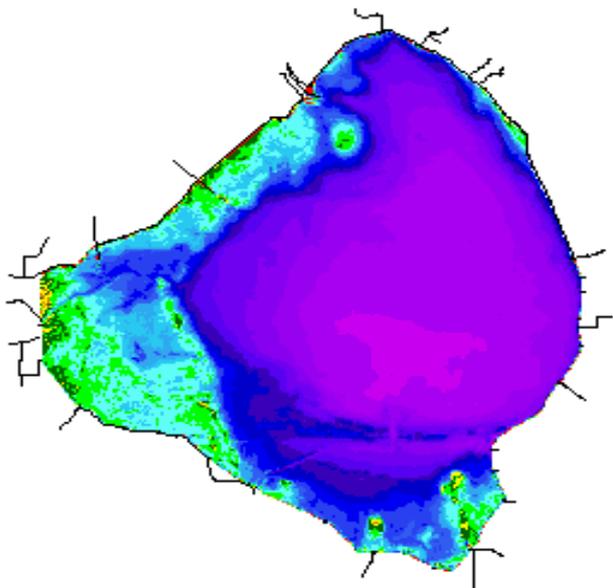
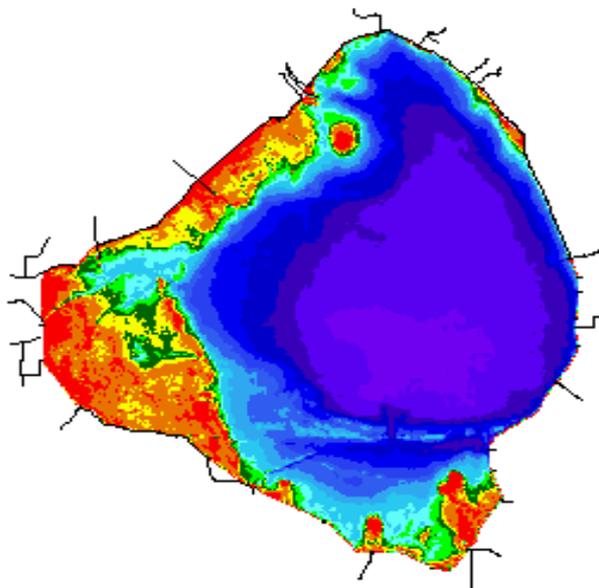
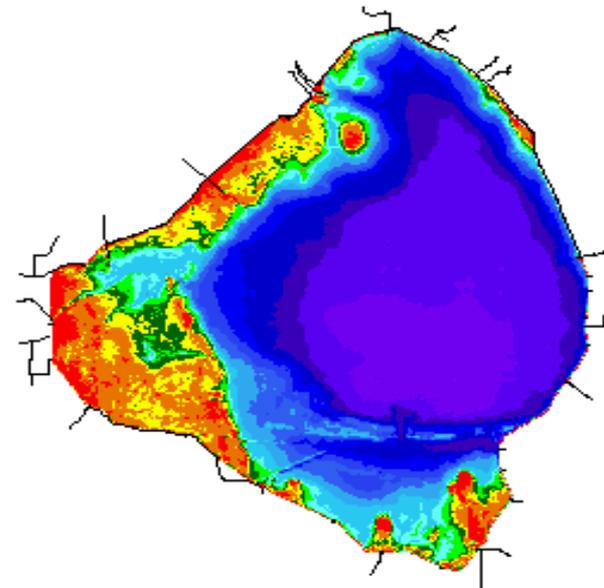
Water Depth Timeseries Maps

1 Year Ago: 09/05/2010

1 Month Ago: 08/06/2011

Current: 09/07/2011

(14.06 ft NGVD29)

(10.26 ft NGVD29)

(10.79 ft NGVD29)

Lowest lake stage this year:
9.53 ft NGVD29 (06/24/11)

Record low lake stage:
8.82 ft NGVD29 (7/2/07)

CURRENT LAKE LEVEL:
10.79 ft NGVD29 (09/07/11)

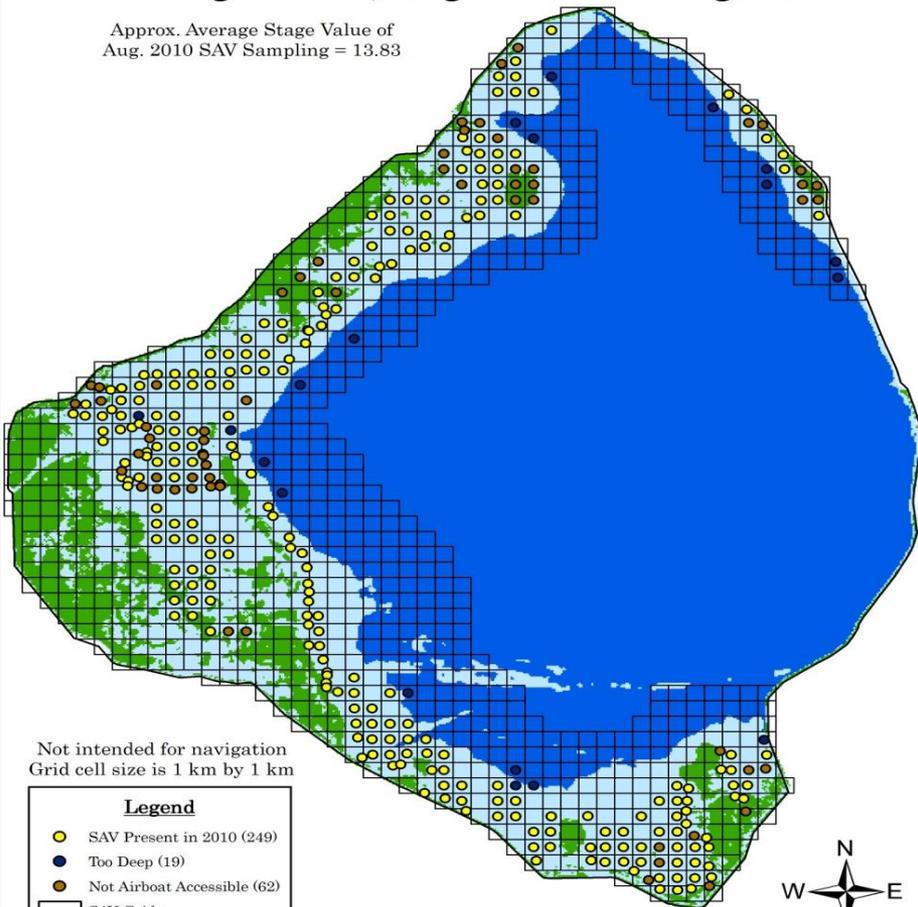
Lake Okeechobee SAV Distribution at Peak Growing Season, August 2010: Stage 13.83

Approx. Average Stage Value of Aug. 2010 SAV Sampling = 13.83

Not intended for navigation
Grid cell size is 1 km by 1 km

Genera represented include:
Chara, Hydrilla, Vallisneria, Ceratophyllum, Potamogeton, Najas, Utricularia, Bacopa, and Nitella

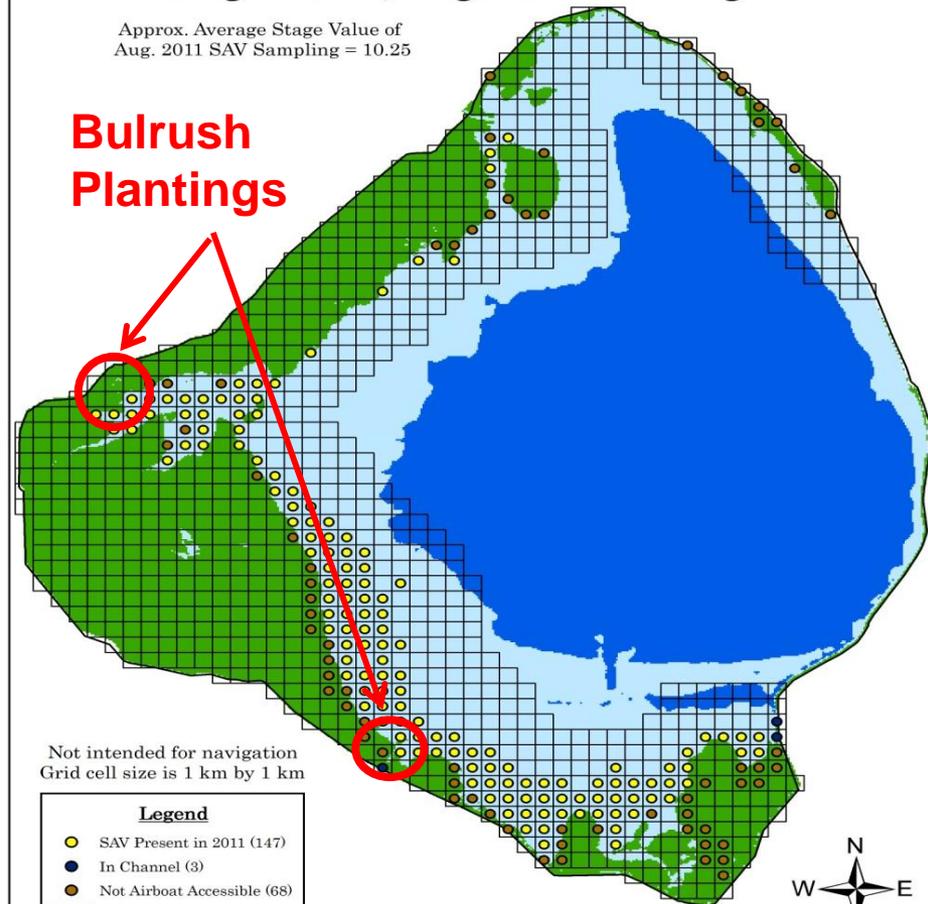
Lake Okeechobee SAV Distribution in Peak Growing Season, August 2011: Stage 10.25

Approx. Average Stage Value of Aug. 2011 SAV Sampling = 10.25

Bulrush Plantings

Not intended for navigation
Grid cell size is 1 km by 1 km

Genera represented include:
Chara, Hydrilla, Vallisneria, Ceratophyllum, Potamogeton, Najas, Utricularia, Bacopa, and Nitella

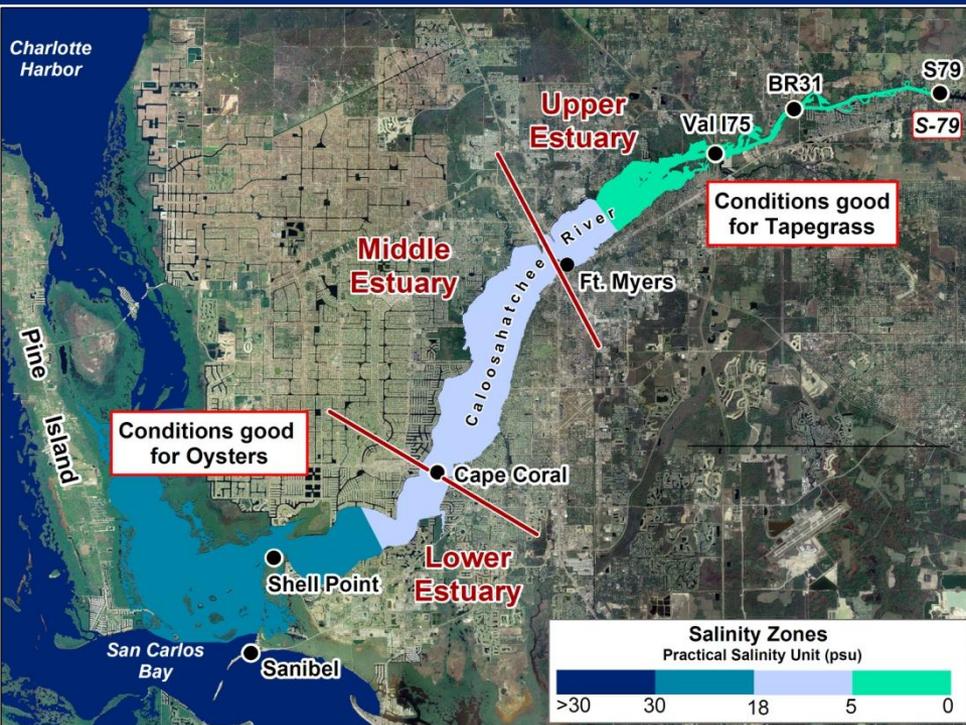
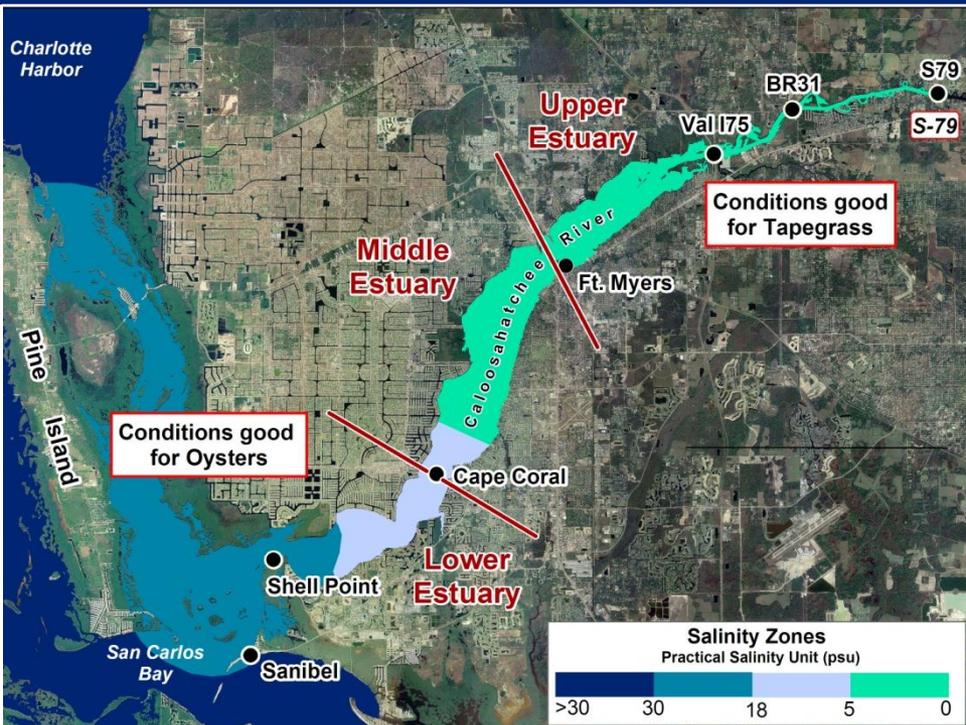
Salinity Conditions

August 8, 2011

September 5, 2011

NOTE: Optimal Range for Oysters: 14 – 28 psu

Optimal Range for Tape Grass: 0 – 5 psu

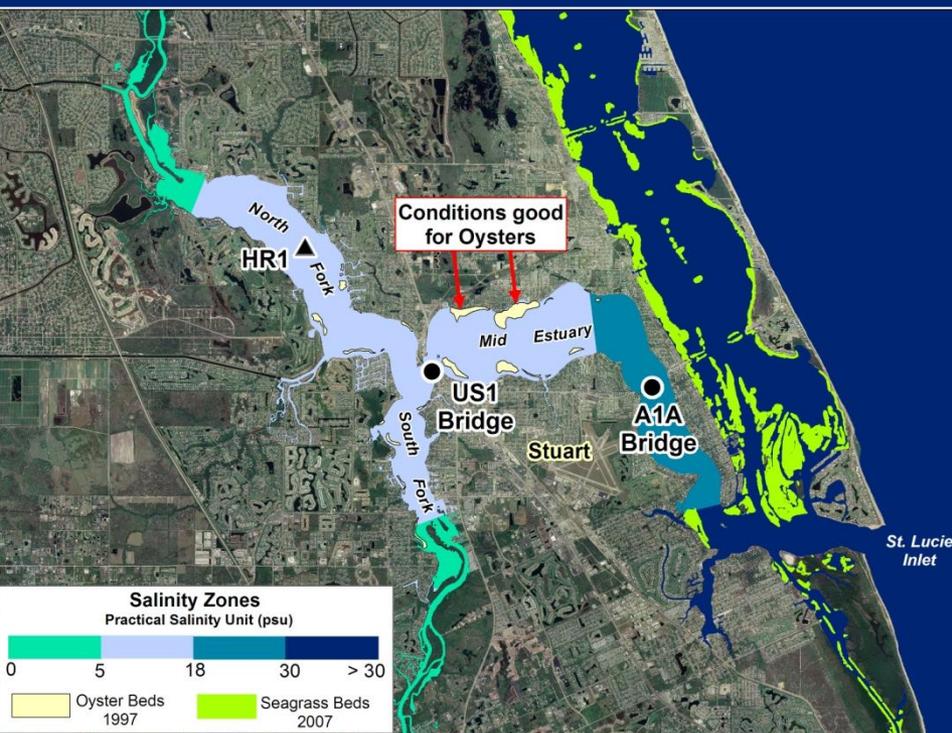
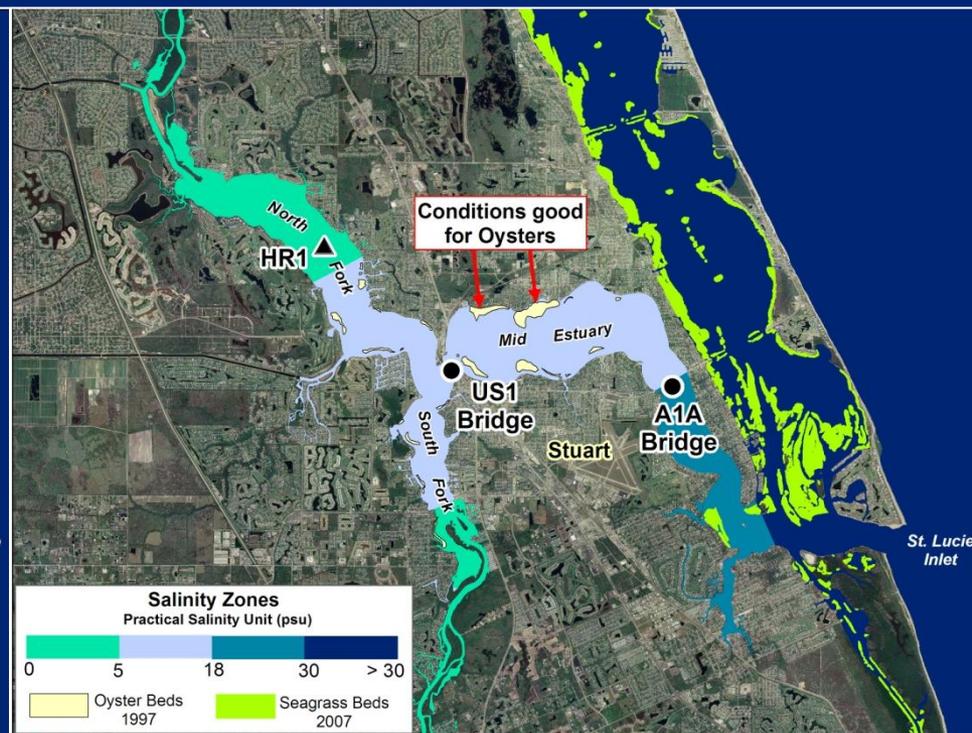
Salinity Conditions

August 8, 2011

September 5, 2011

NOTE: Optimal Range for Oysters: 14 – 28 psu

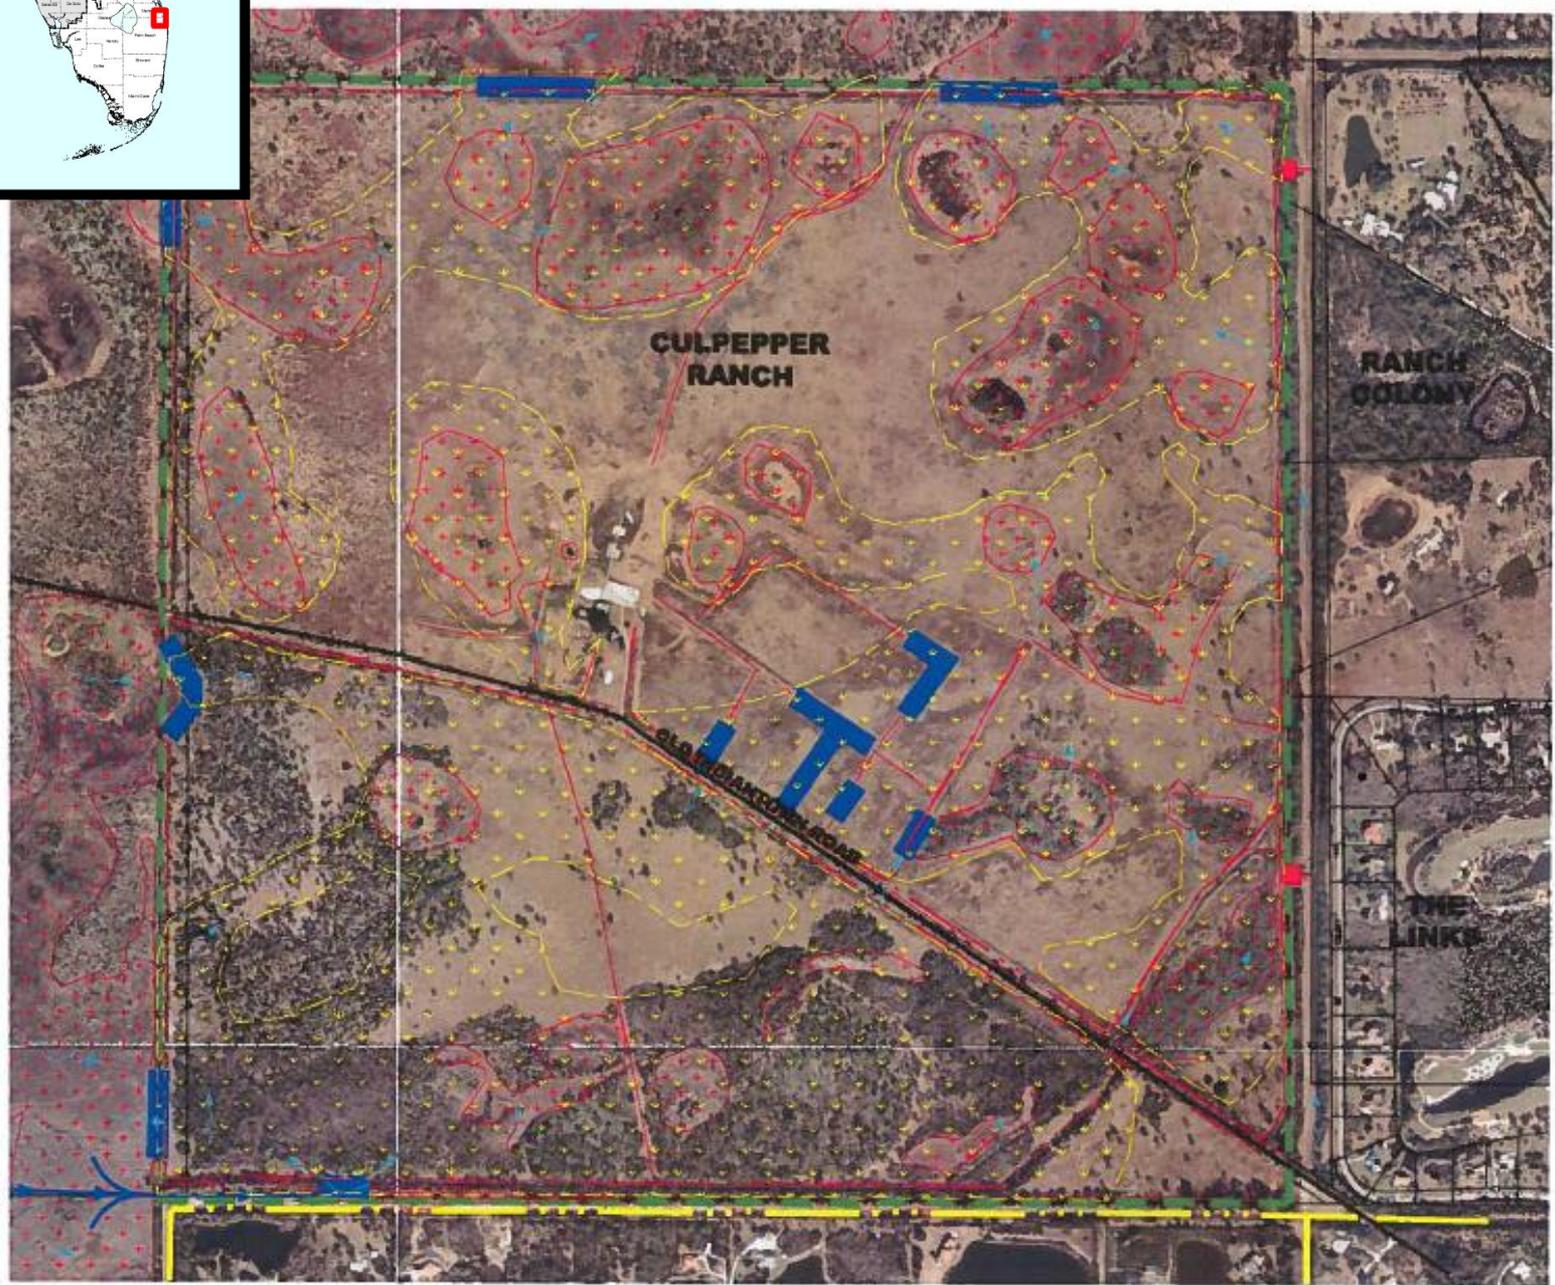
Culpepper Wetland Restoration

- Property purchased in 3 phases with Martin County
 - 1,280 acres – primarily cattle ranch
 - Component of Flowway 3– Lox. River Watershed Restoration Project
- Restoration activities
 - Loxahatchee River Preservation Initiative funding
 - Joint permit from DEP to Martin County and SFWMD
 - Ditch plugs and berm breaches – completed April 2011
 - Physical and chemical control of exotics
 - Two monitoring stations (water level/rainfall)
 - Estimated improvement of 450-500 wetland acres

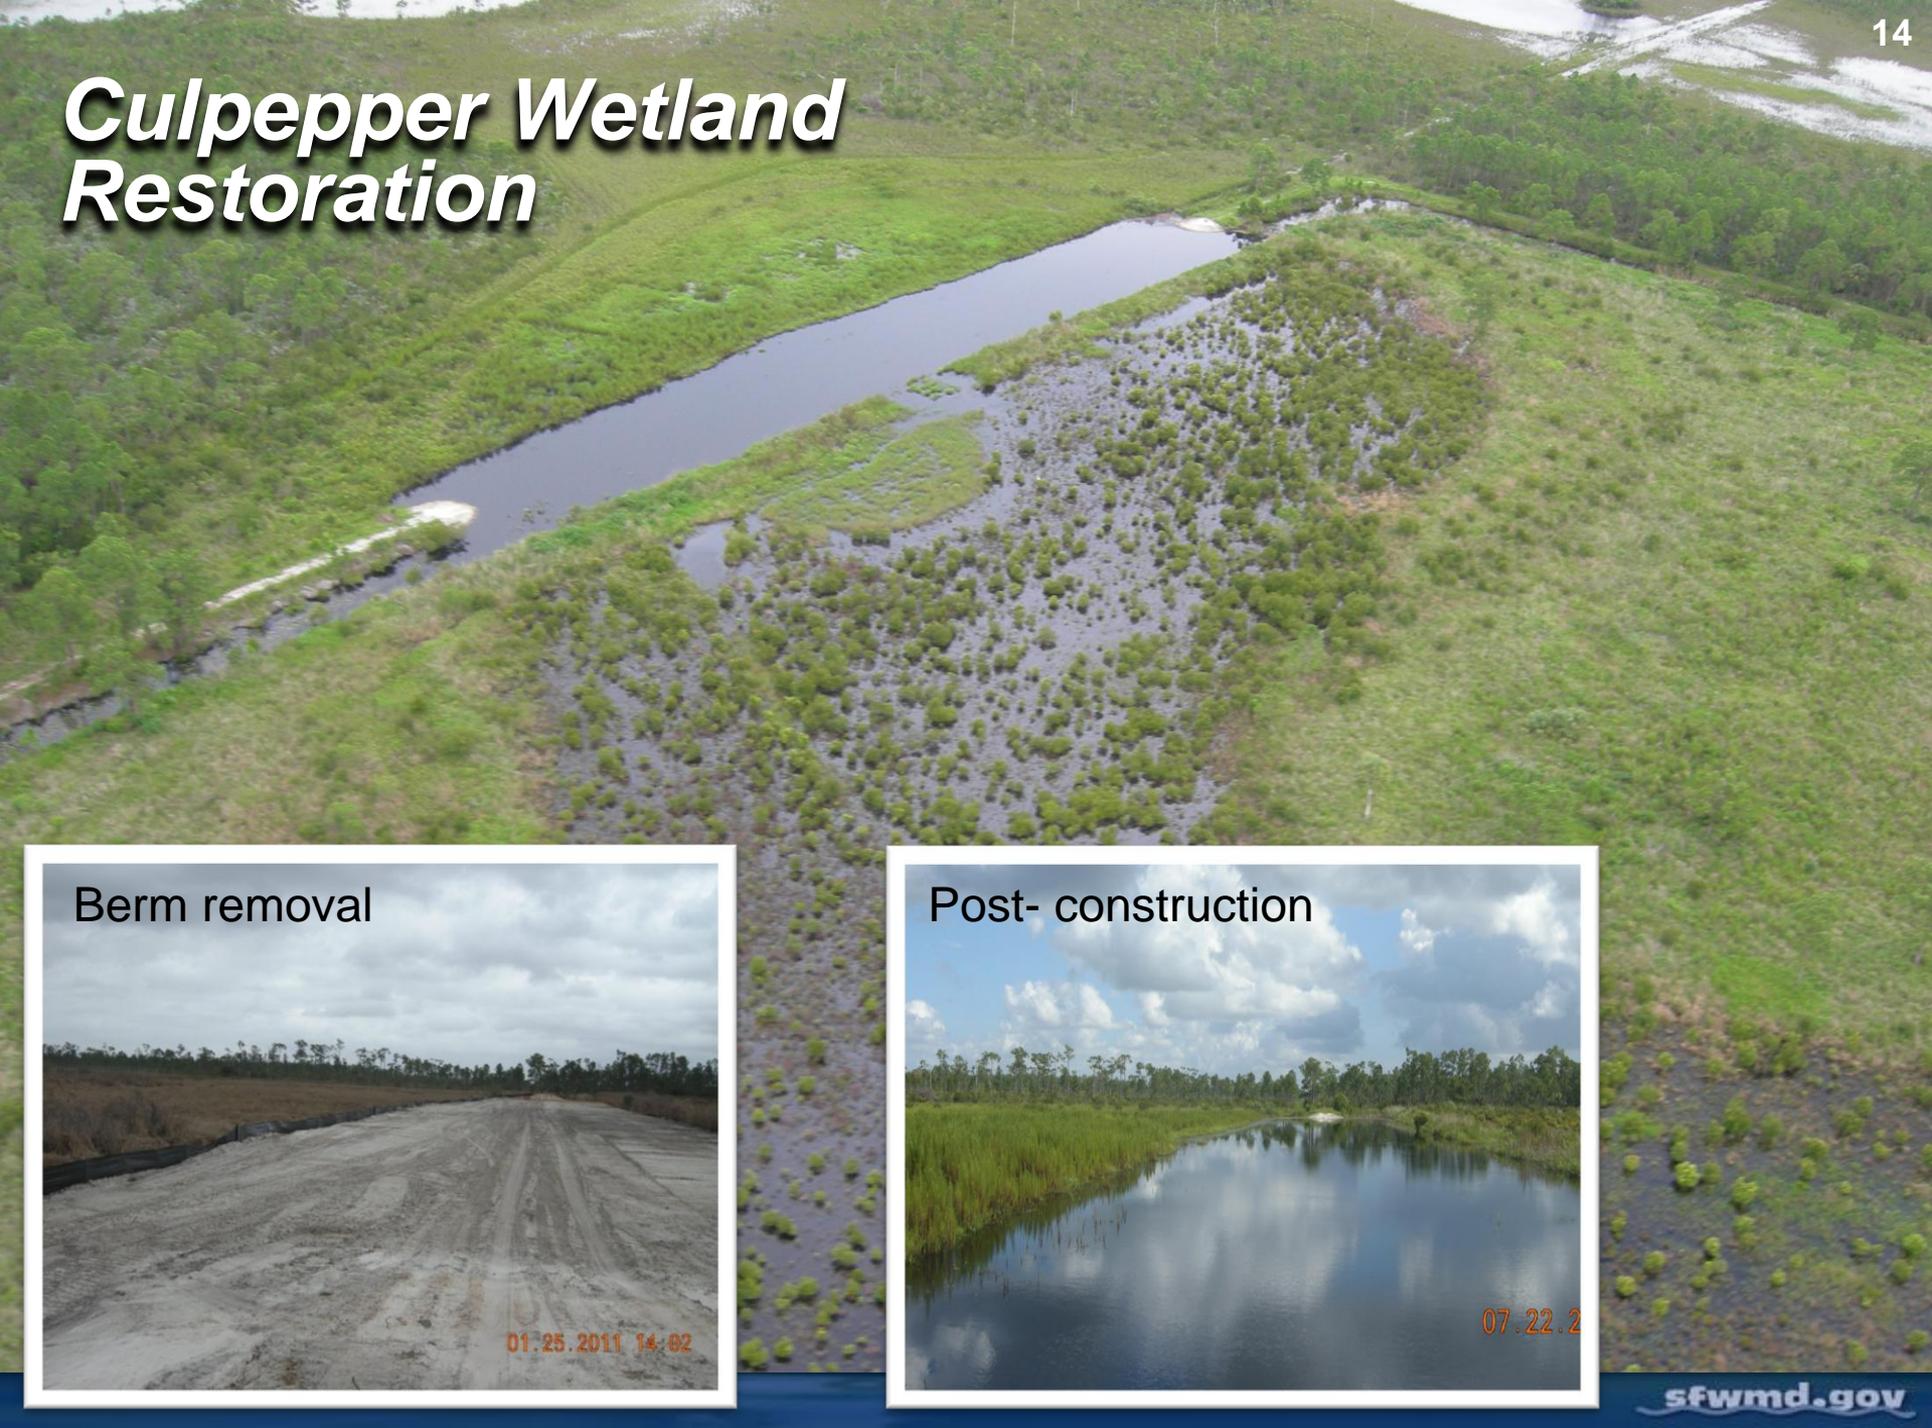
Berm removal

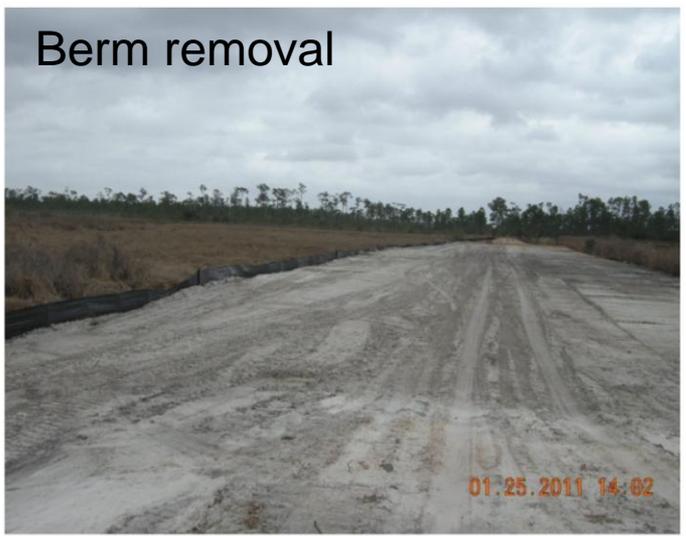
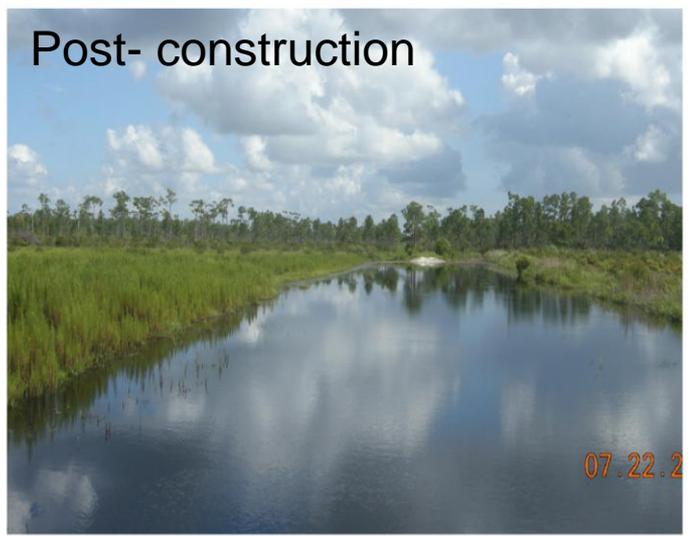
Post- construction

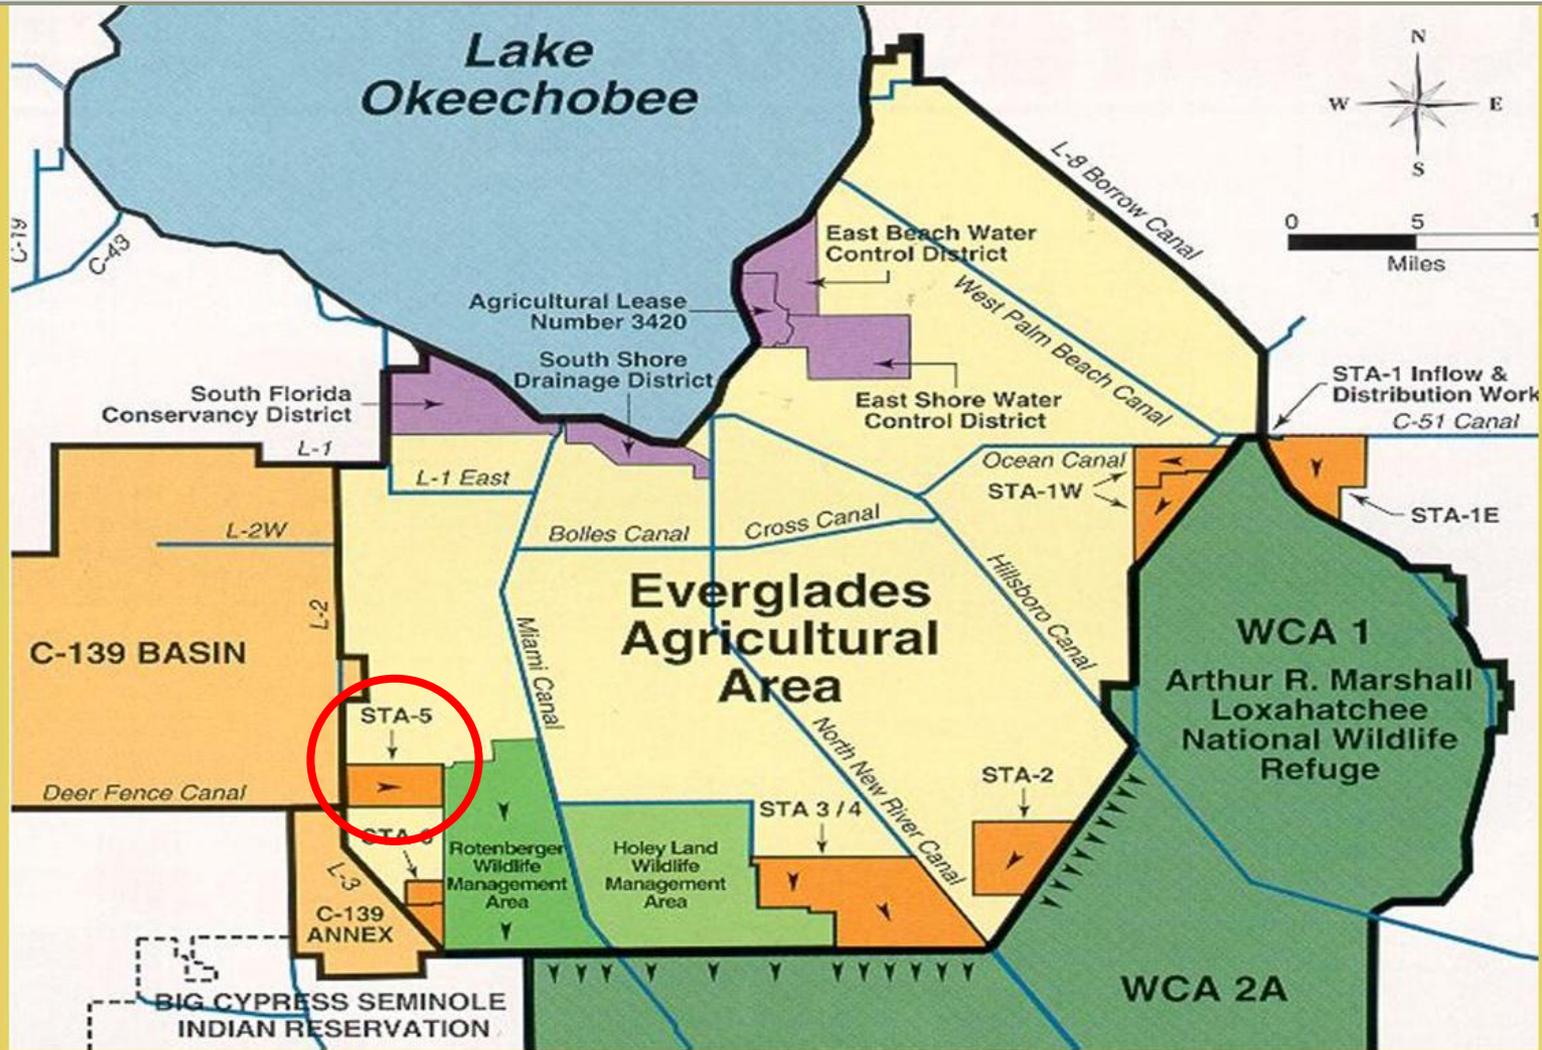
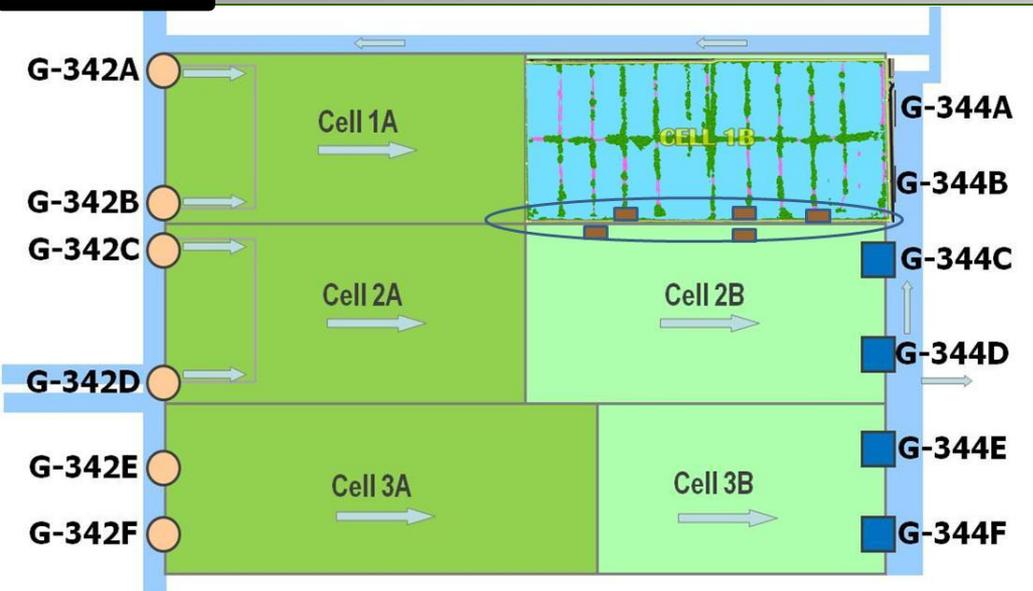
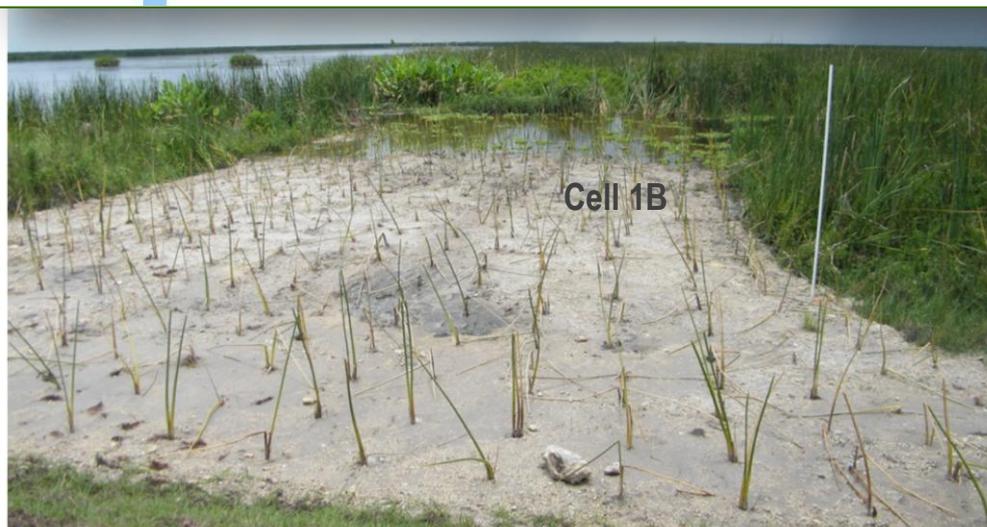
Stormwater Treatment Area 5 Vegetation Strip Plugs & Plantings

- Deep areas along the levee in Cell 1B and 2B plugged June 2011
 - Plugs expected to reduce hydraulic short-circuiting
 - Create continuous vegetation strips across treatment cell
- Bulrush was planted on the plugs & open areas in the Cell 1B vegetation strips
- Coordinated by Vegetation Management Division

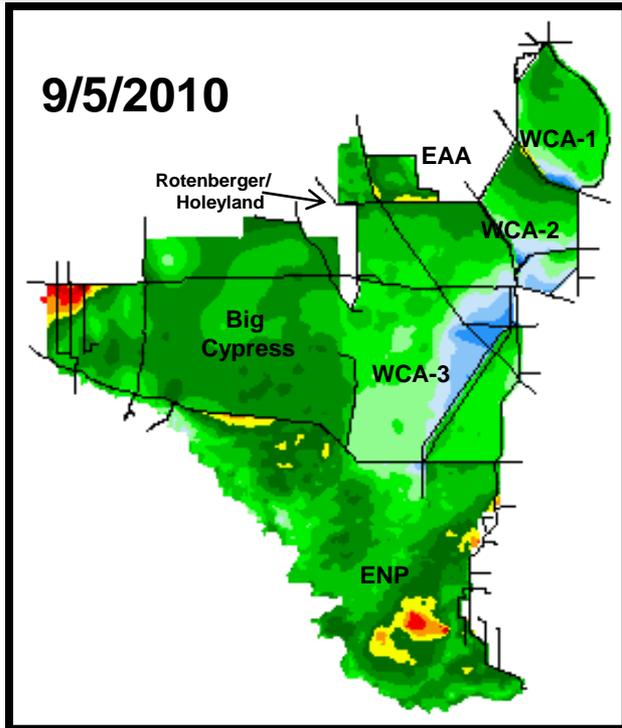
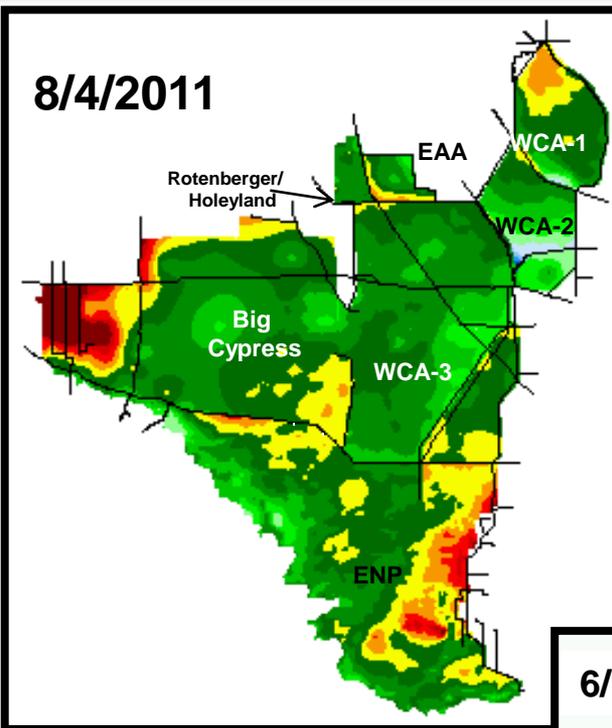
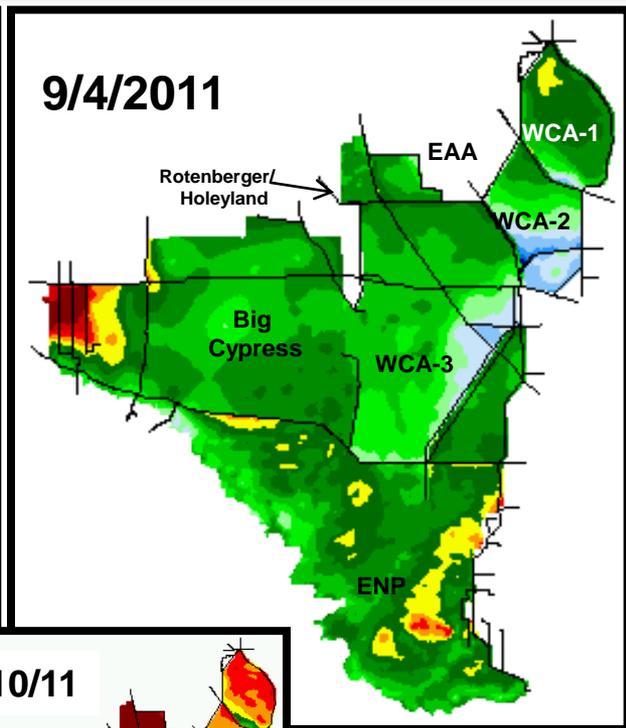
Greater Everglades Water Depth Monthly Snapshots

Water Depth (feet)
