Governing Board Meeting

September 8, 2011

Ecological Conditions Update

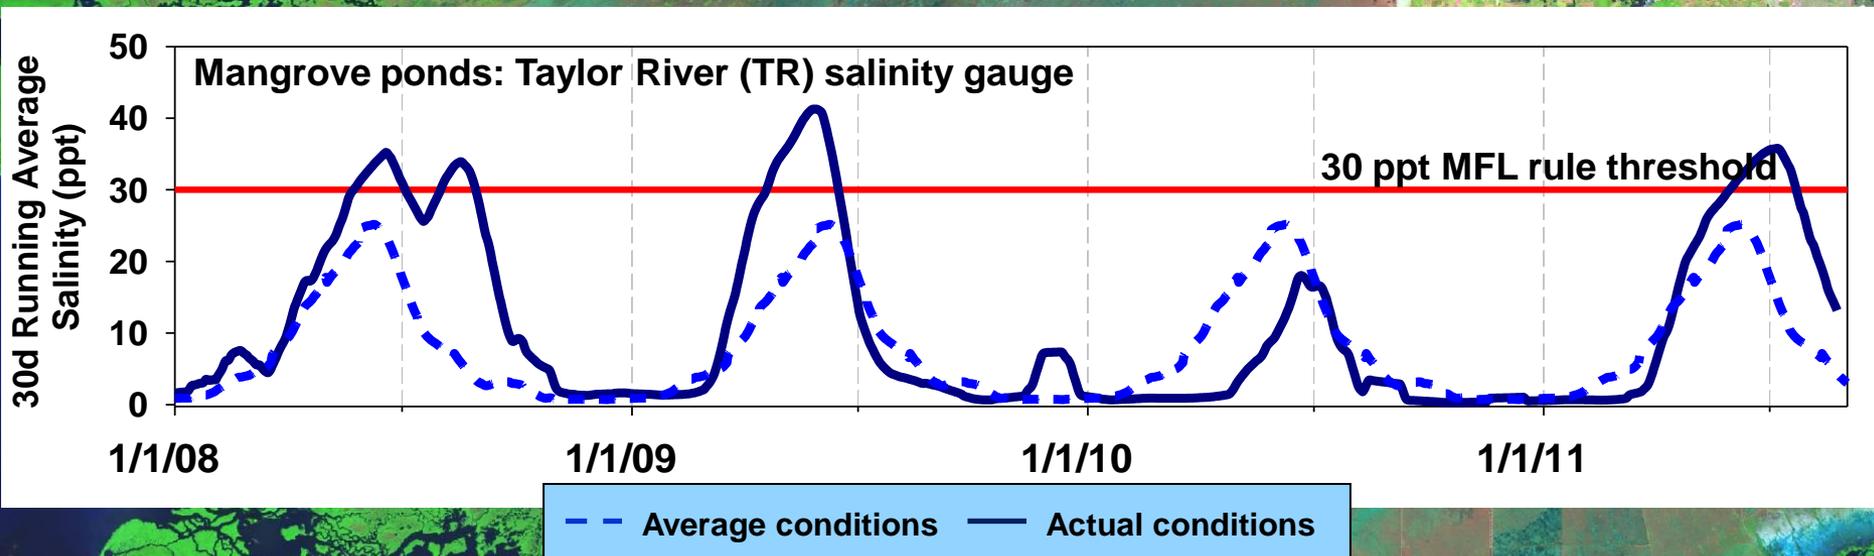
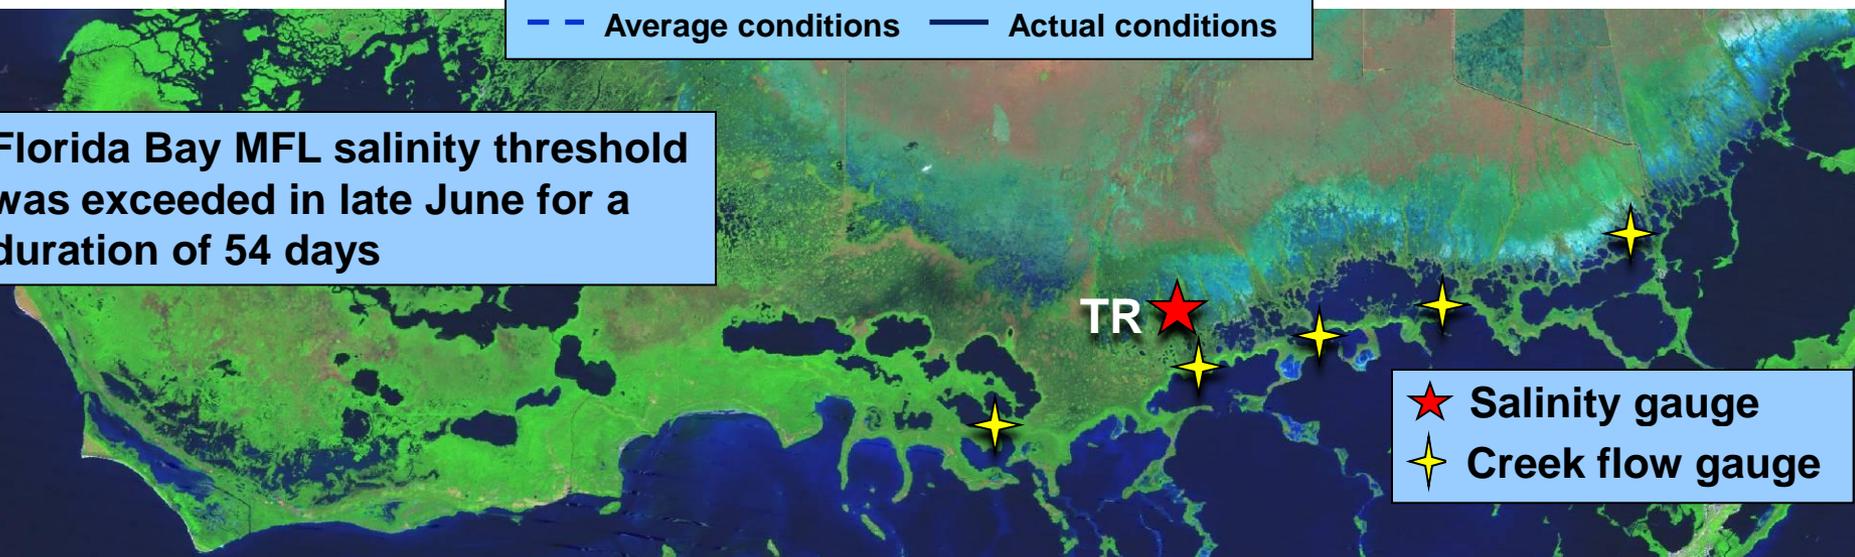
Tracking Salinity in Florida Bay

Florida Bay MFL salinity threshold was exceeded in late June for a duration of 54 days

★ Salinity gauge
★ Creek flow gauge
