# **Adaptive Protocols for Lake Okeechobee Operations**

**Ecological Retrospective**  
*November, 2013 – May, 2014*  
*and Near Future Expectations*

Susan Gray, Ph.D.  
Chief Environmental Scientist  
Applied Sciences Bureau

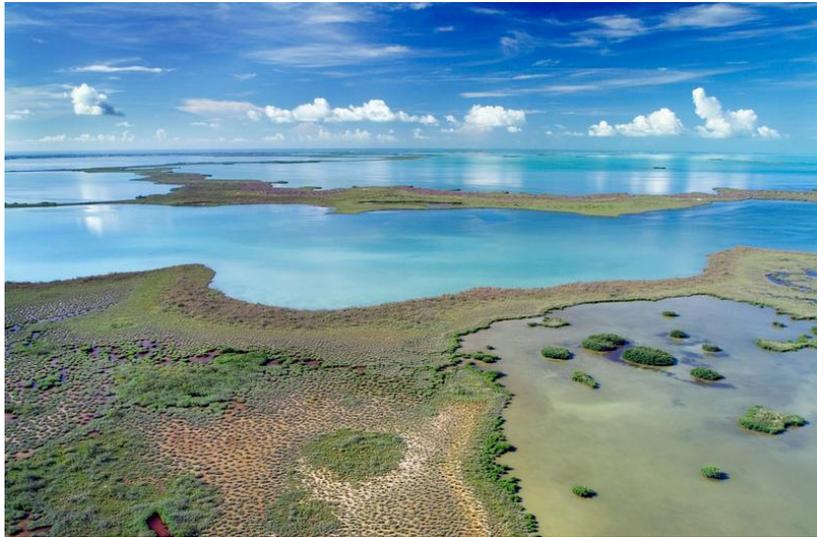
- Water levels in ENP wetlands were generally 2-4 inches above average.
- Salinities in the near-shore areas of Florida Bay remained low, favoring seagrasses and fish production. The MFL site salinity has remained very low (< 5 psu)
- Poor recession rates in Taylor Slough resulted in poor nesting conditions for Roseate Spoonbills.

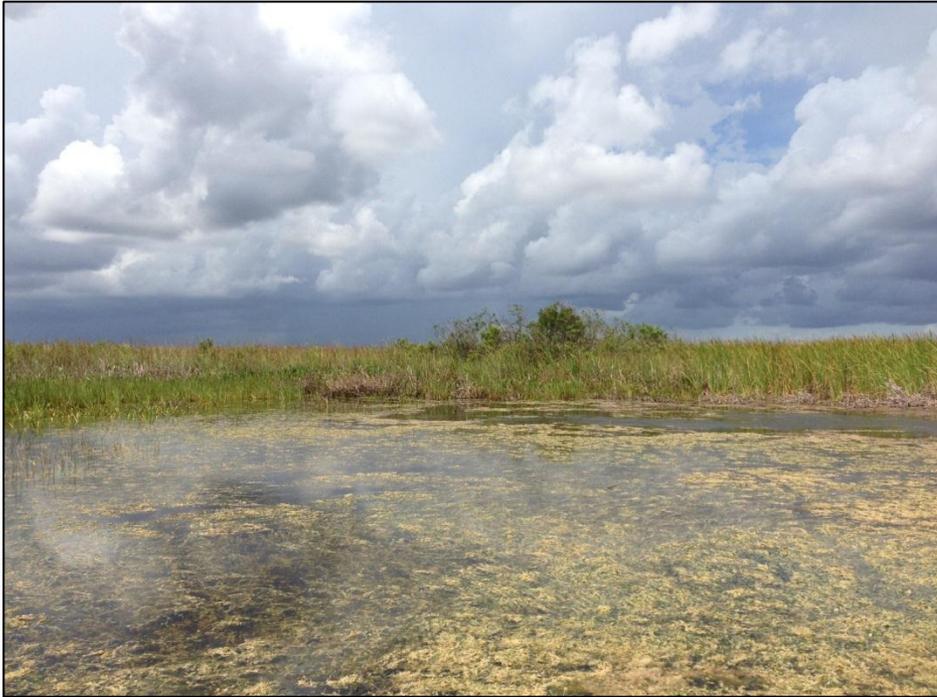
- Water levels are anticipated to be normal to above normal with a normal precipitation outlook.
- Wading bird prey bases are expected to remain good in advance of next year's dry season.
