**Governing Board Meeting  
June 09, 2011**

# **Ecological Conditions Update**

**Linda L. Lindstrom, P.G.**

Director, Restoration Sciences Department

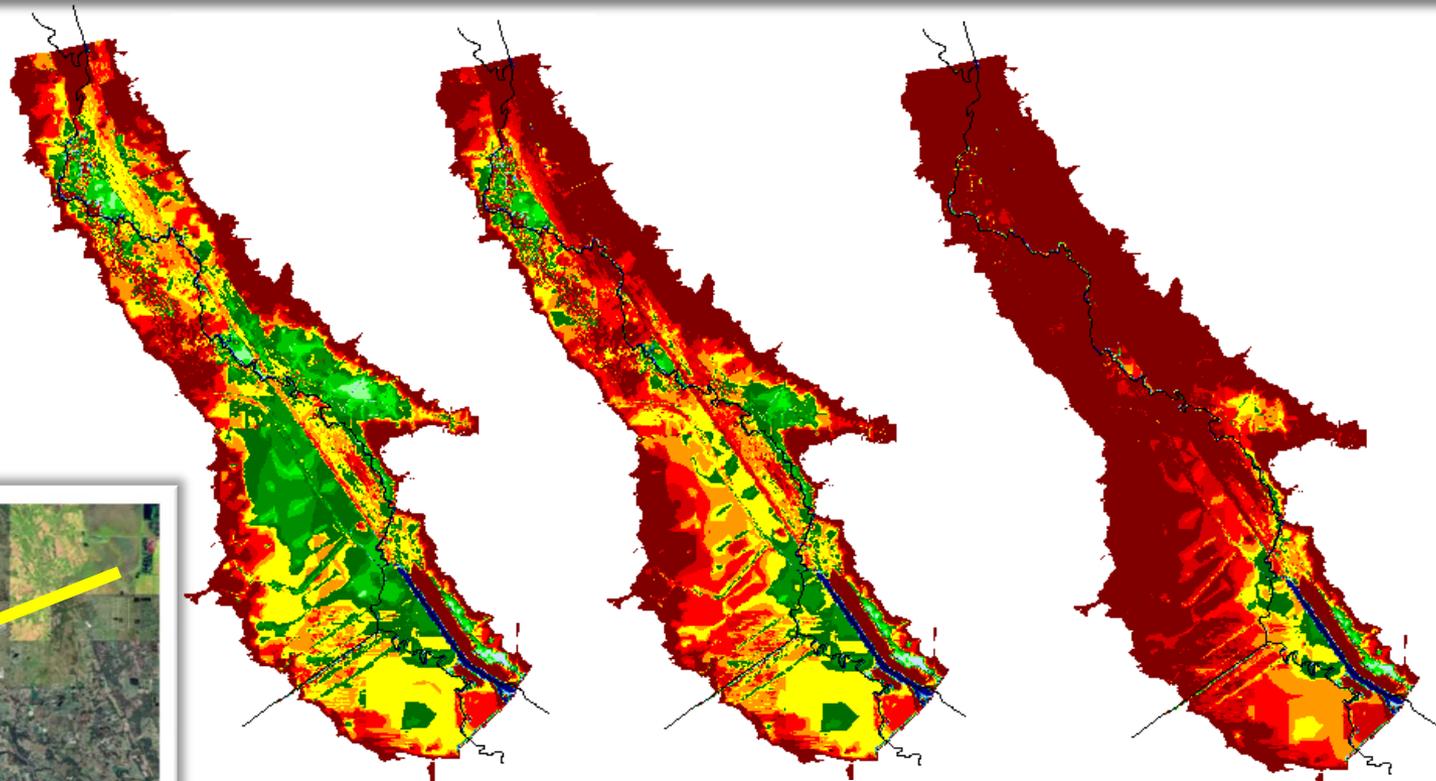
# Kissimmee Basin Water Depth Maps

4/6/2011

5/6/2011

6/6/2011

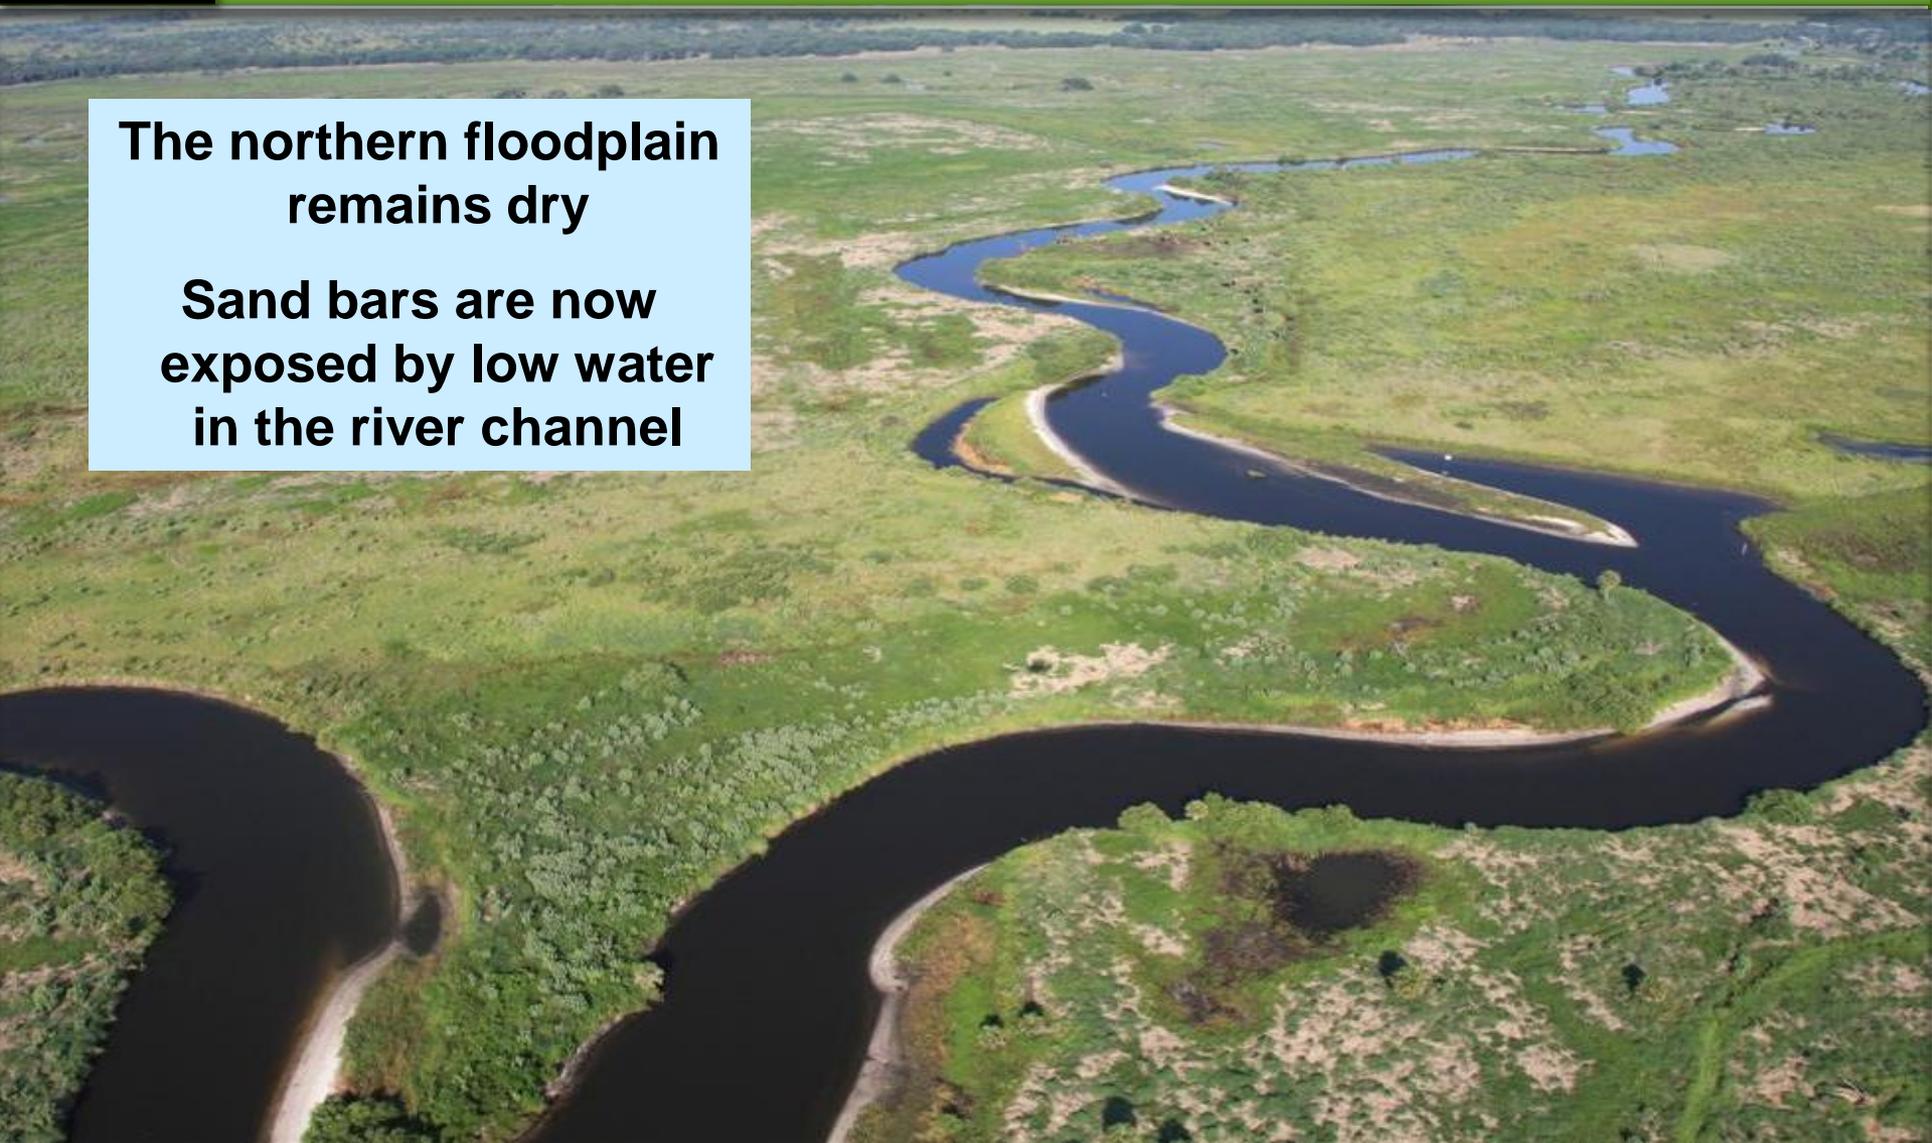
# Kissimmee Basin

**The northern floodplain  
remains dry**

**Sand bars are now  
exposed by low water  
in the river channel**

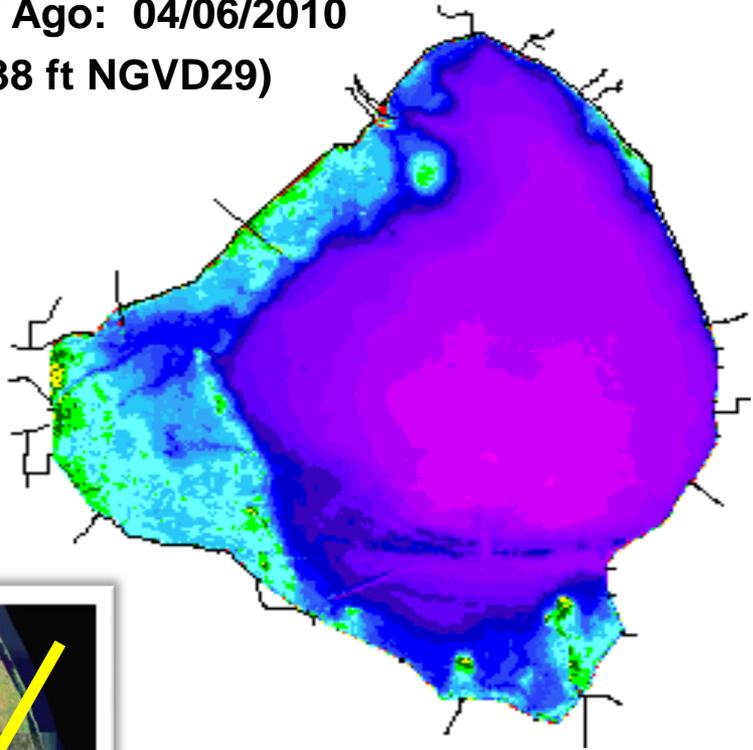
1 Year Ago: 04/06/2010  
(14.38 ft NGVD29)

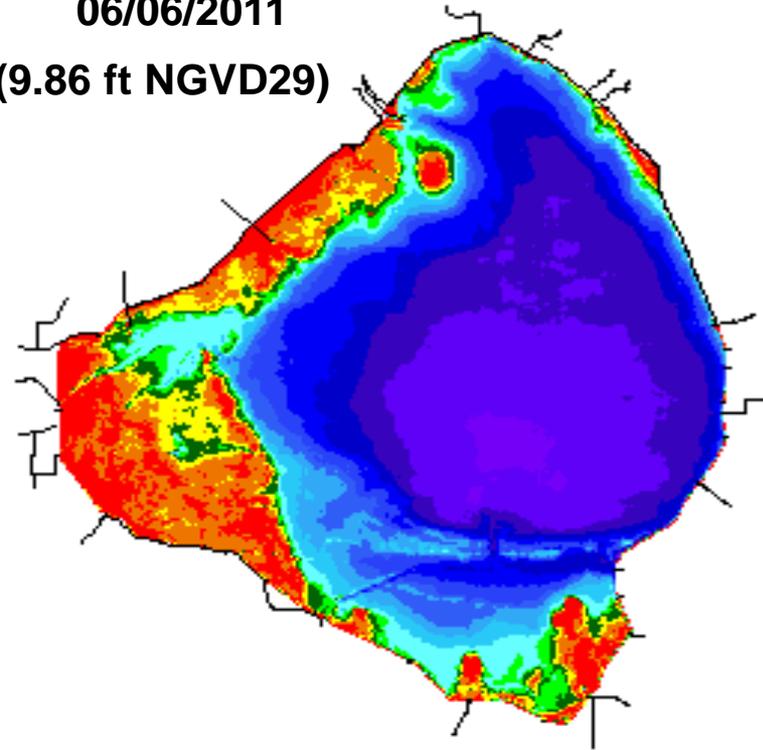
06/06/2011  
(9.86 ft NGVD29)

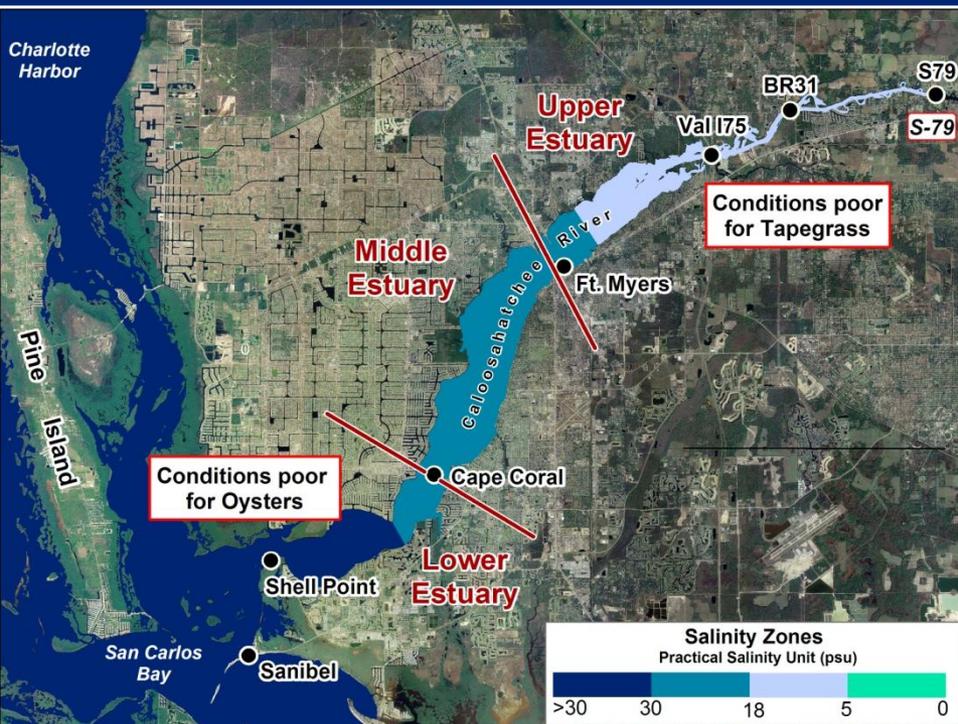
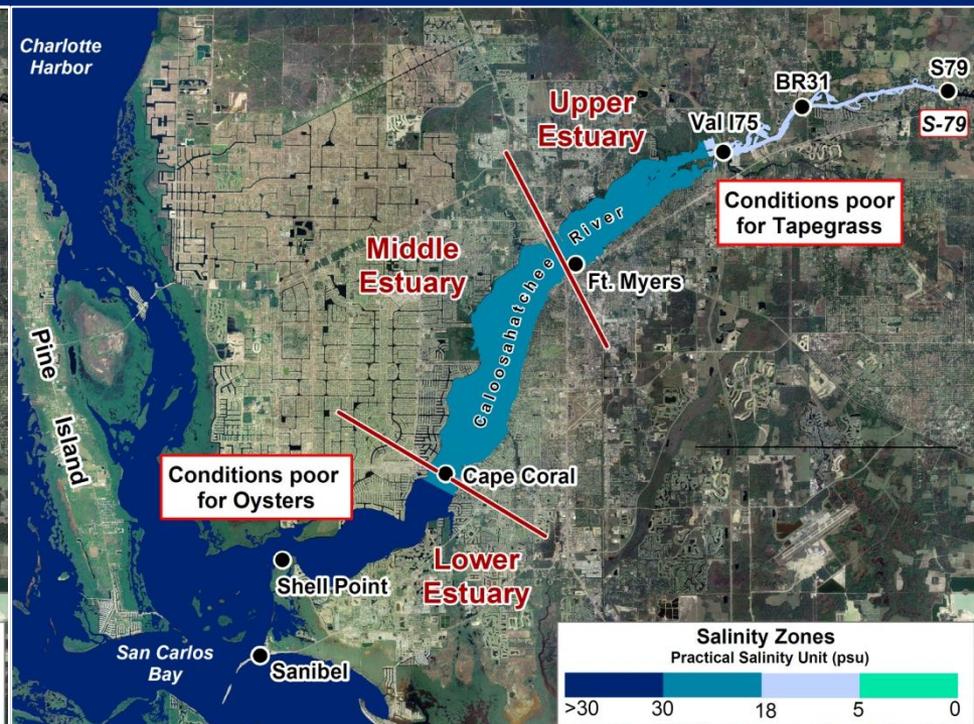
## Salinity Conditions

May 9, 2011

June 6, 2011

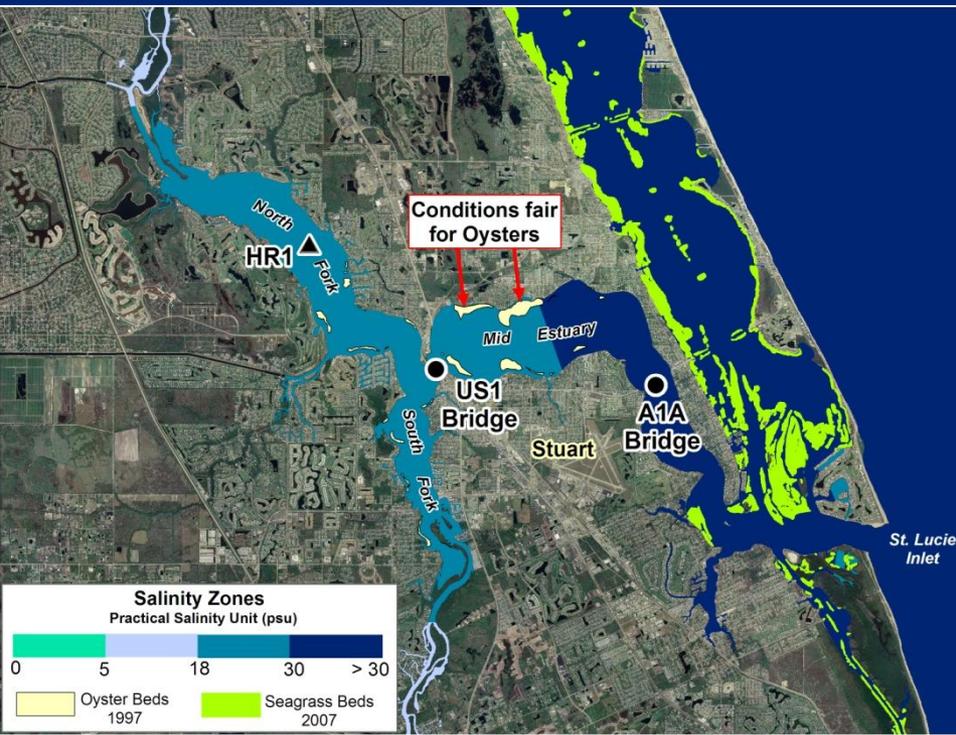
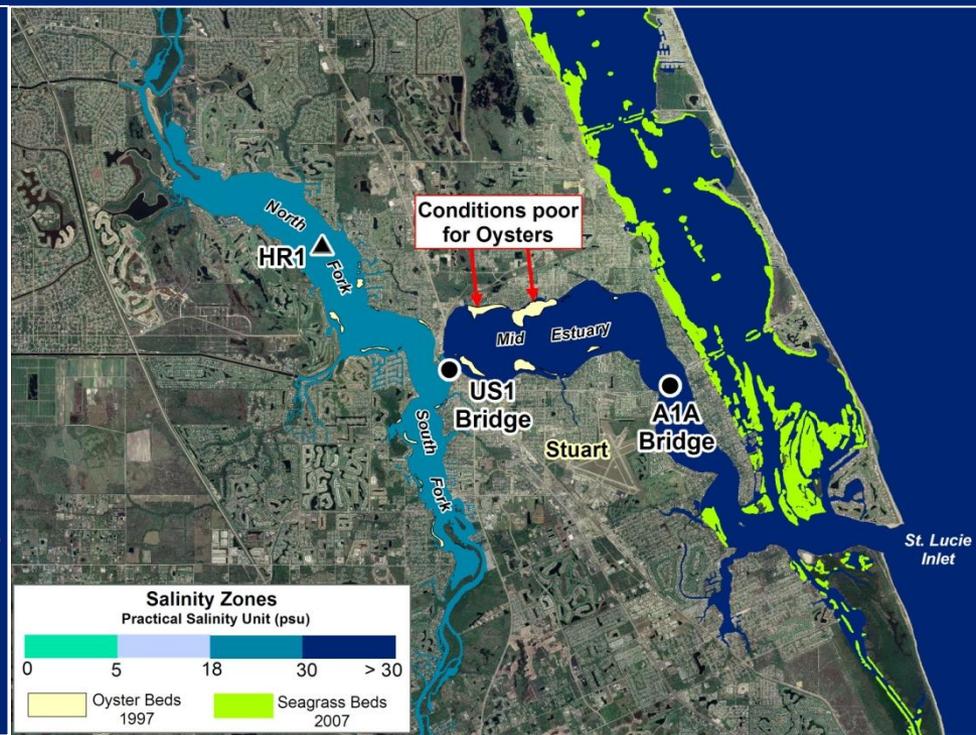
## Salinity Conditions

May 9, 2011

June 6, 2011

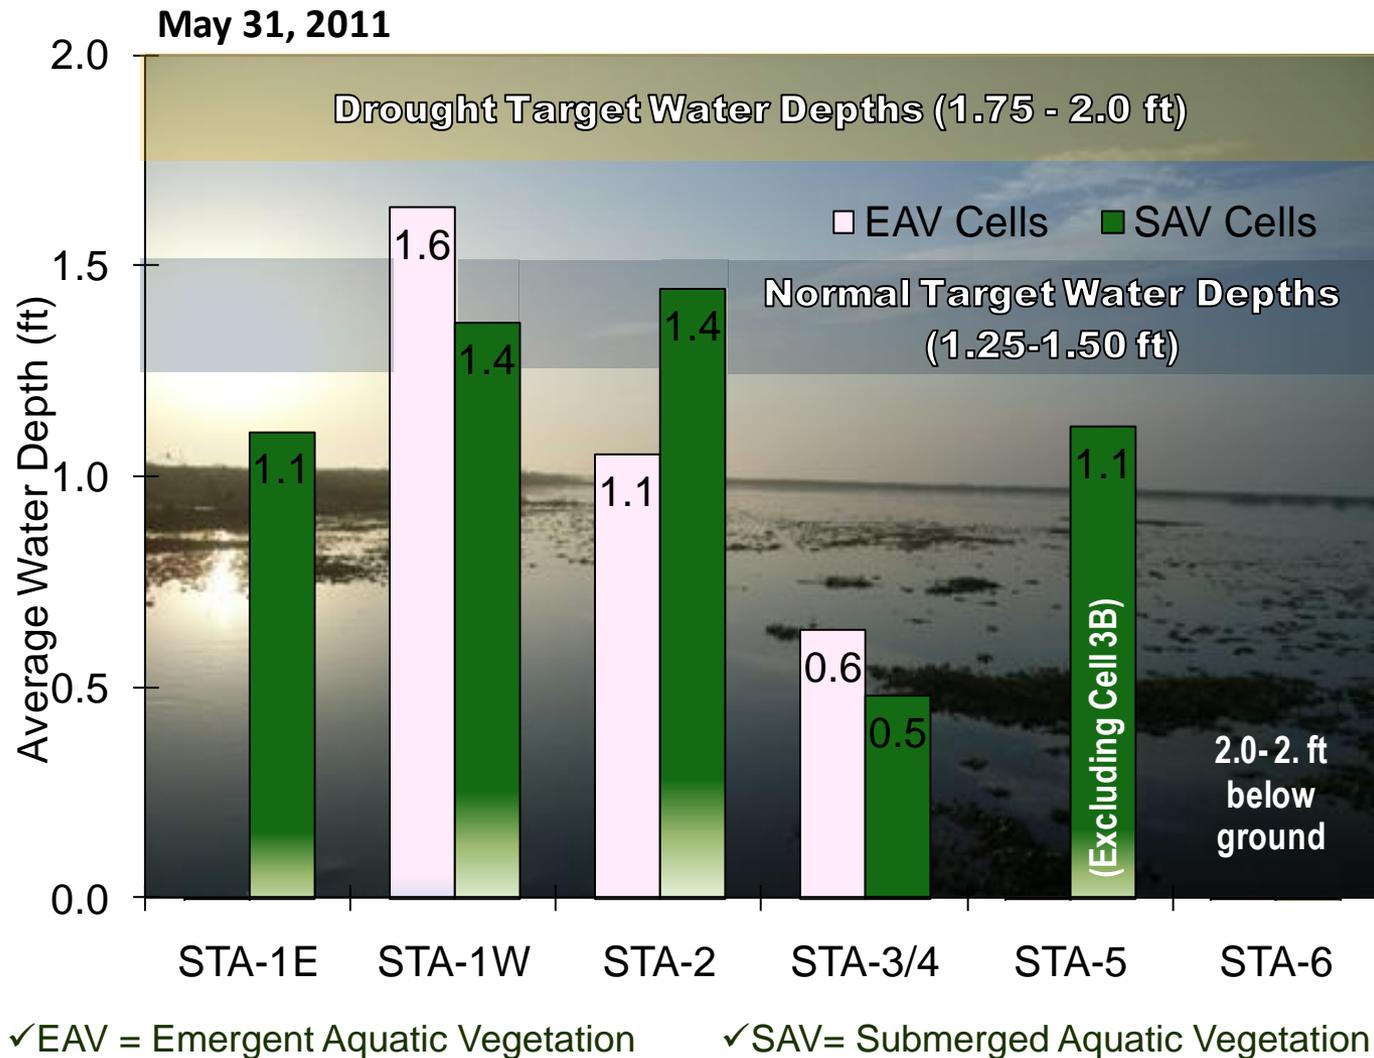
## Water Depth Conditions as of May 31, 2011

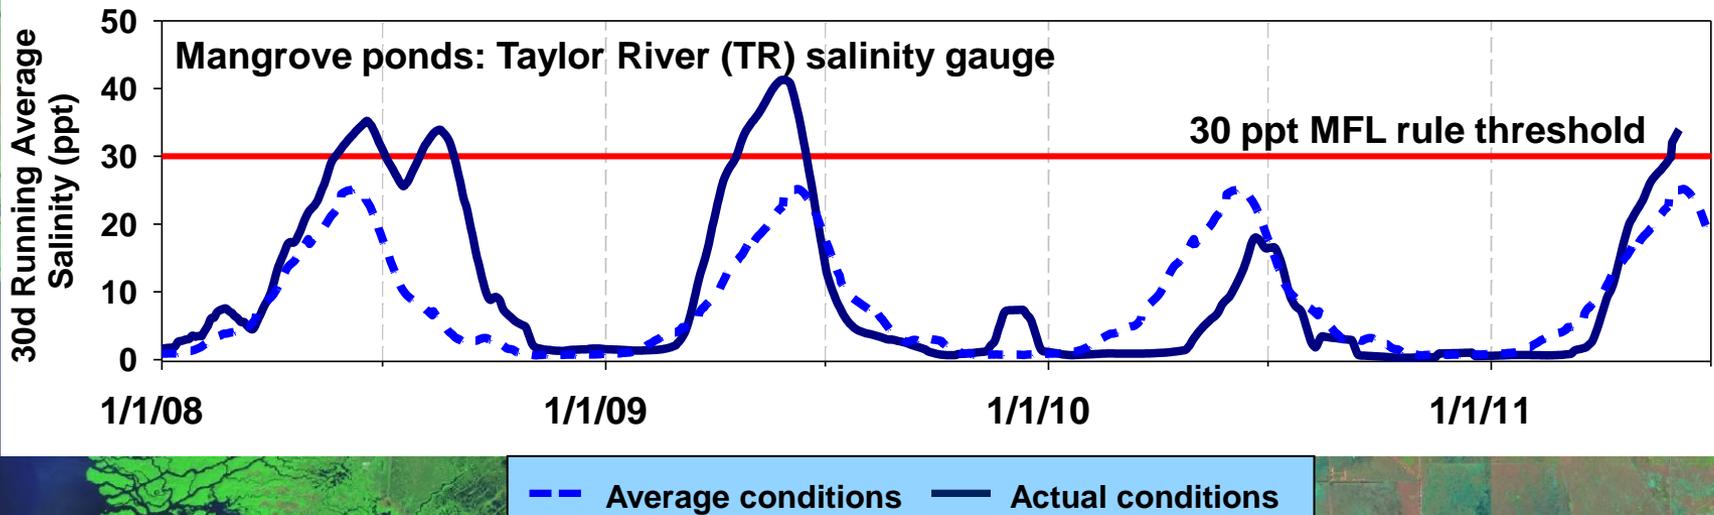
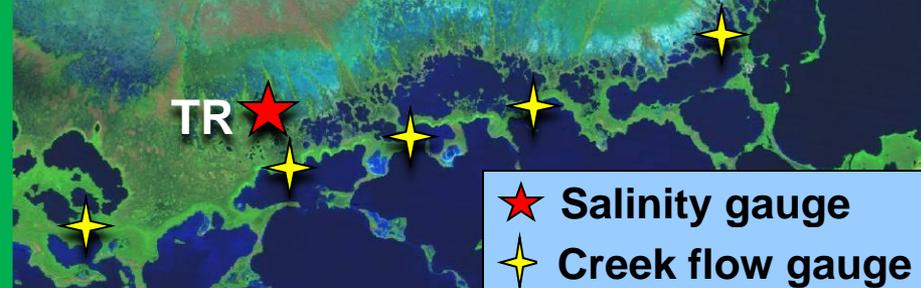
# Tracking Salinity in Florida Bay

- Water levels in the southern Everglades are below average for early wet season
- Florida Bay salinity is slightly above average and rising. Some areas are hypersaline (> 40 ppt)
- Florida Bay MFL salinity threshold was exceeded week of 5/30
