# Environmental Conditions Update

**Governing Board Meeting  
August 9, 2012**

Terrie Bates  
*Division Director*  
Water Resources Division

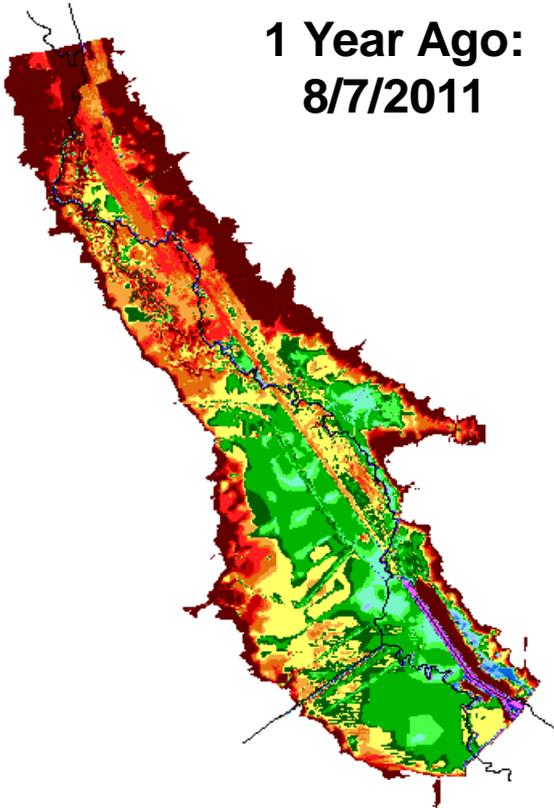
**1 Year Ago:  
8/7/2011**

# Kissimmee River (Pool C)

## Monthly Water Depth Maps

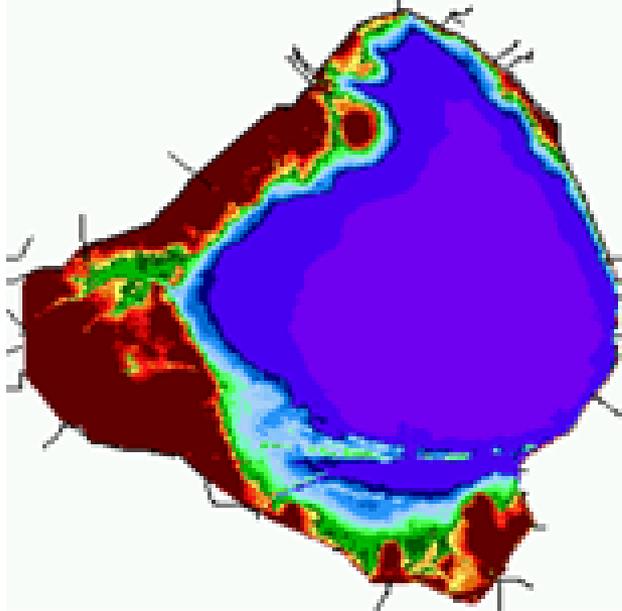
1 Year Ago: 08/07/2011

# Lake Okeechobee Water Depth Timeseries Maps

(10.26 ft NGVD29)

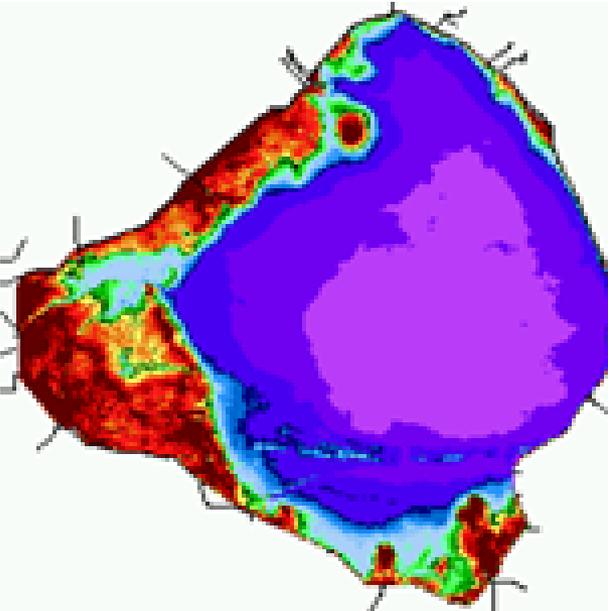
1 Month Ago: 07/07/2012

(12.03 ft NGVD29)

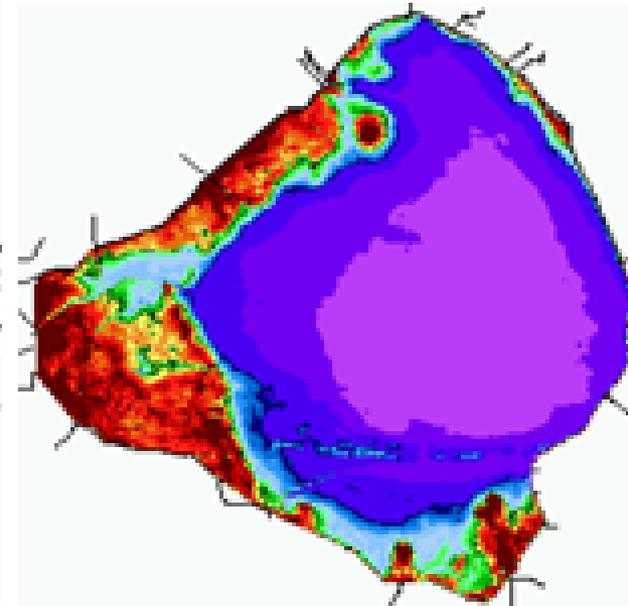
Current: 08/07/2012

(12.12 ft NGVD29)

**Current Lake Level  
12.15 ft NGVD 8/9/12**

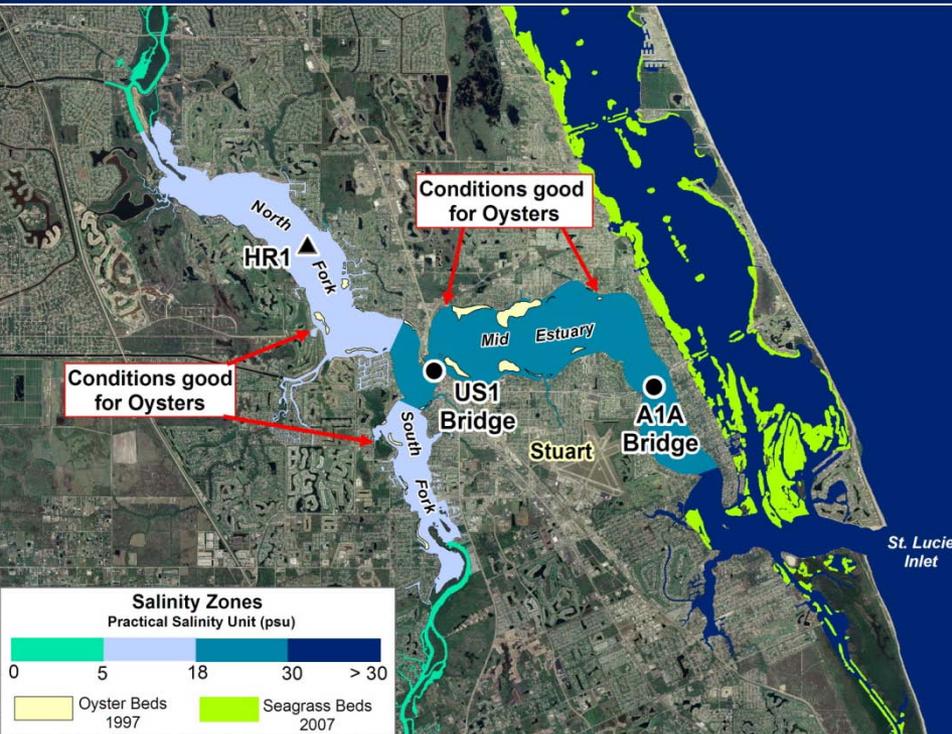
July 9, 2012

## Salinity Conditions

NOTE: Good Range for Oysters: 10 – 30

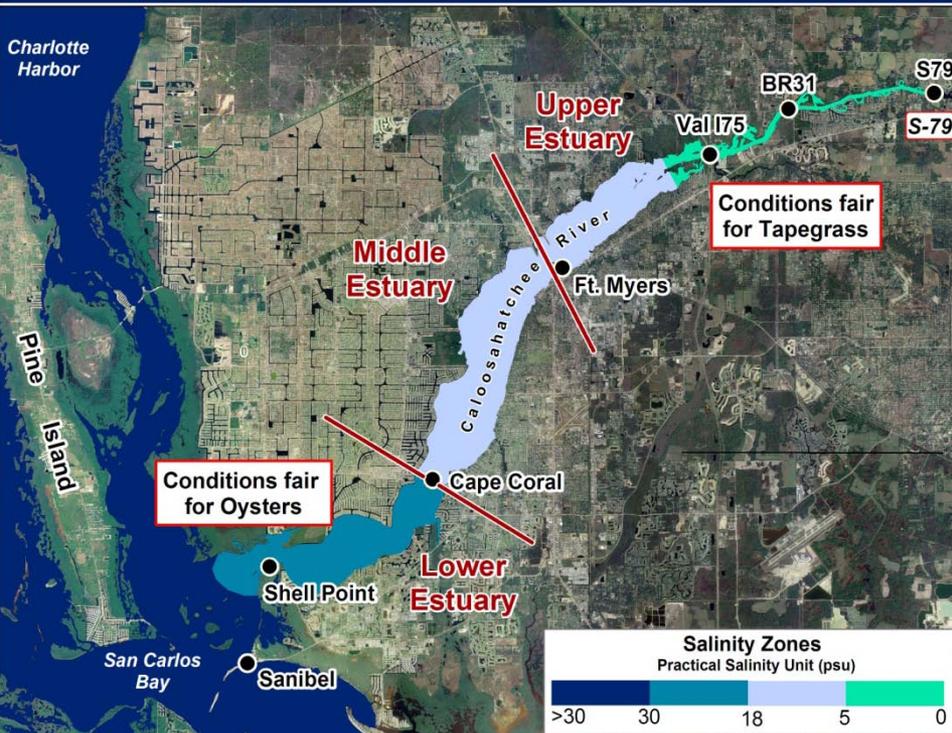
July 9, 2012

## Salinity Conditions

NOTE: Good Range for Oysters: 10 – 30

Optimal Range for Tape Grass: 0 – 5

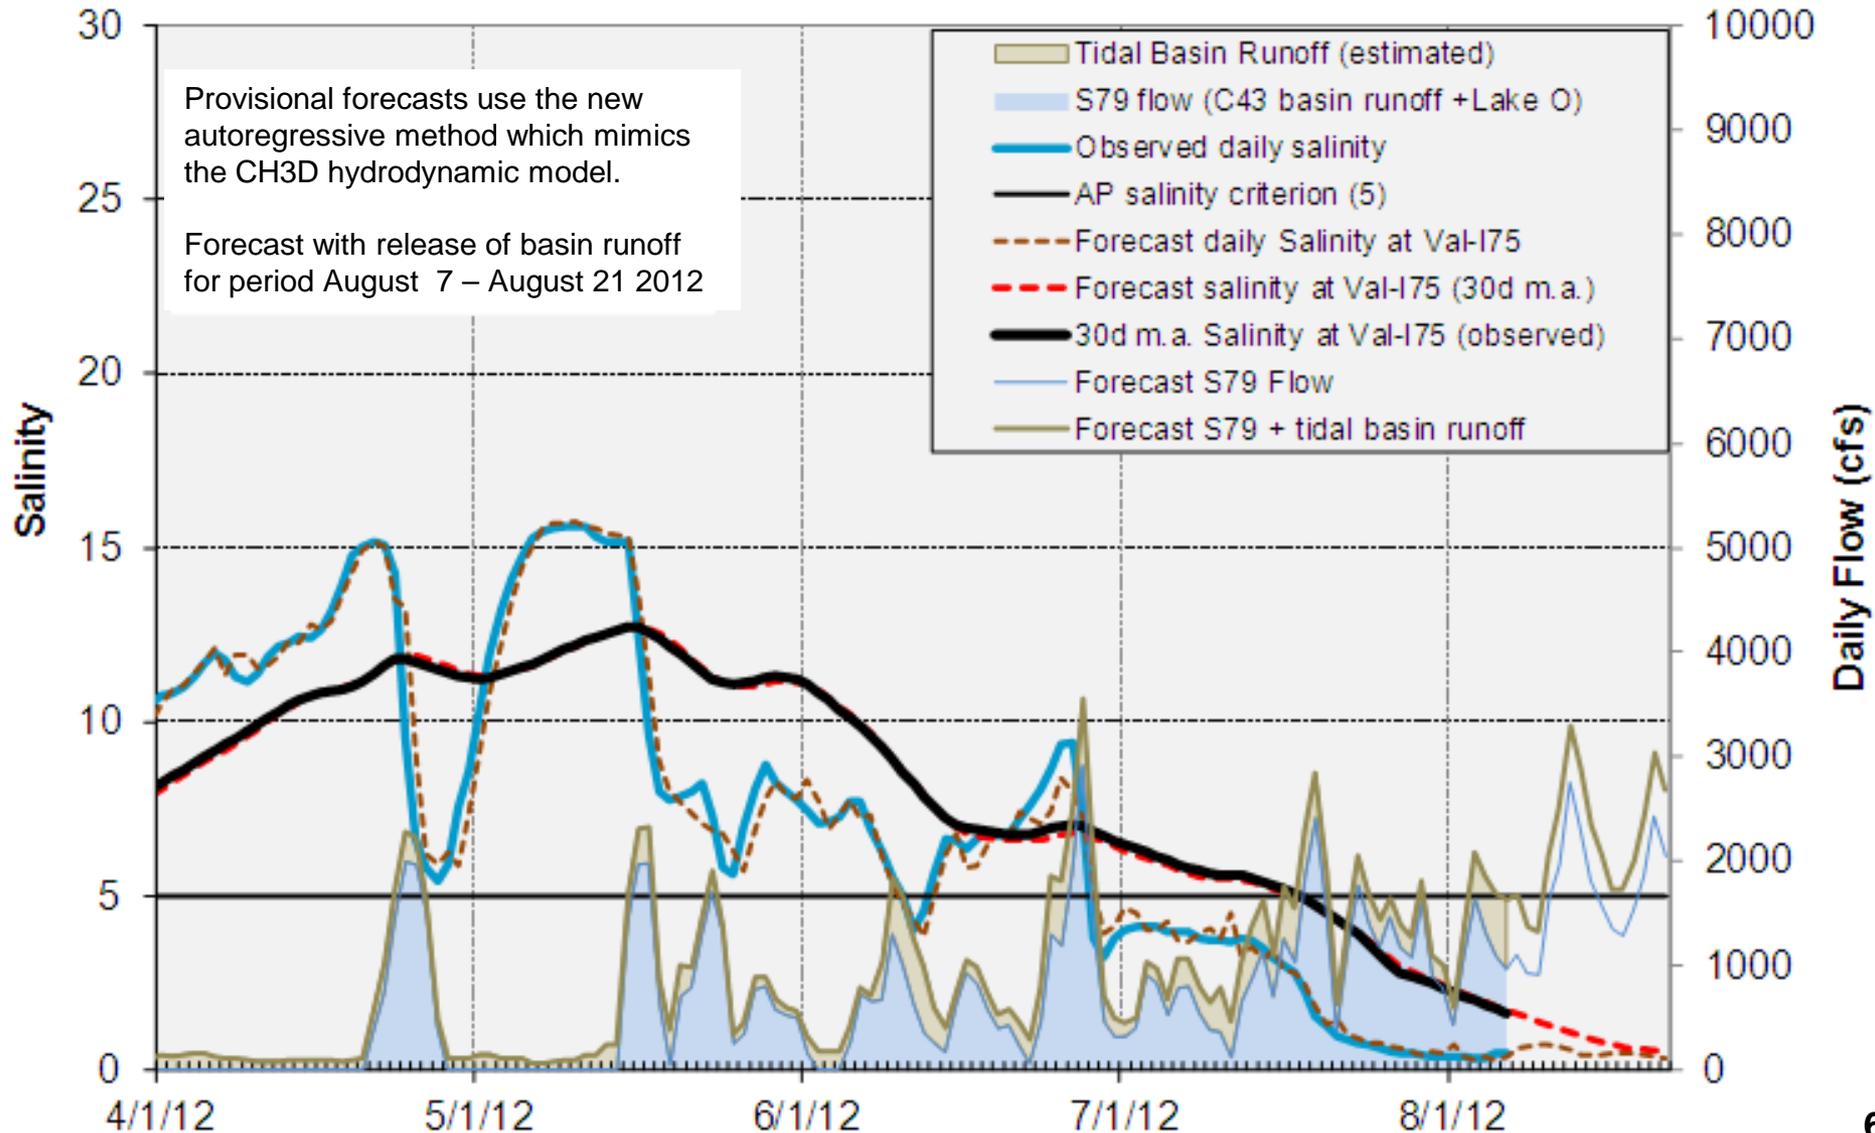
# Caloosahatchee Estuary Flows and Salinity Observed and Forecast Salinity at Val I-75

**Forecast 1: S-79 = 1700 cfs of C-43 basin runoff & TBR = 520 cfs**

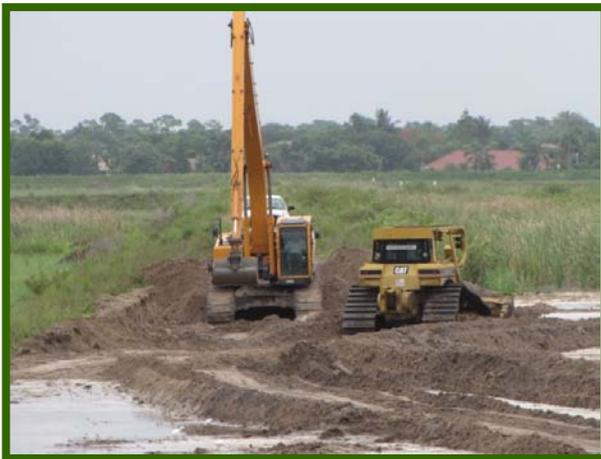
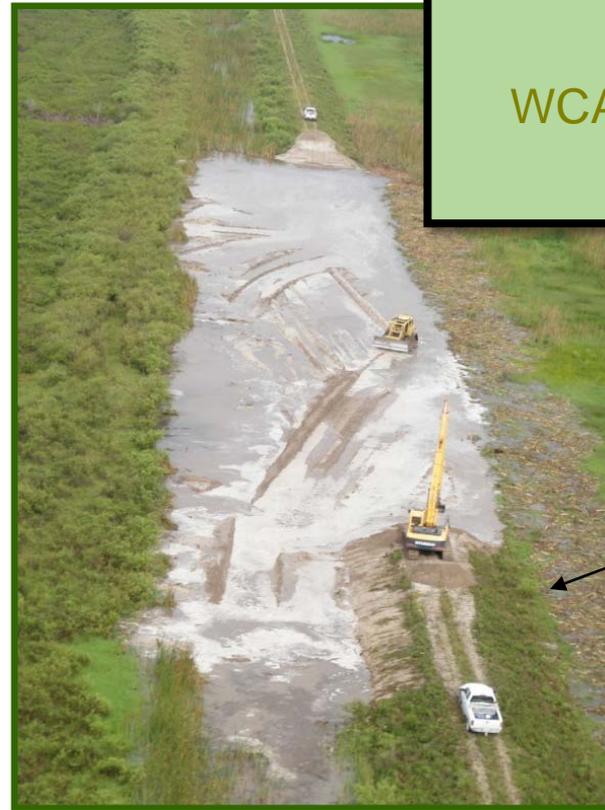
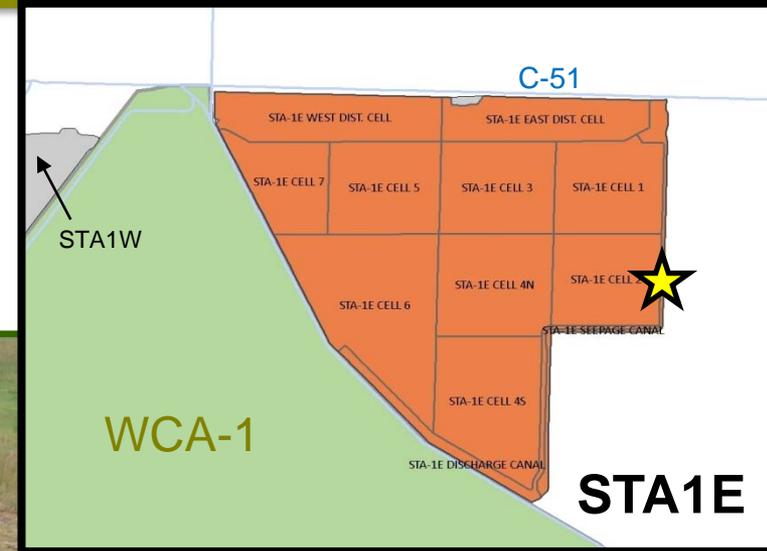
### Berm associated w/completed Army Corps of Engineers PSTA Demonstration Project in Cell 2 partially degraded

- Reduces obstruction to flow
- Allows for full operation of Eastern Flow-way

*Partial degradation of berm in STA-1E Cell 2.*

*The truck & back hoe are parked near the section of the berm where a 500' cut was made*

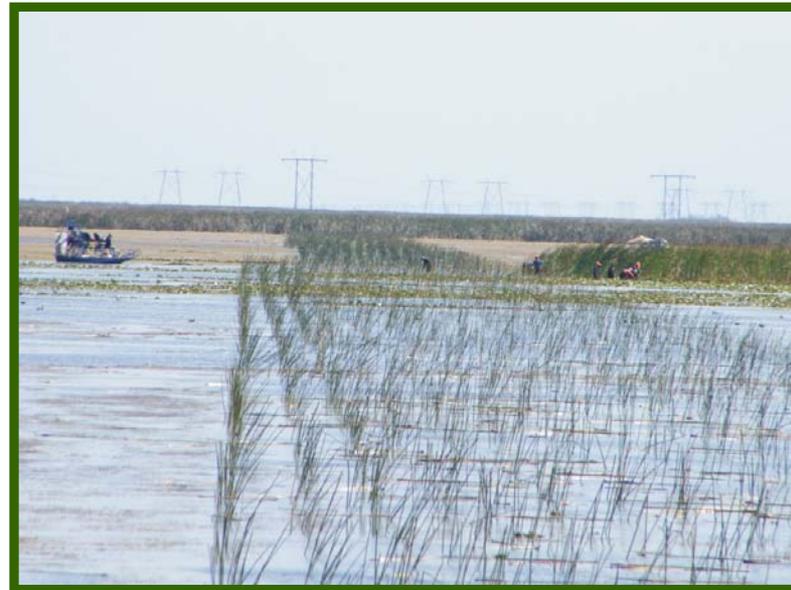
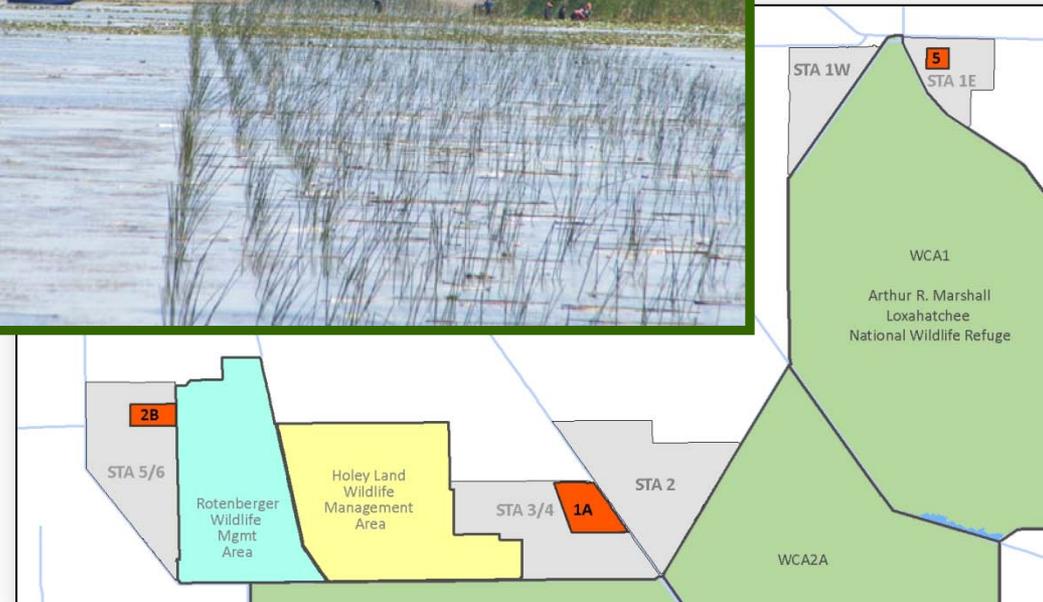
## Completed bulrush planting in STA-1E Cell 5, STA-3/4 Cell 1A, and STA-5 Cell 2B

- Bulrush planted in open water areas or areas devoid of vegetation
  - Reduces hydraulic short-circuiting
  - Provides protective vegetation strips
  - Improves phosphorus removal efficiency

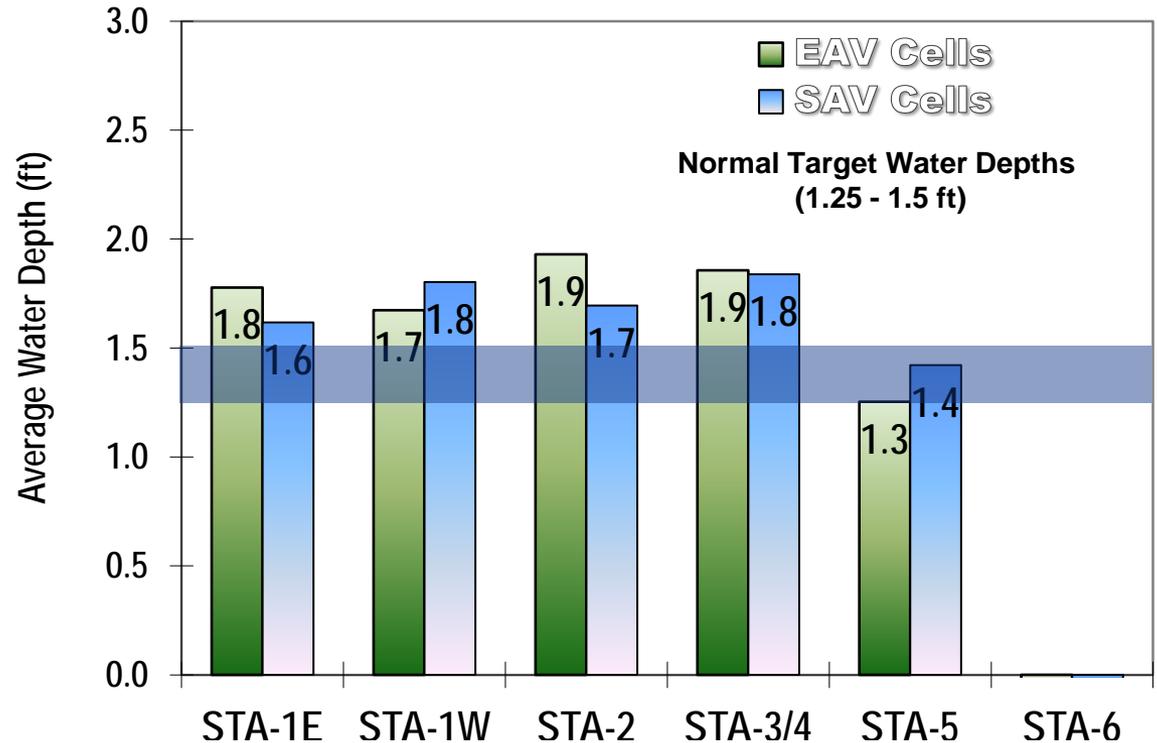
August 6, 2012

## Water Depths

*Except for STA-6:*

- Water depths are at or above target
- Inflows received over last month

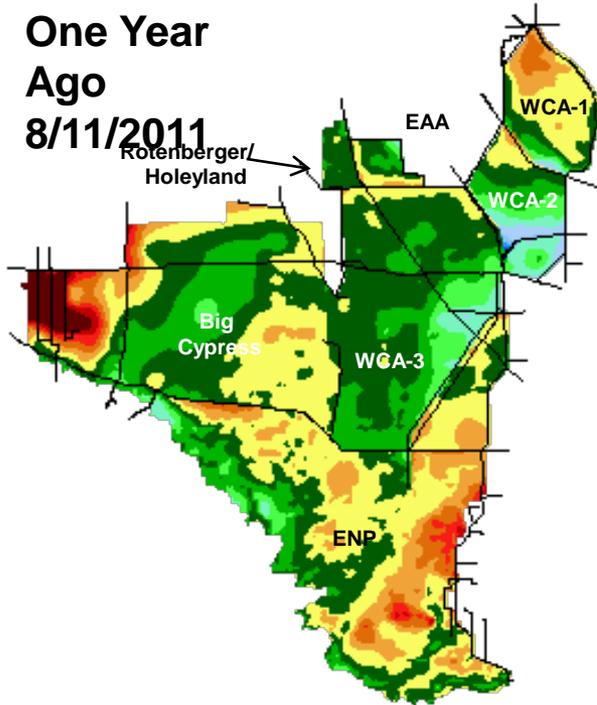
One Year  
Ago  
8/11/2011

# Greater Everglades Water Depth Monthly Snapshots

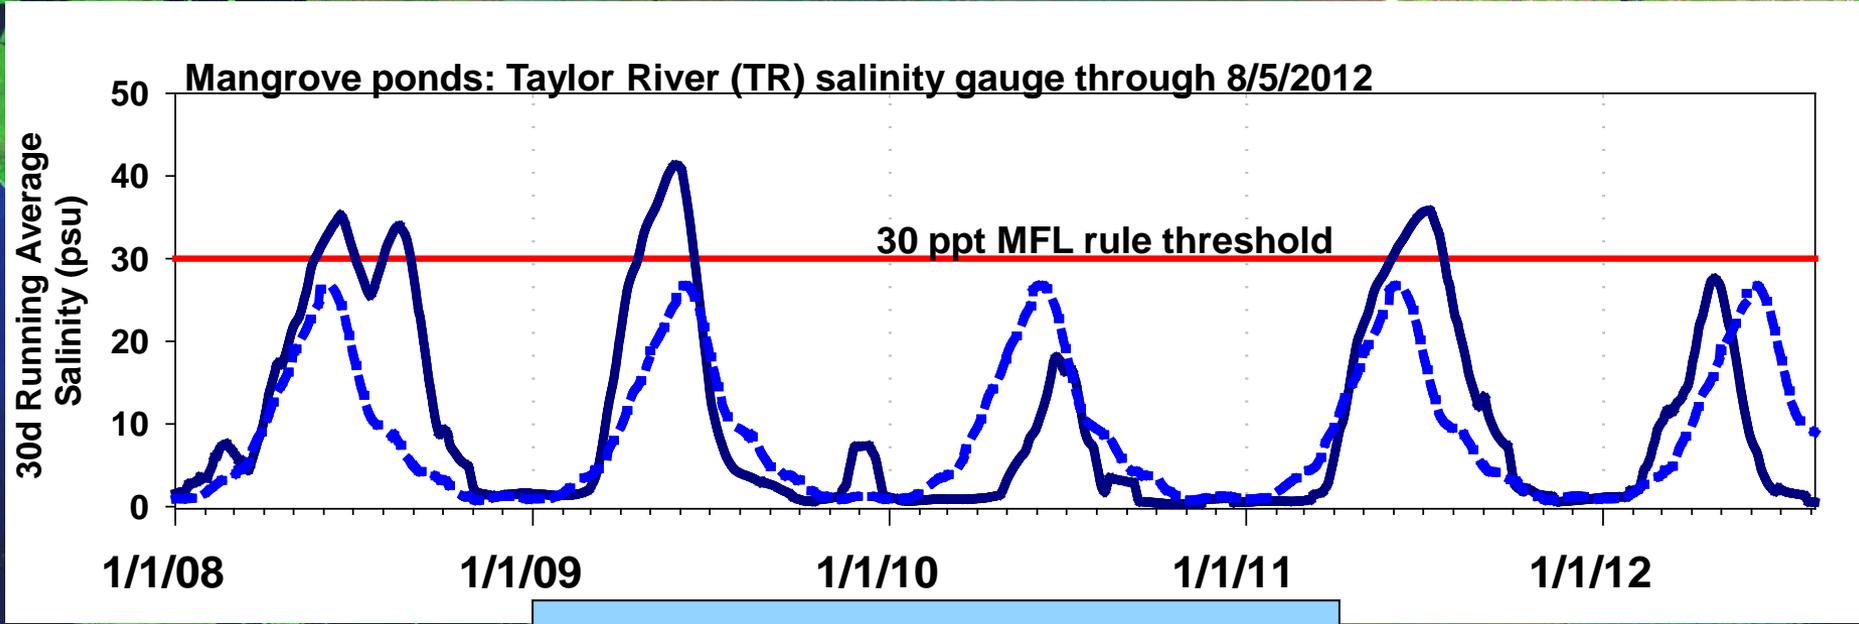
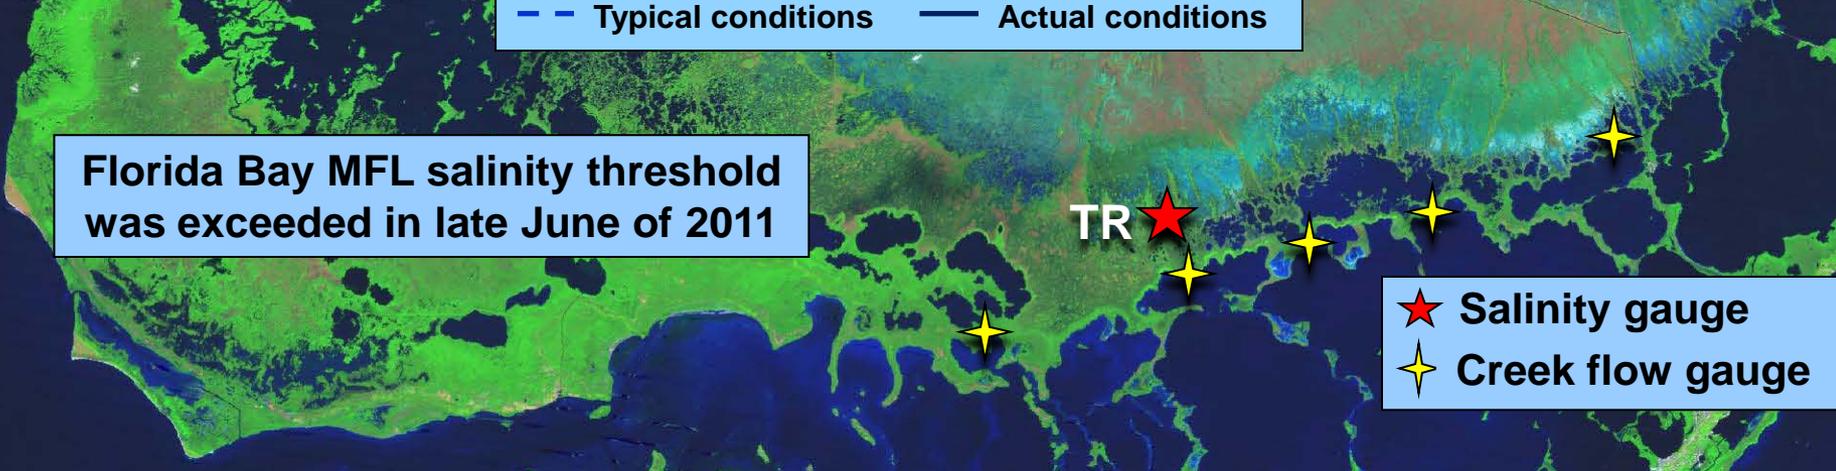
# Tracking Salinity in Florida Bay

Florida Bay MFL salinity threshold was exceeded in late June of 2011
