Broward County East Coast Protective Levee Technical Evaluation

Tommy B. Strowd, P.E.
Deputy Executive Director

Project & Lands Committee Meeting
January 12, 2011

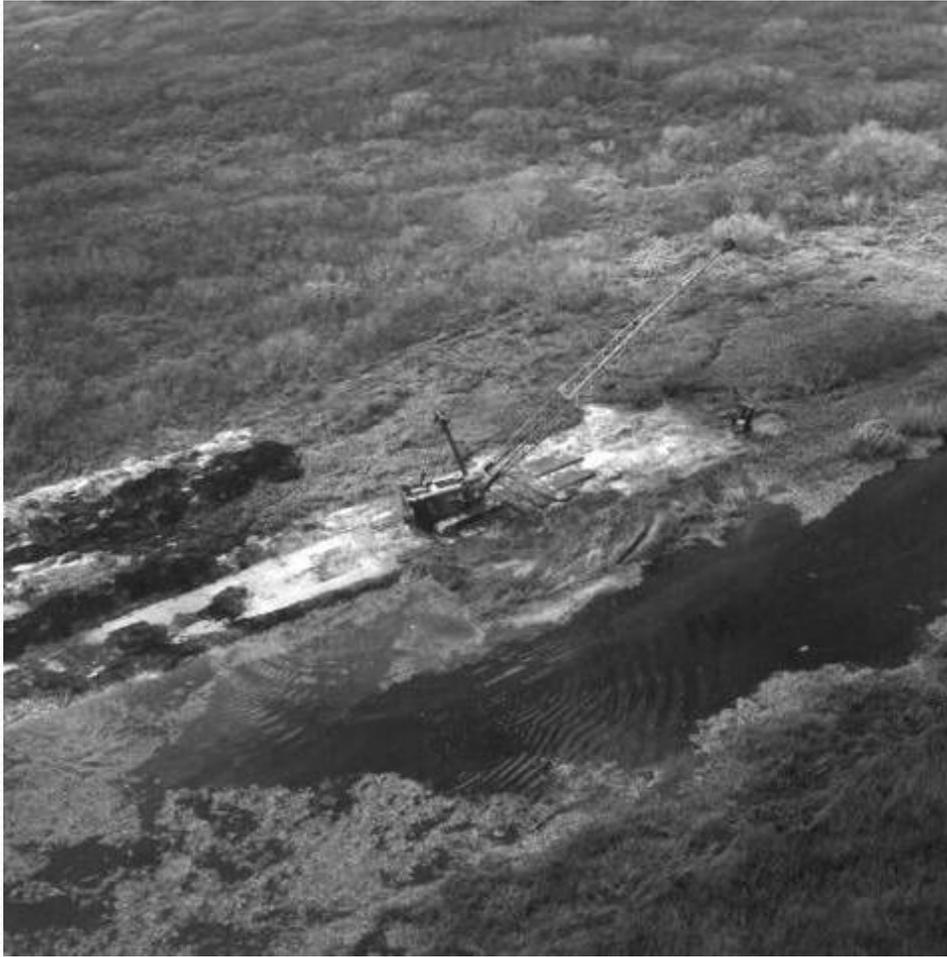
East Coast Protective Levee

- Authorized by Congress in 1949
- Constructed between 1952 and 1954
- Basic design consisted of locally dredged limestone placed on top of a thin layer of organic peat.
 - Levee and adjacent borrow canal.
 - In the 1950's peat was considered a suitable material to reduce seepage

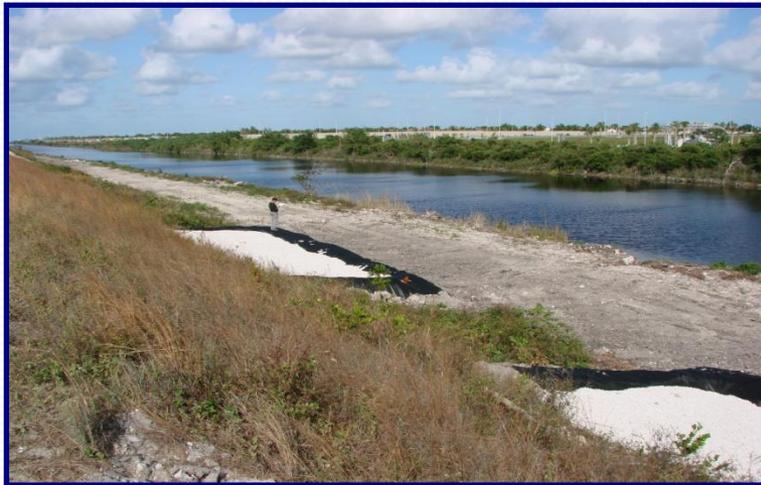
BCI Levee Evaluation Objectives

- Review Existing Records
- Determine Current Condition
- Complete Engineering Analyses using Current Design Standards
- Confirm FEMA Requirements
- If found, Note Deficiencies and Possible Remediation
- Provide Certification per 44 CFR 65.10

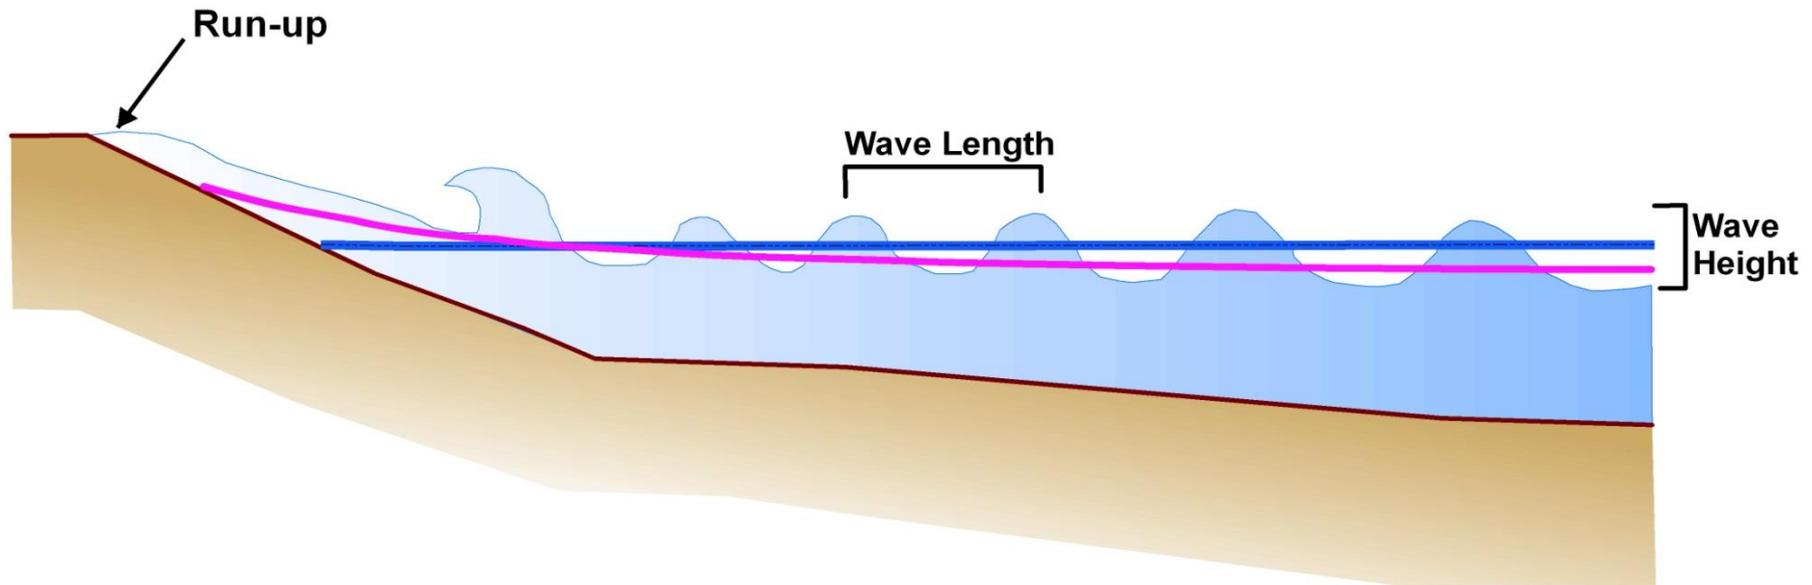
A levee crest will be deemed to meet the freeboard criteria described in CFR 44 Ch.1 §65.10 if its elevation is at least a foot higher than the height of maximum wave run-up associated with the computed 100-year static water level.

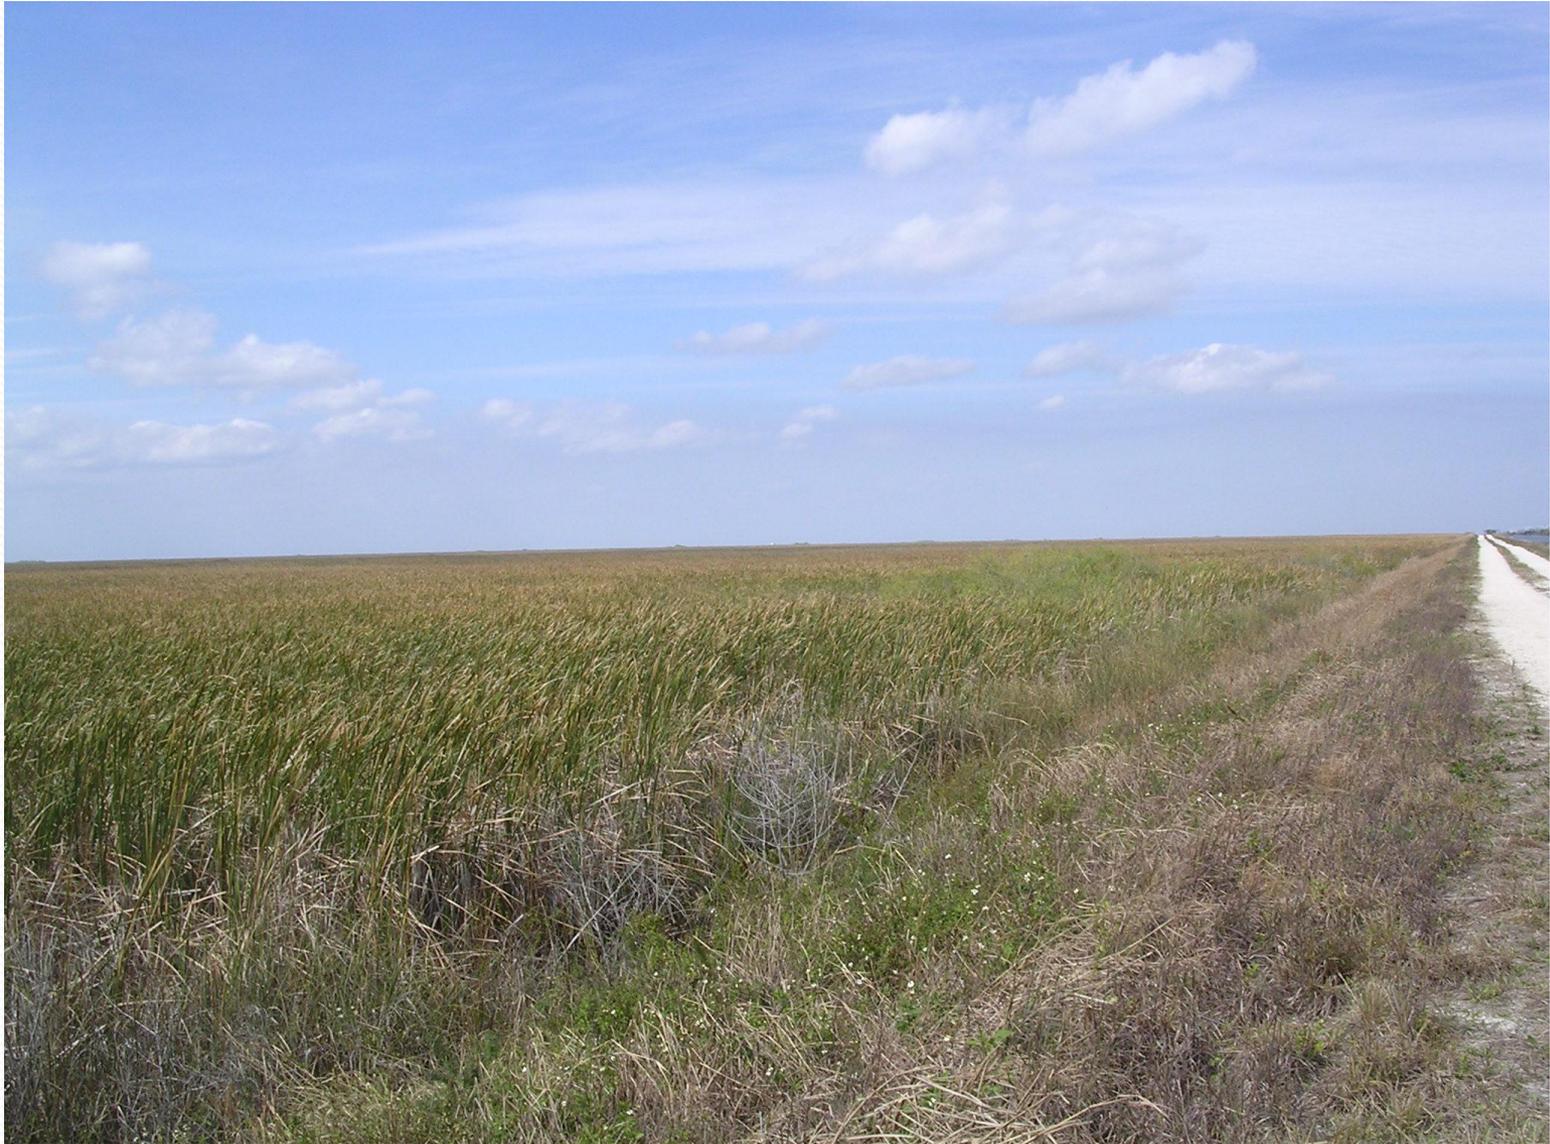
Dense Vegetation Reduces Winds and Waves

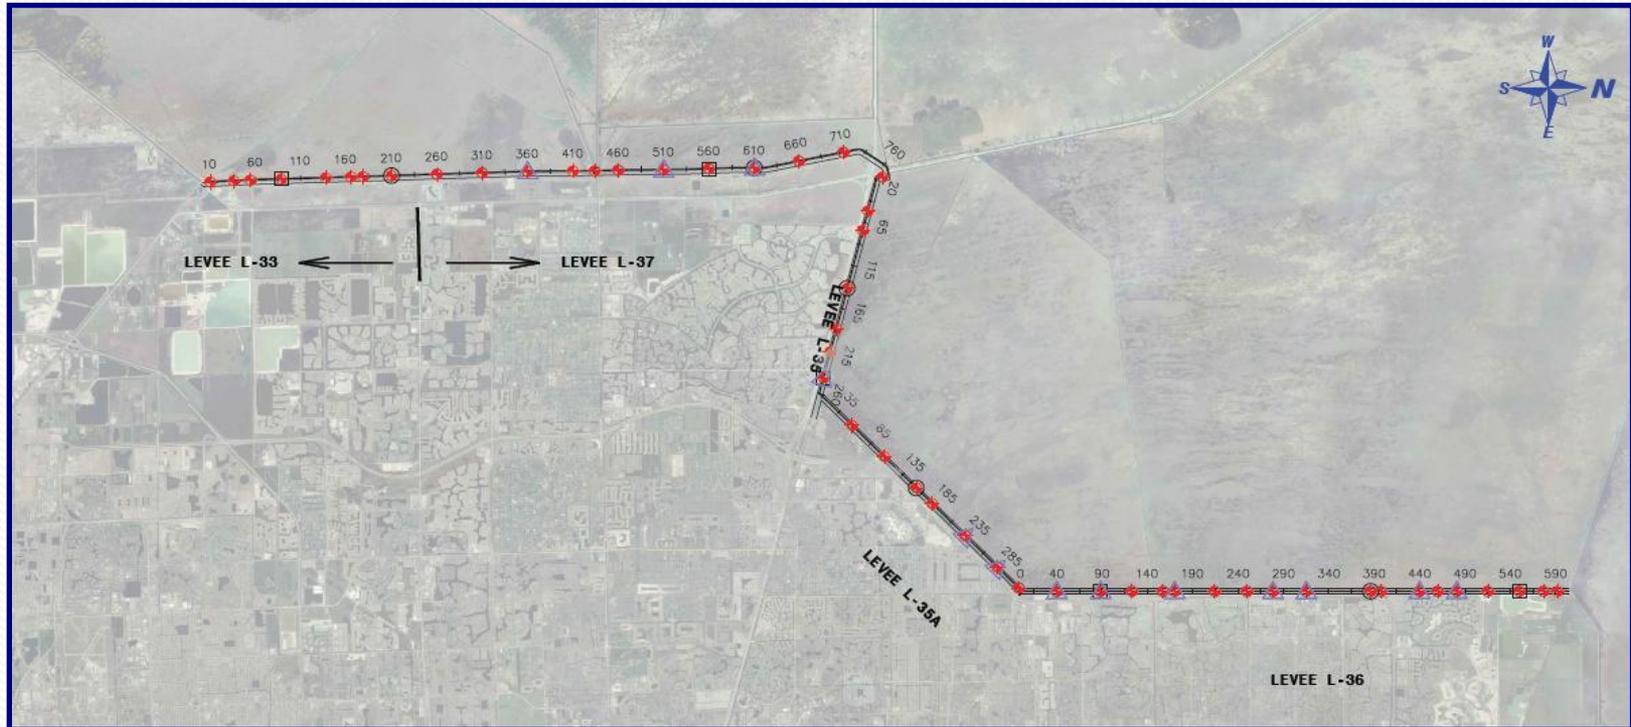
Site Investigation Plan

- 59 SPT borings
- 22 Shelby tubes attempted
- 5 levee bulk samples
- 10 In-Situ Hydraulic Conductivity Tests

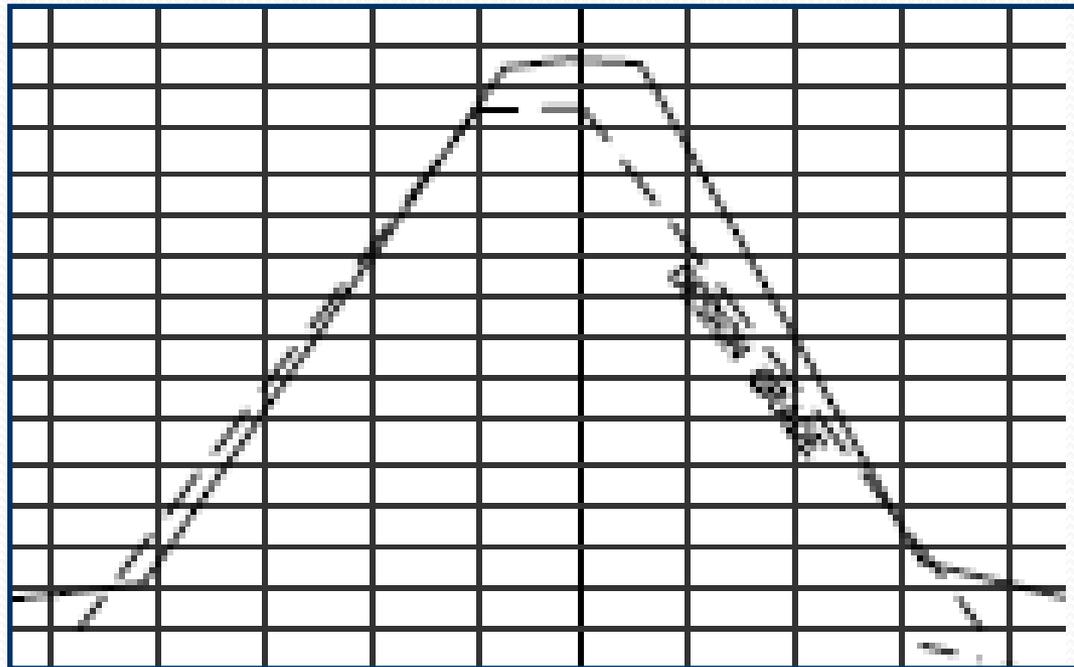
- Portions of the east Coast Protective Levee have side slopes that are steeper than designed
- This could create slope stability issues

- Raise crest of about 1000 feet of L-36 in the vicinity of S-38B
- Recommend Construction of Downstream Toe Berm along Levee Alignments
 - Engineering design will determine;
 - Most appropriate areas for remediation and their priority
 - Cost & schedule
- Flatten Upstream Slope; parts of L-36
- Perform additional geo-tech analysis in specific areas
