**PRELIMINARY REPORT ON
RAINSTORM OF
JUNE 23-30, 1992**

December 1992

**South Florida Water Management District
West Palm Beach, Florida**

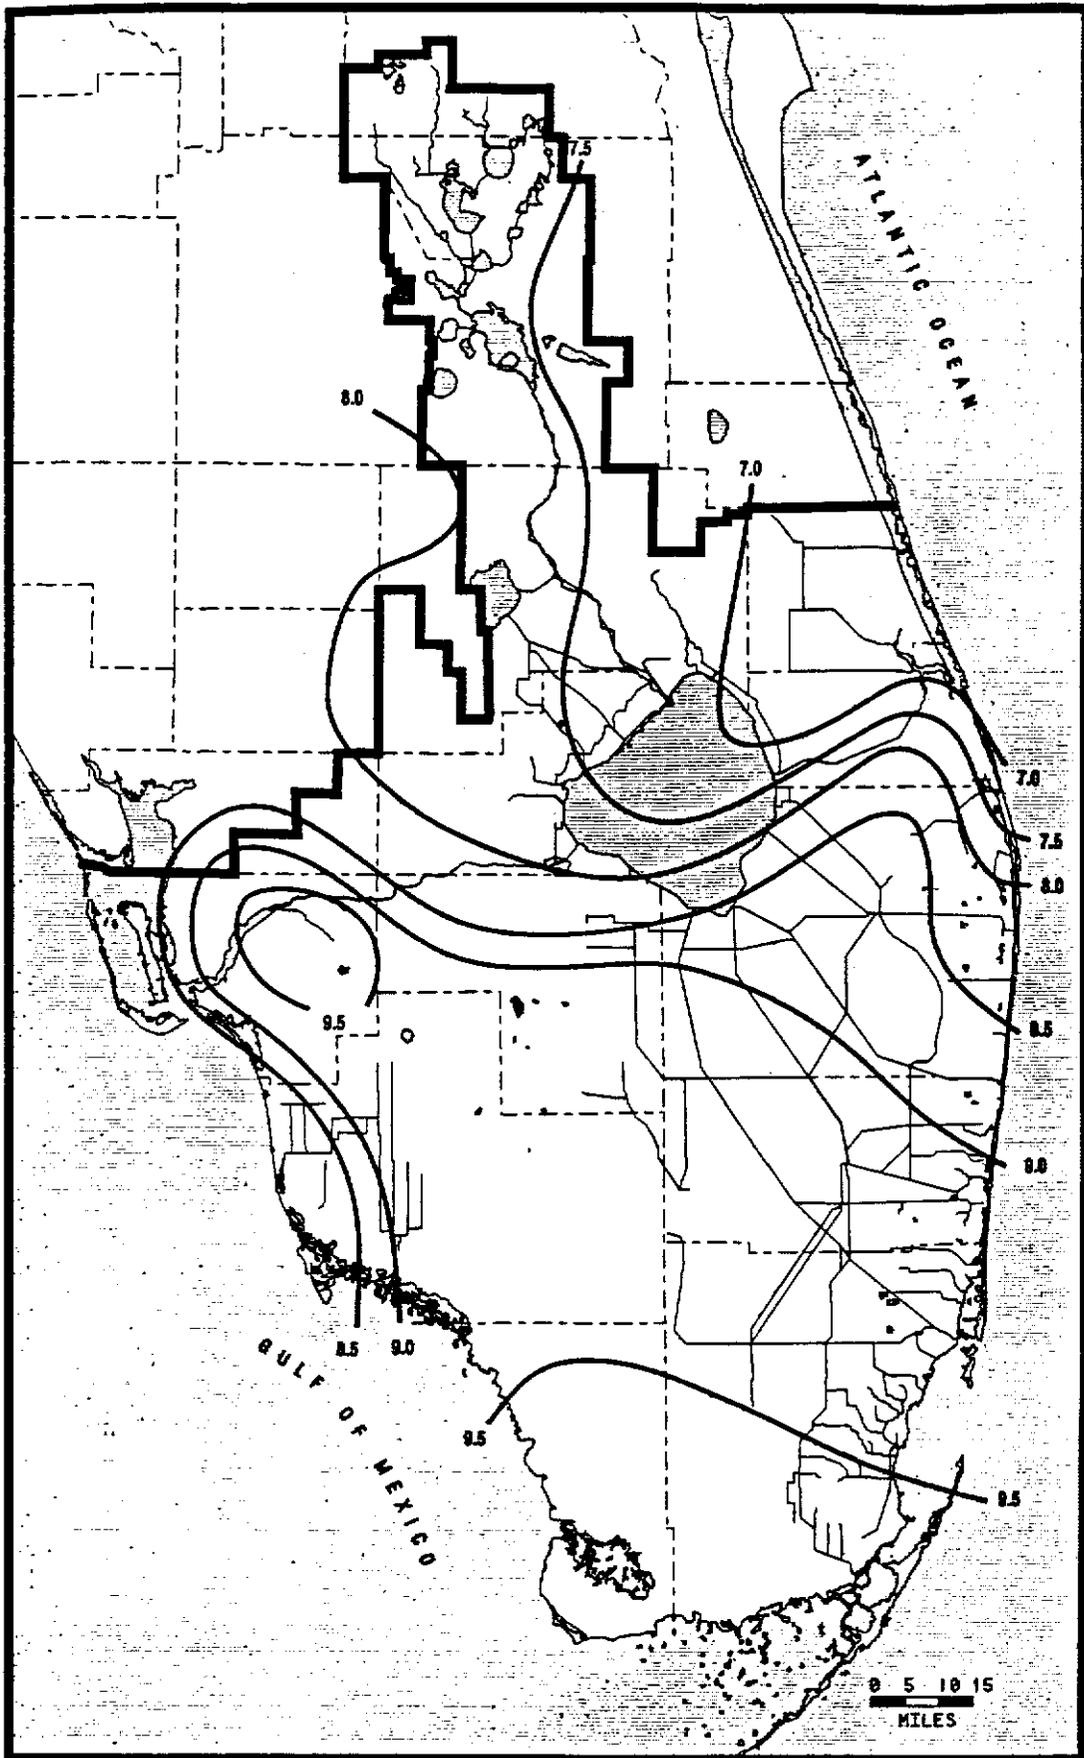
Figure 2. Monthly Average Rainfall - June (inches)

Figure 2 depicts the spatial distribution of the average June rainfall values in terms of isohyetal lines (Tech. Pub 83-2, Rainfall Averages and Selected Extremes for Central and Southern Florida). As depicted in Figure 2, the average June rainfall amount varies from 7.00 inches for the Fort Pierce and Stuart area to a high of 9.5 inches in the Homestead area.

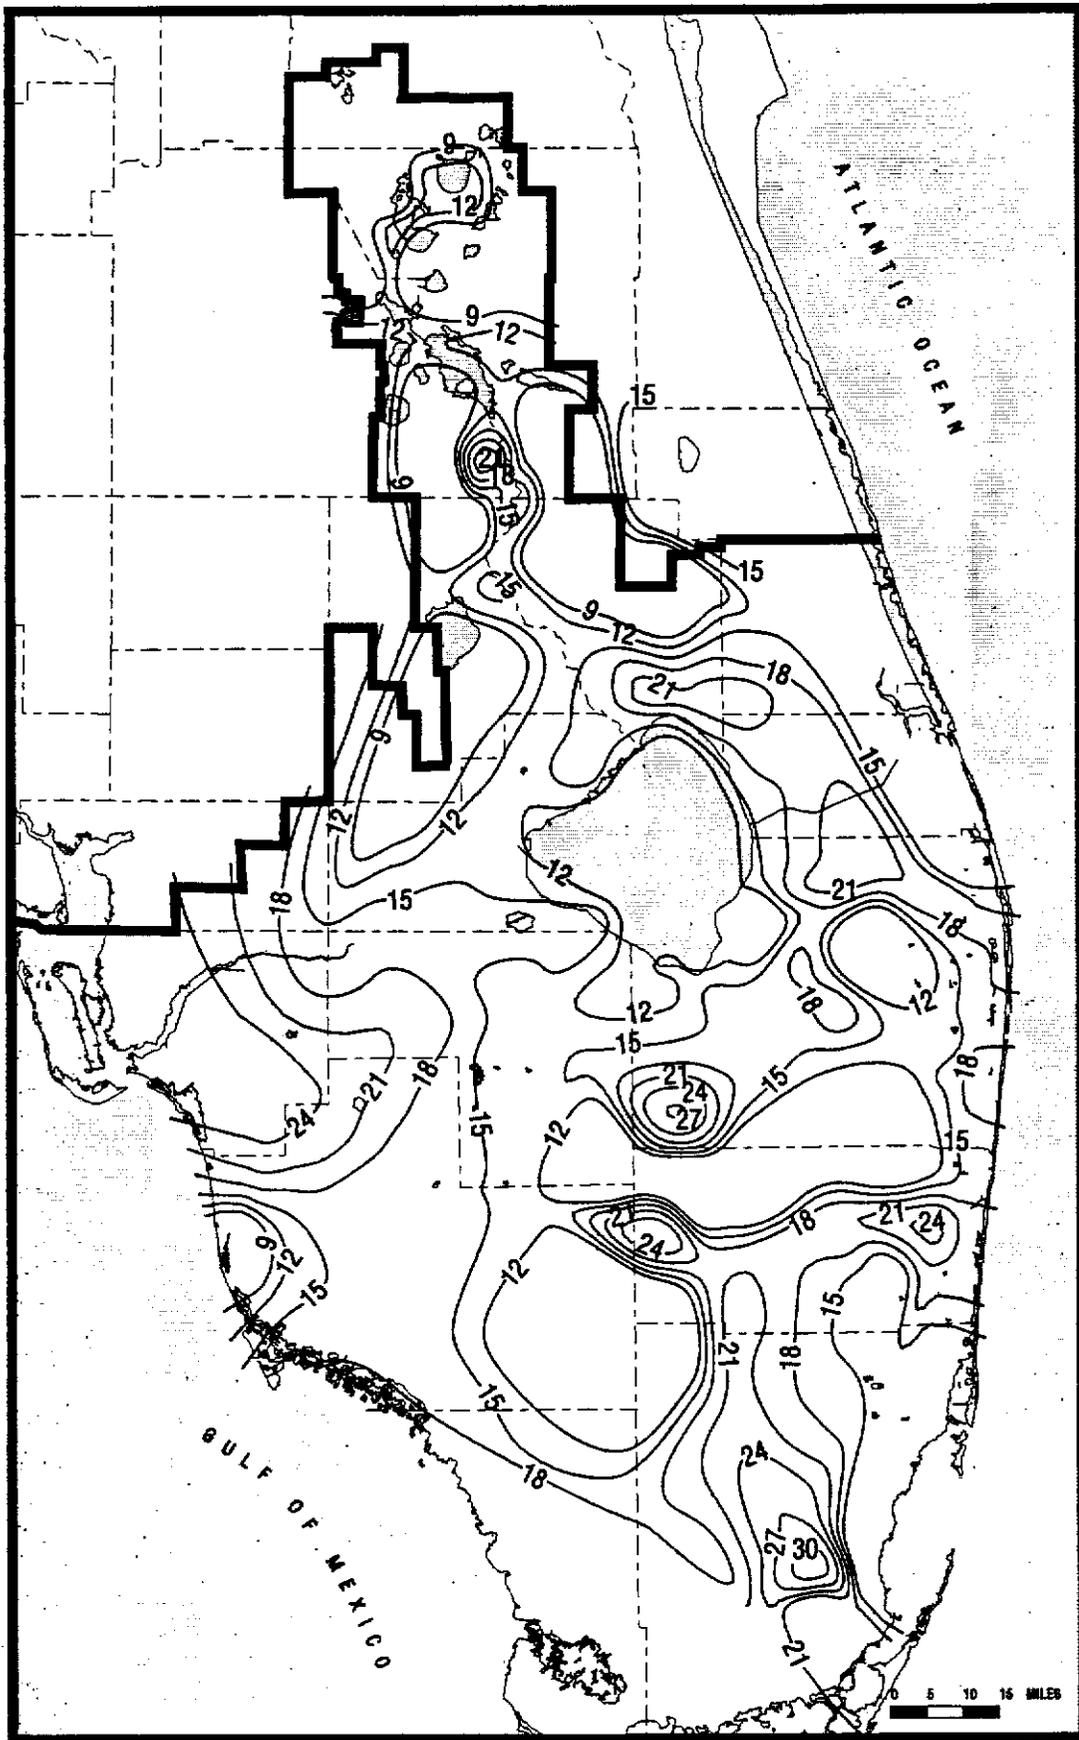
Figure 3. Monthly Rainfall Distribution, 3-Inch Contour Interval, June 1992

To illustrate the spatial distribution of the June 1992 rainfall within the District, isohyetal maps were plotted using the bilinear interpolation method for surface plotting. This software is available in the ARC/INFO geographic information system. Spatial distribution of the monthly total, 8-day total (June 23-30), as well as the maximum 1-, 3- and 5-day amounts, were plotted (Figures 3-7). Comparison of the June 1992 rainfall total with other years' June rainfall was made, and plotted for the Planning Areas of the District (Appendix B). These figures show that the Lower East Coast Planning Area, Water Conservation Area III-A, and Lake Okeechobee recorded the highest amount of rain for the month of June in history.

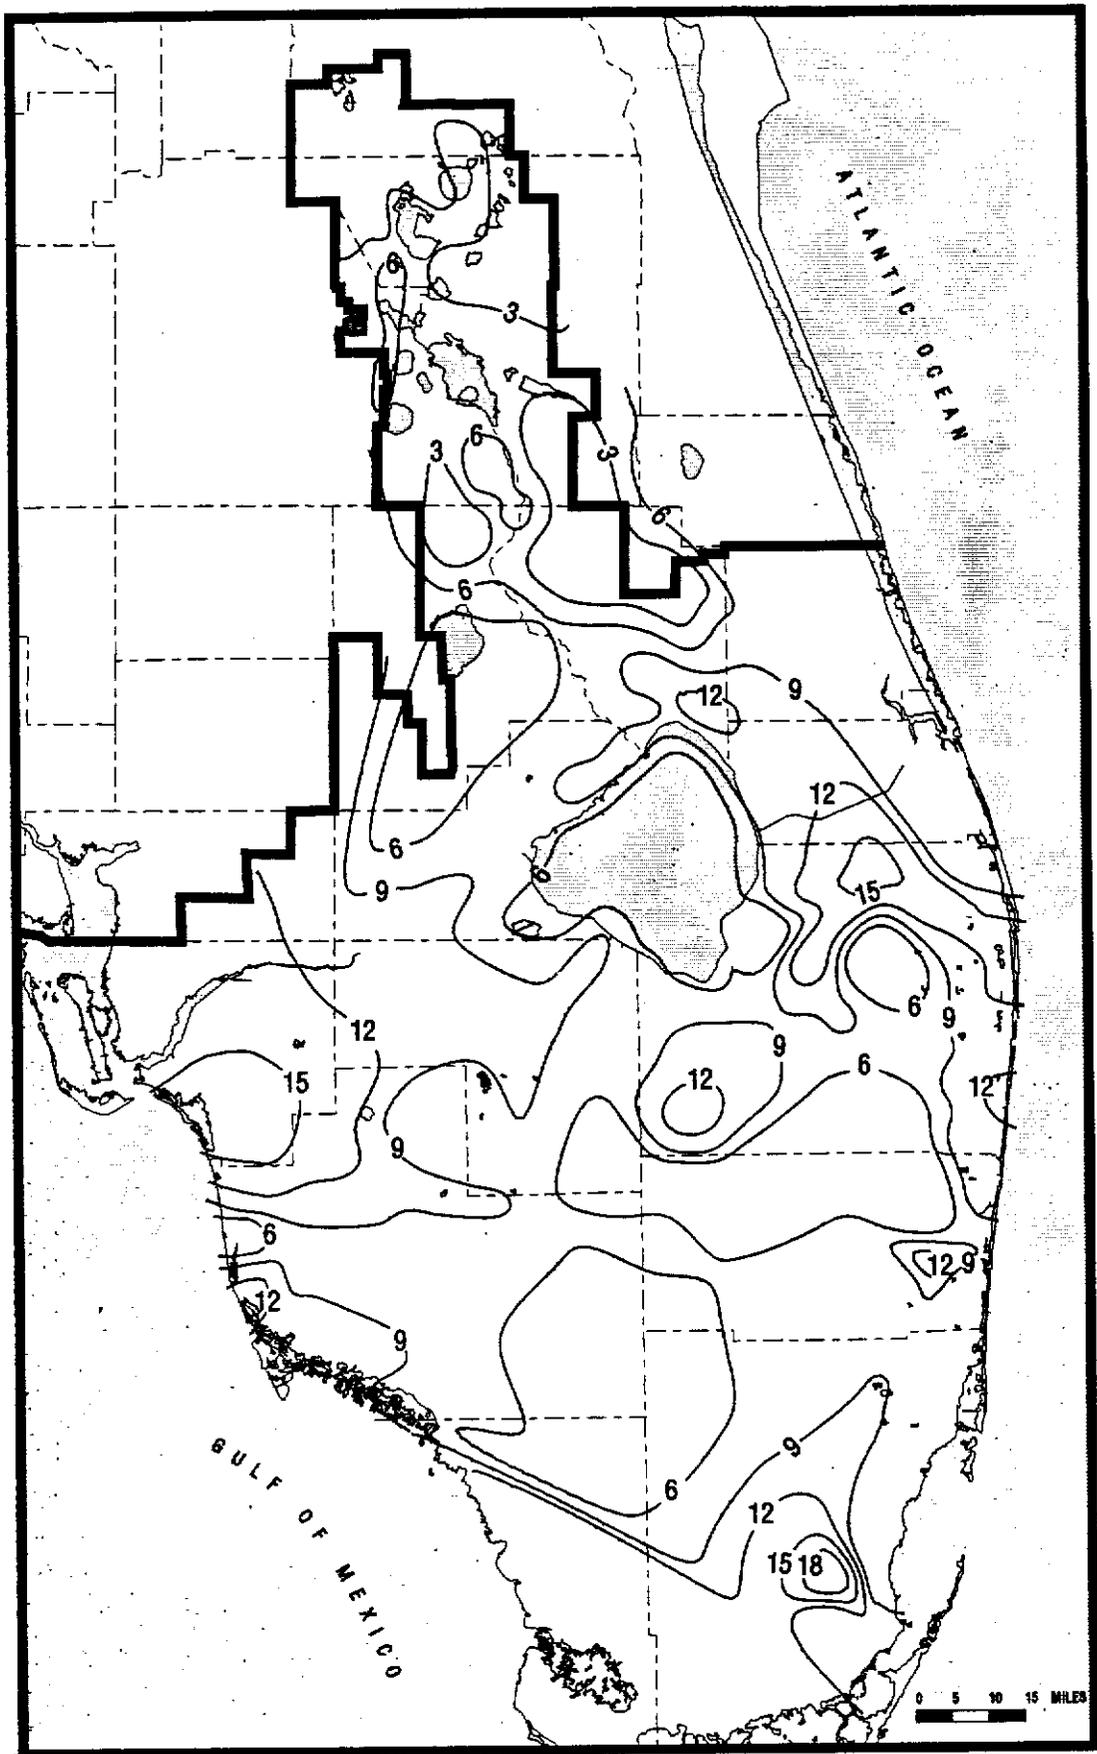
Figure 4. Eight-Day Rainfall Distribution, 3-Inch Contour Interval, June 1992

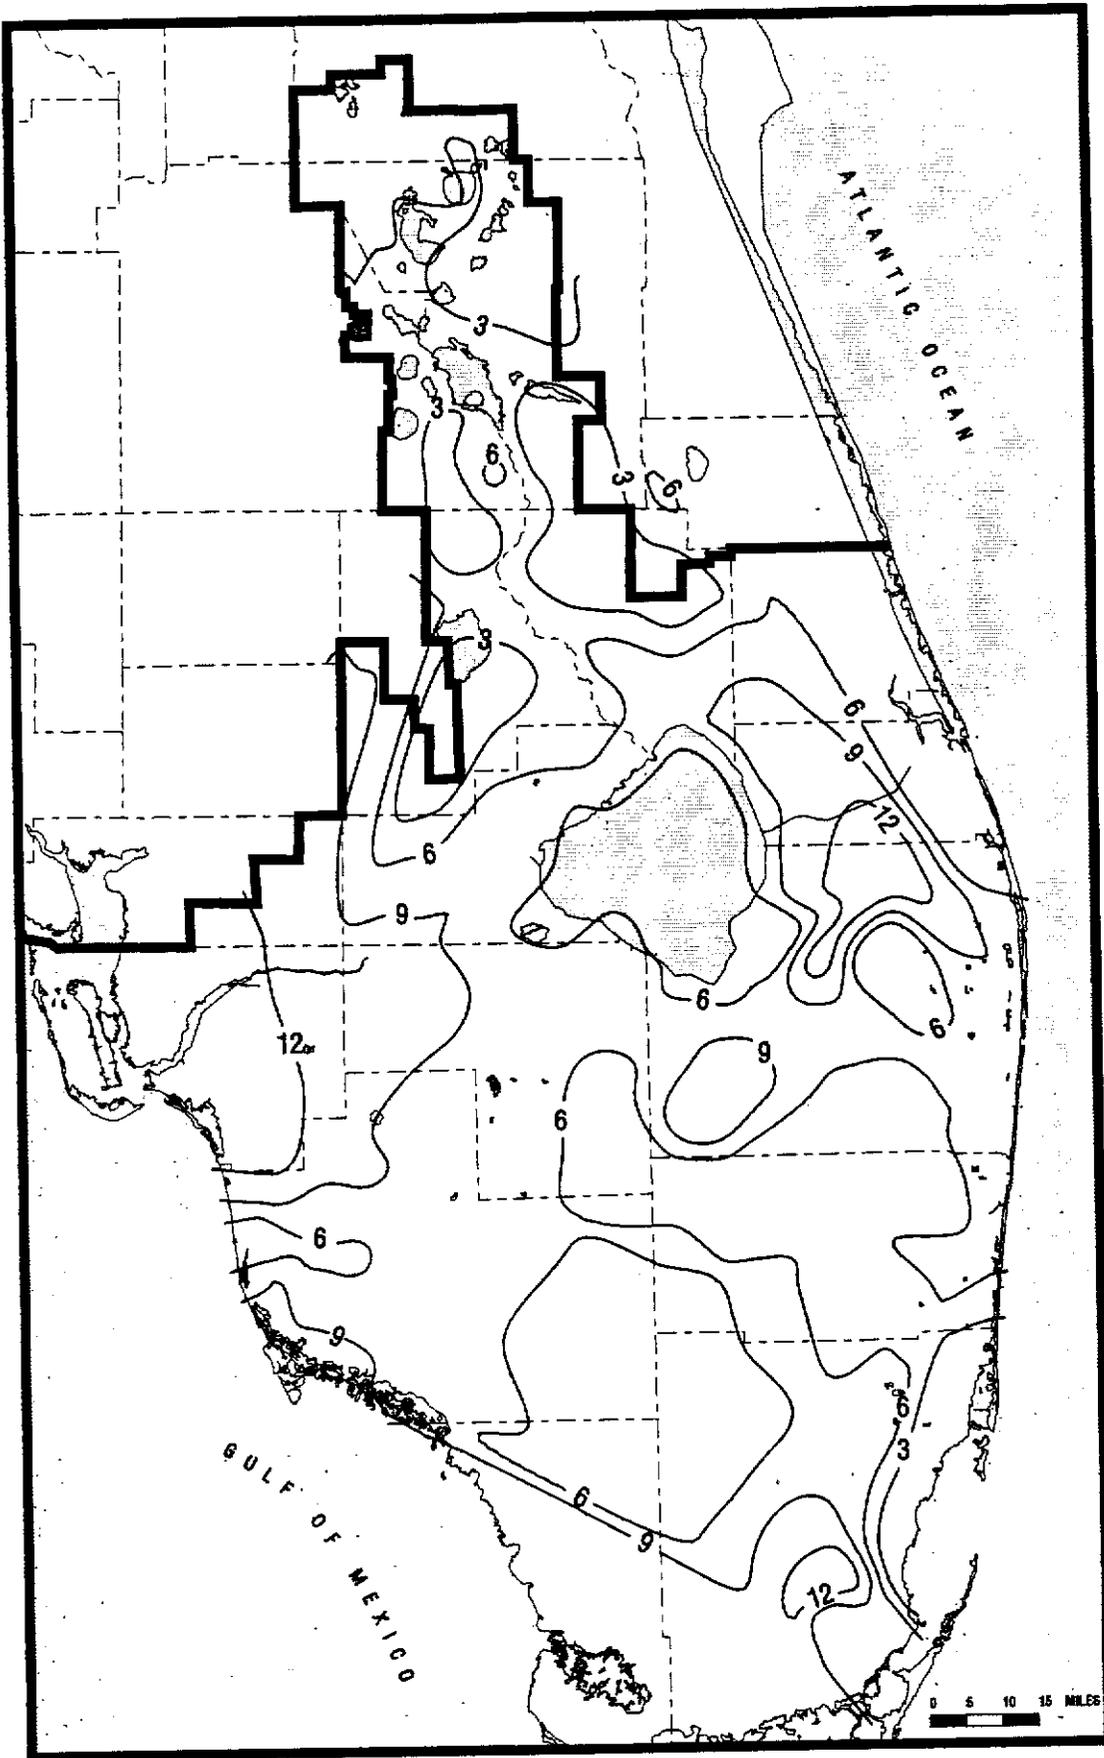
Figure 5. Five-Day Rainfall Distribution, 3-Inch Contour Interval, June 1992

Figure 5 shows the distribution of the 5-day maximum rainfall. Homestead recorded 13.24 inches and Bonita Springs 12.72 inches. Figures 6 and 7 depict the 3-day and the 1-day distributions.

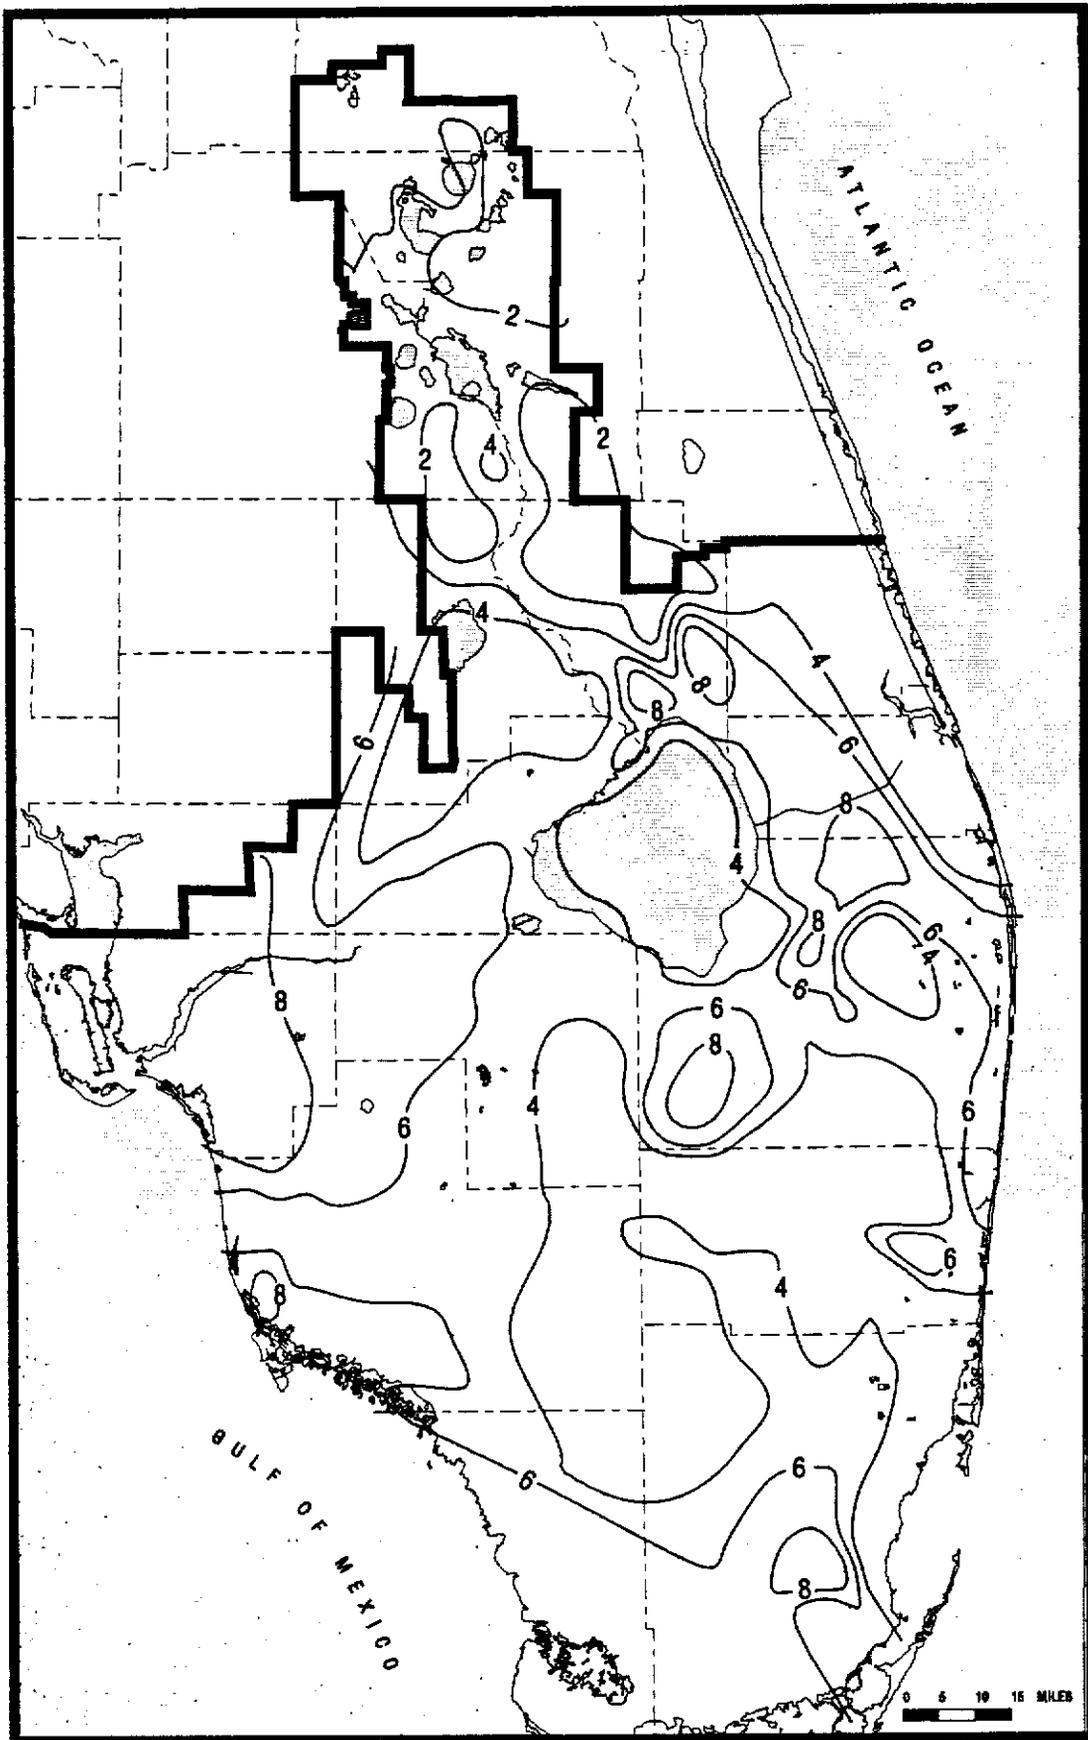
Figure 6. Three-Day Rainfall Distribution, 2-Inch Contour Interval, June 1992

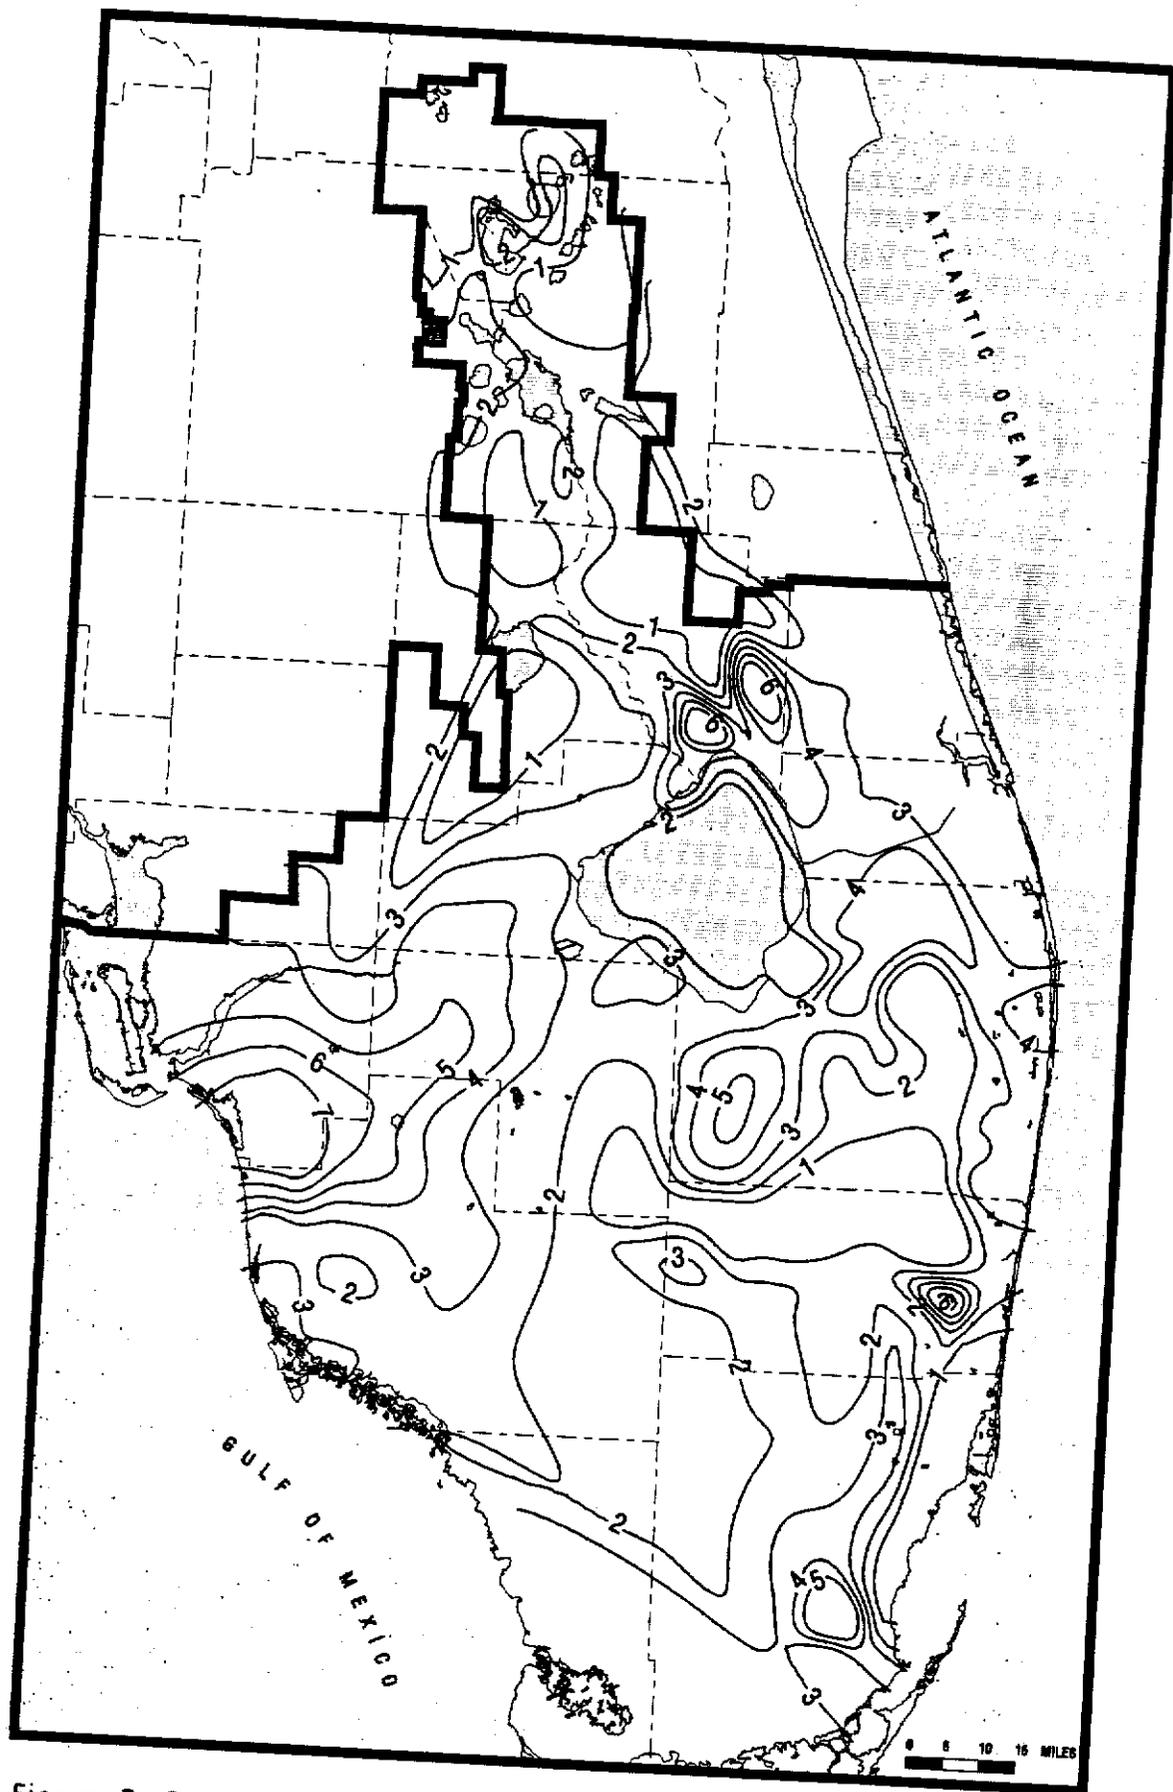
Figure 7. One-Day Rainfall Distribution, 1-Inch Contour Interval, June 1992

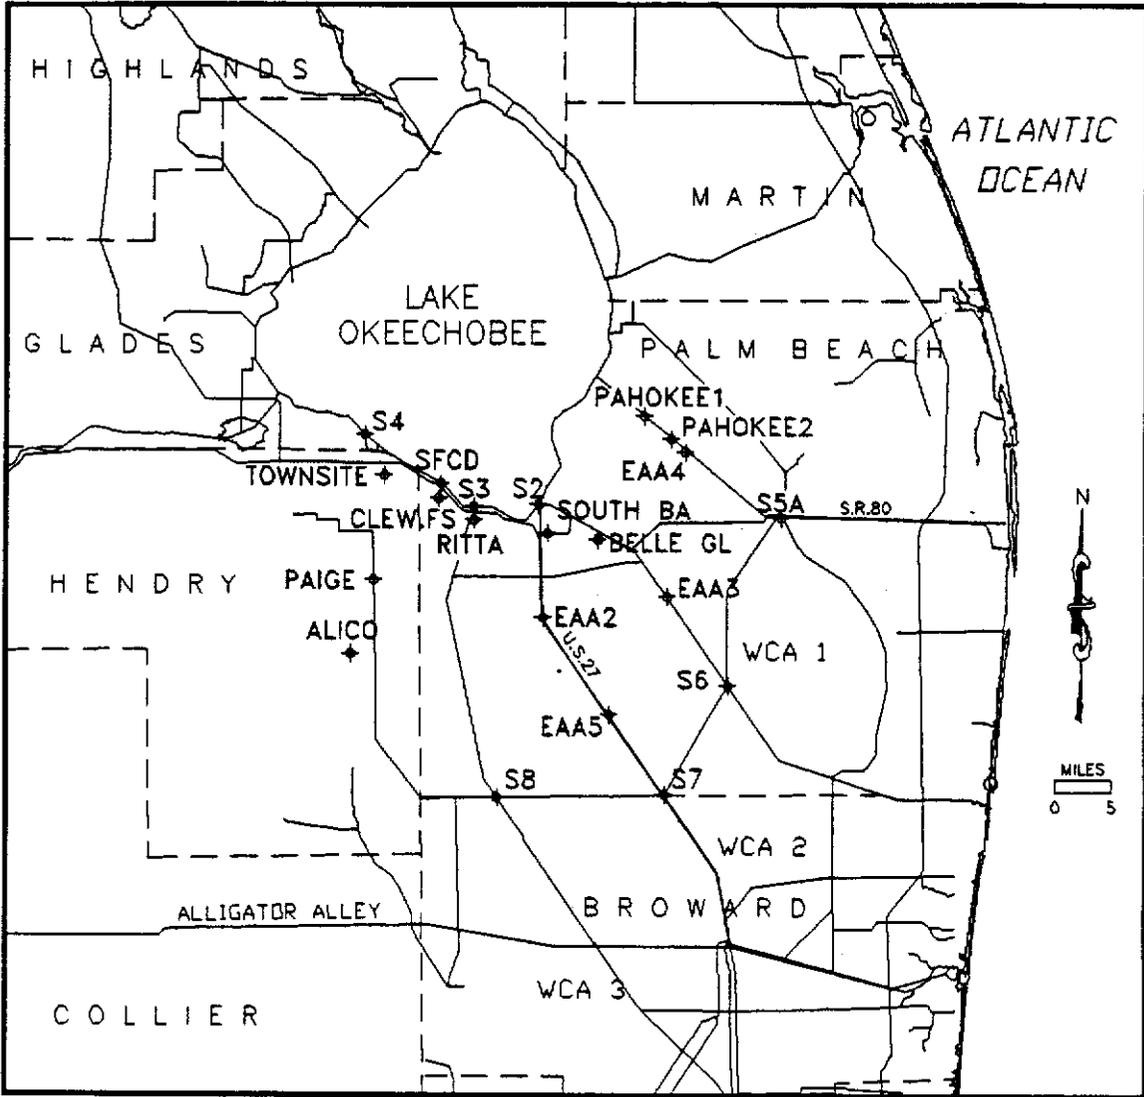
Figure 8. Lake Okeechobee and EAA with Raingauge and Water Control Structures

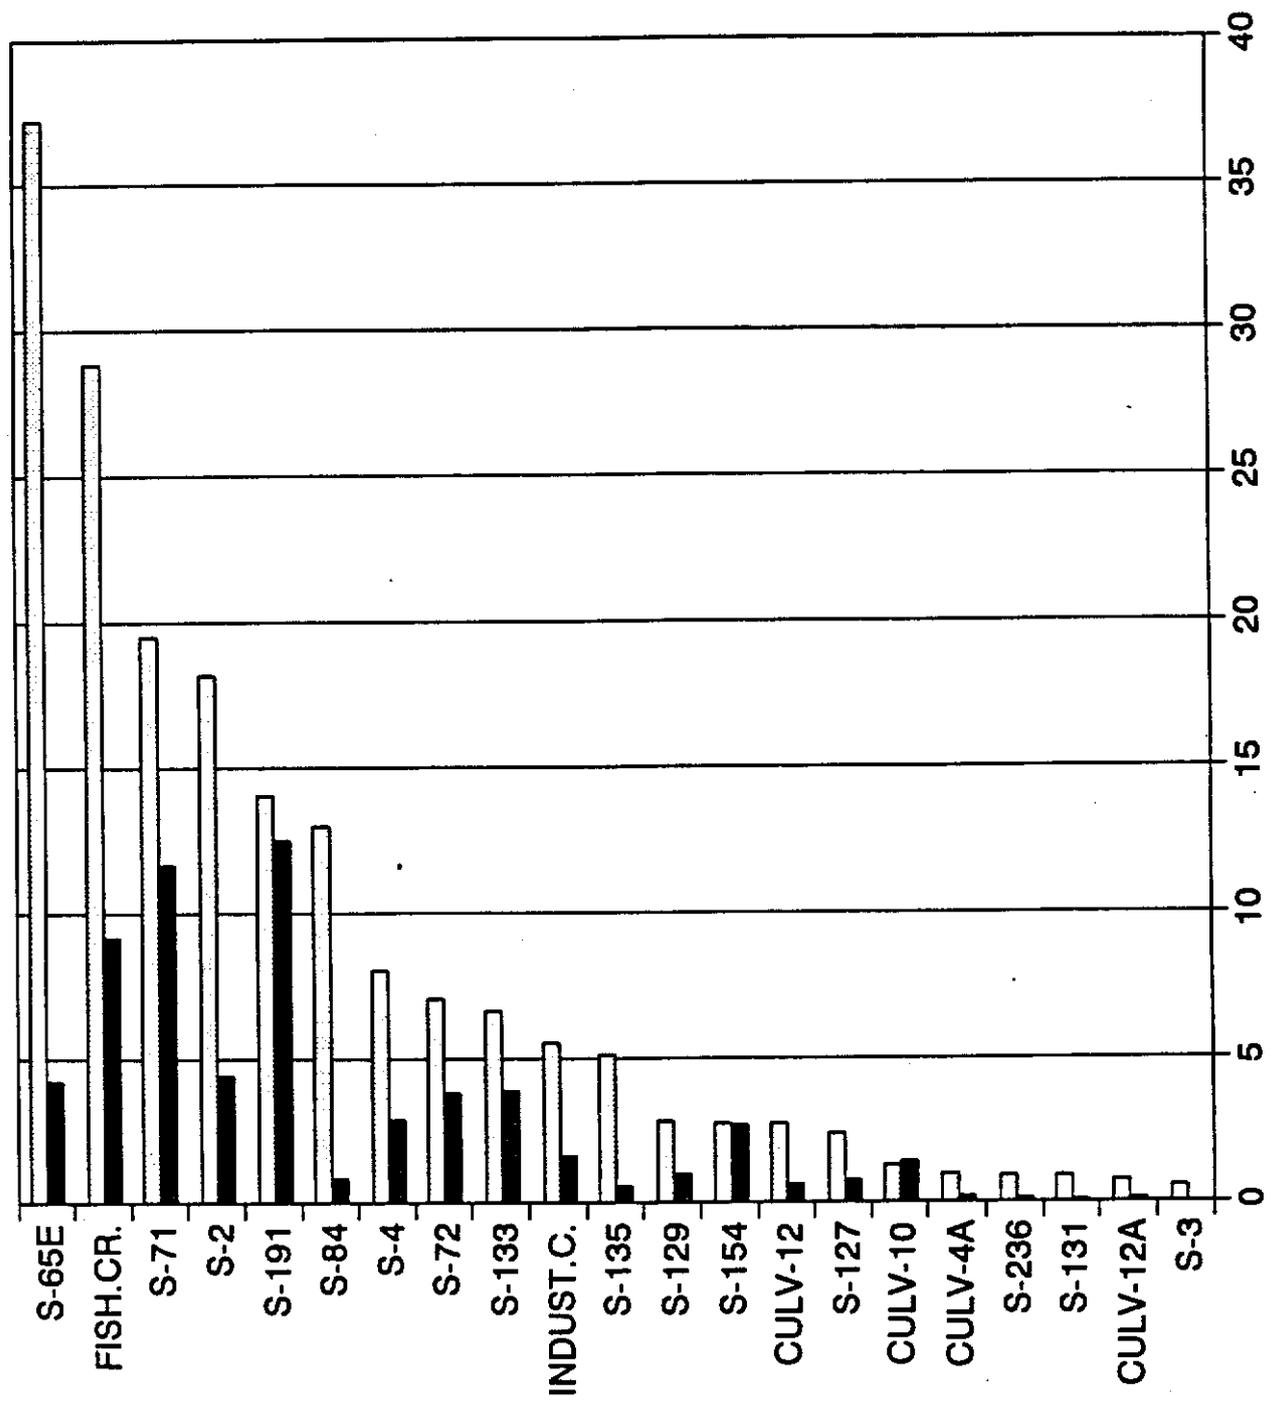
Figure 9. Phosphorus Inputs into Lake Okeechobee during June 23-30, 1992

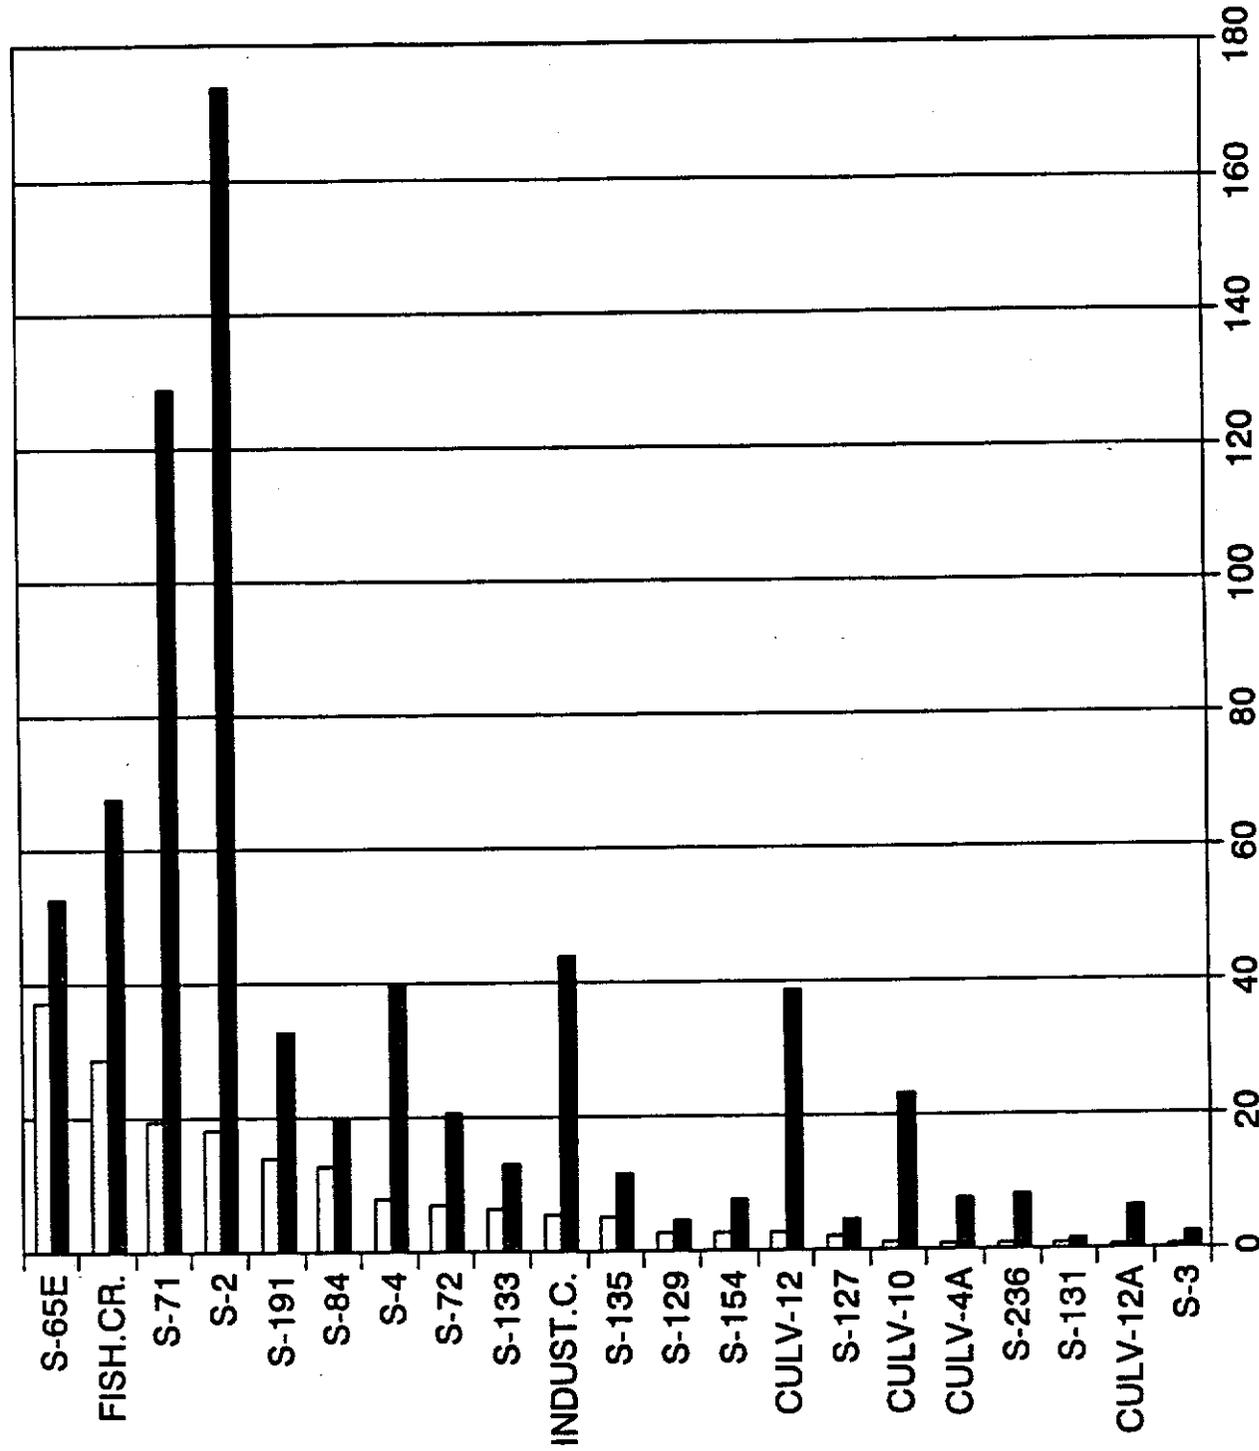
Figure 10. Nitrogen Inputs into Lake Okeechobee during June 23-30, 1992

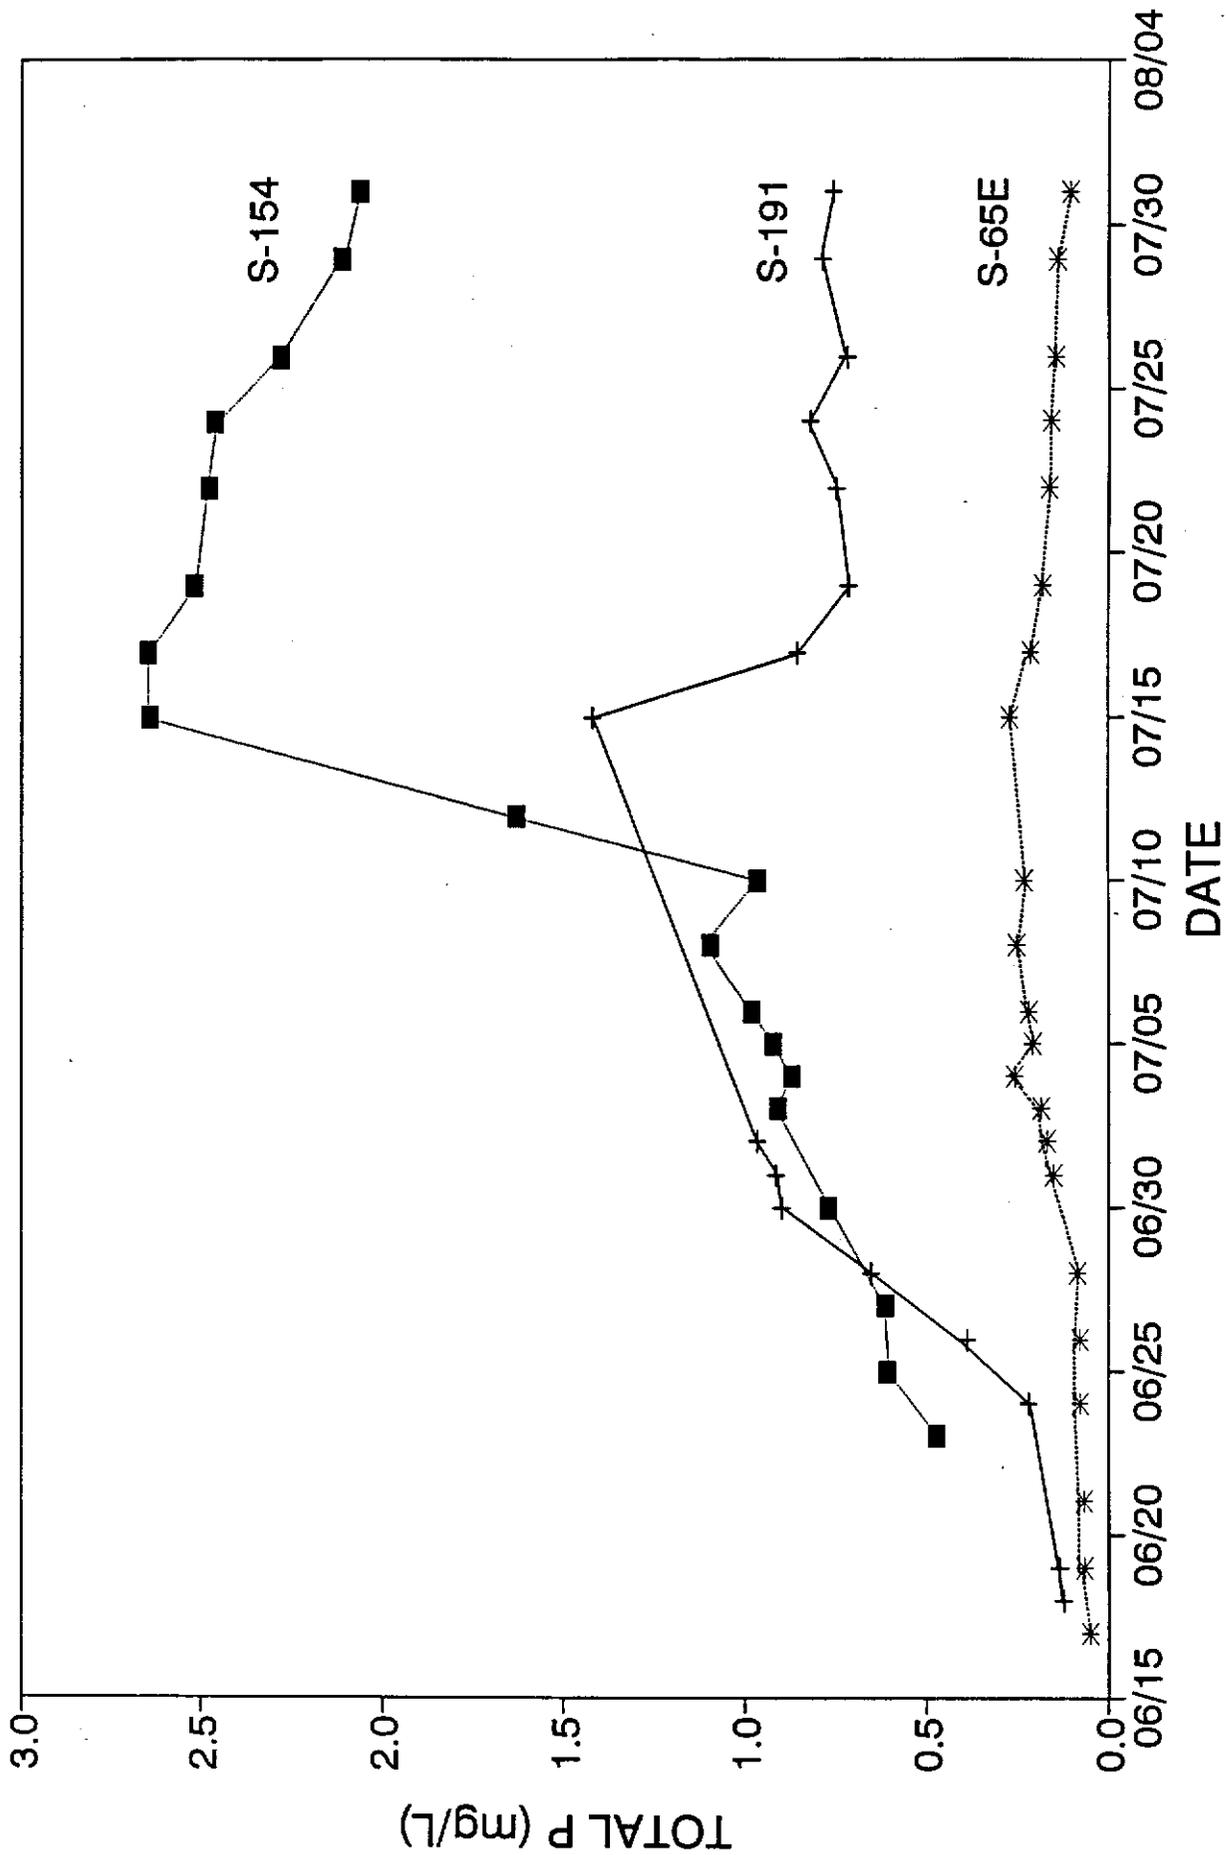
Figure 11. Phosphorus Concentrations at S-191, S-154, and S-65E

The stormwater runoff in June and later in July caused dramatic increases in phosphorus concentrations and loads at S-191, S-154, and S-65E (Figures 11 and 12). Concentrations at S-191 and S-65E were within historical ranges for these two months, but S-154 values were much higher than normal. Auto-sampler data show that phosphorus concentrations at S-154 increased from 0.5 mg/L at the storm's start to about 1 mg/L in early July, and then peaked at over 2 mg/L. The June and July loads from these three structures totaled 75 tons, of which 44, 23, and 8 tons were contributed from S-191, S-65E, and S-154, respectively. For comparison, the average contribution (1987-91) from these structures is 217 tons per year.

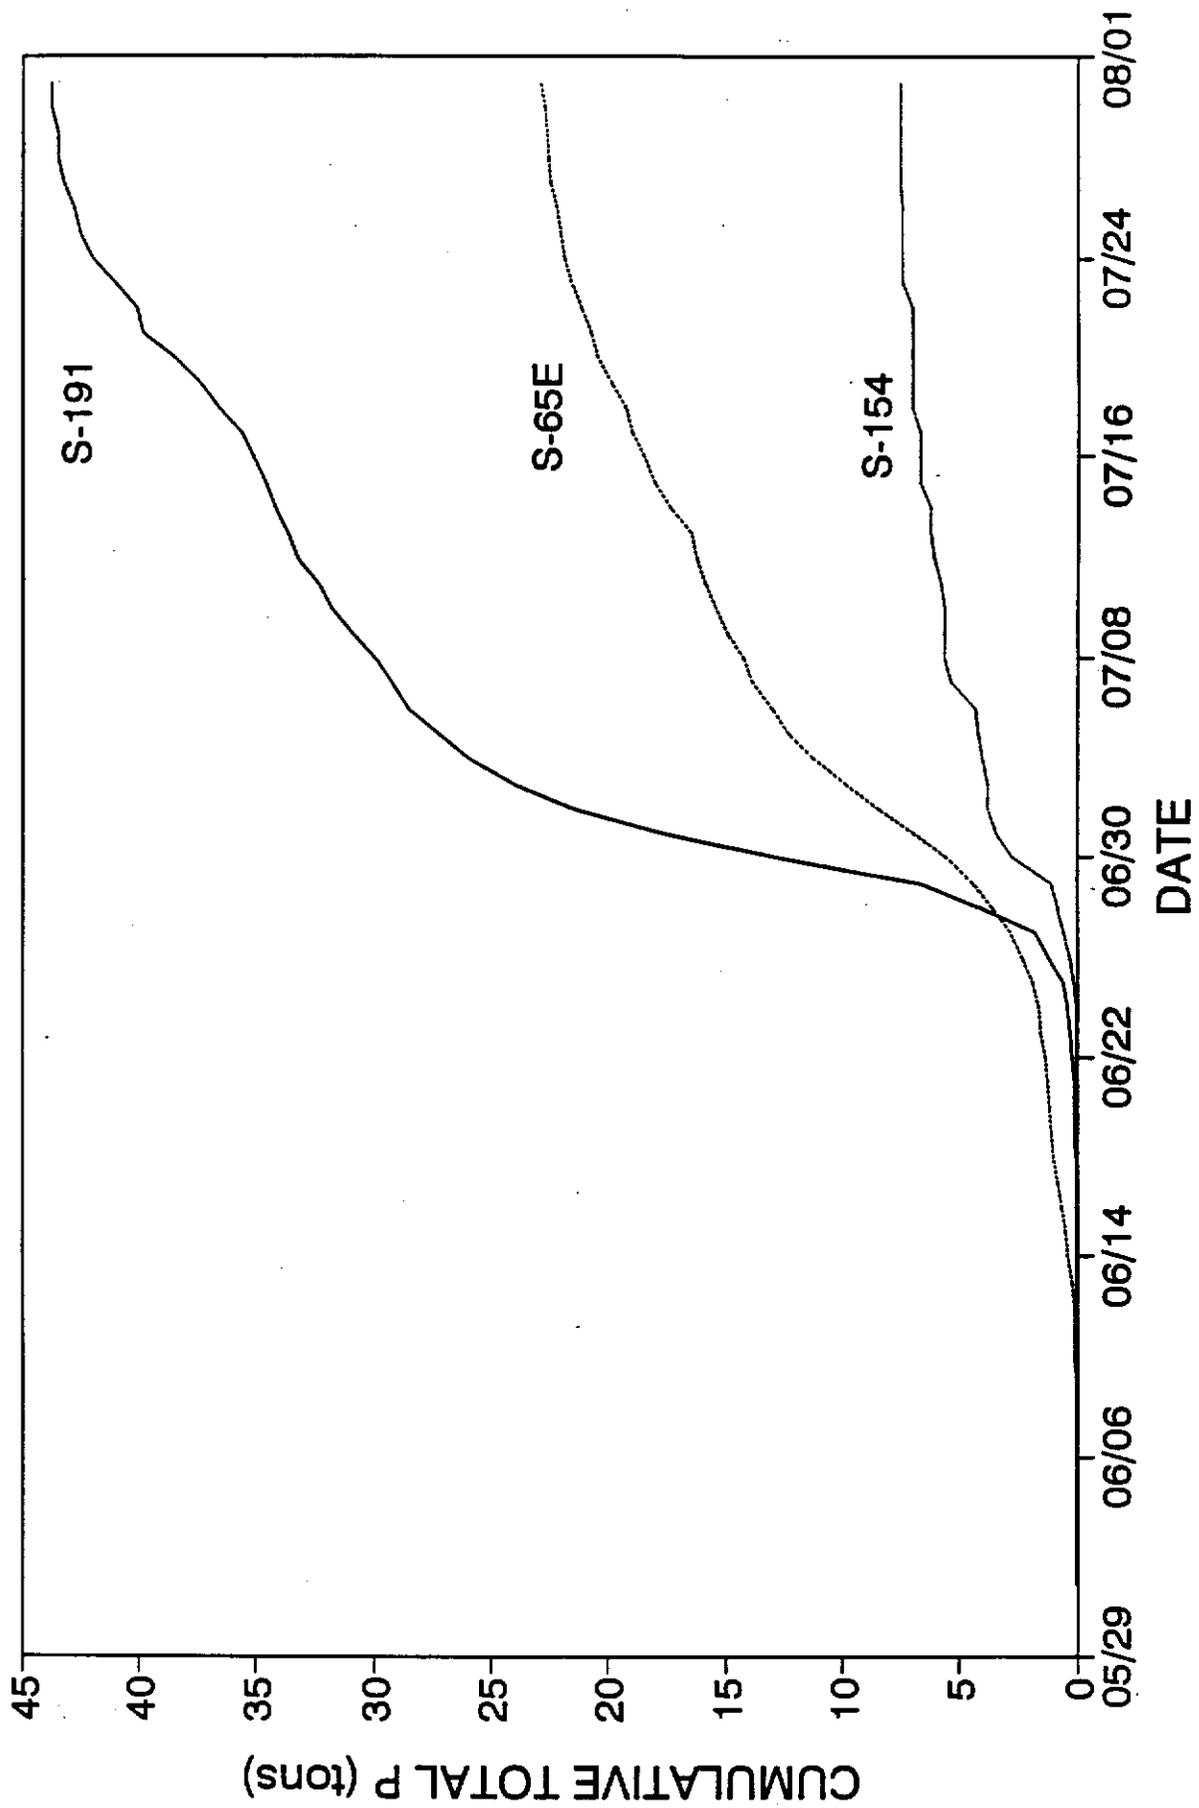
Figure 12. Phosphorus Loads from S-191, S-65E and S-154 for June-July, 1992
