**PRELIMINARY REPORT ON
RAINSTORM OF
JUNE 23-30, 1992**

December 1992

**South Florida Water Management District
West Palm Beach, Florida**

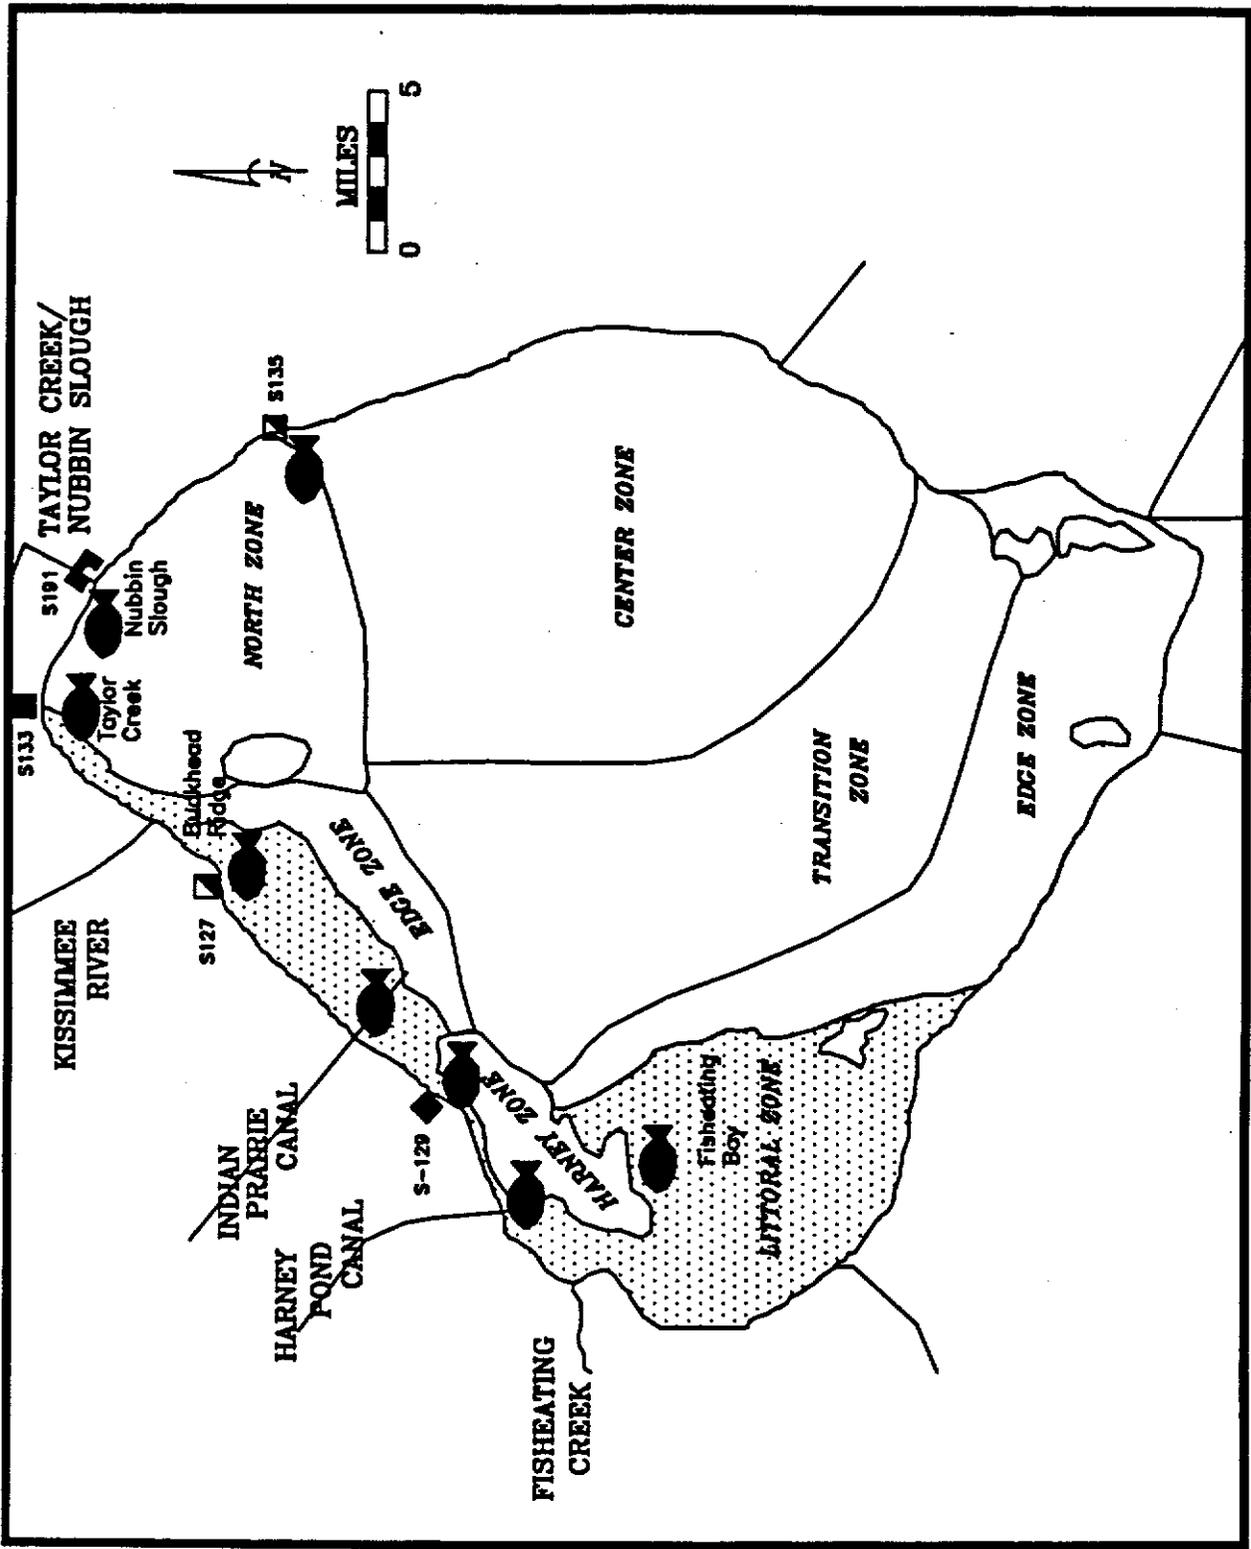
Figure 13. Reported Locations of Fish Kills, July 1-7, 1992

During the first week of July 1992, a large fish kill was observed in Lake Okeechobee (Figure 13). Mr. Don Fox of the Florida Game and Freshwater Fish Commission (FGFWFC) estimated two million fish died during the week. Most of the dead fish were found near the Lake's northern and western shore near major tributaries and/or District control structures. The areas most affected included: Chancy Bay (S-135), Taylor Creek/Nubbin Slough (S-191), S-133, Sportsman's Village Canal, Buckhead Ridge, S-127, Indian Prairie Canal, S-129, Harney Pond Canal, and Fisheating Bay. The most commonly collected species of dead fish were: largemouth bass (*Micropterus salmoides*), bluegill sunfish (*Lepomis macrochirus*), redear sunfish (*Lepomis microlophus*), bullhead catfish (*Ictalurus* sp.), gar (*Lepisosteus* sp.), bowfin (*Amia calva*), mosquito fish (*Gambusia affinis*) and least killifish (*Heterandria formosa*).

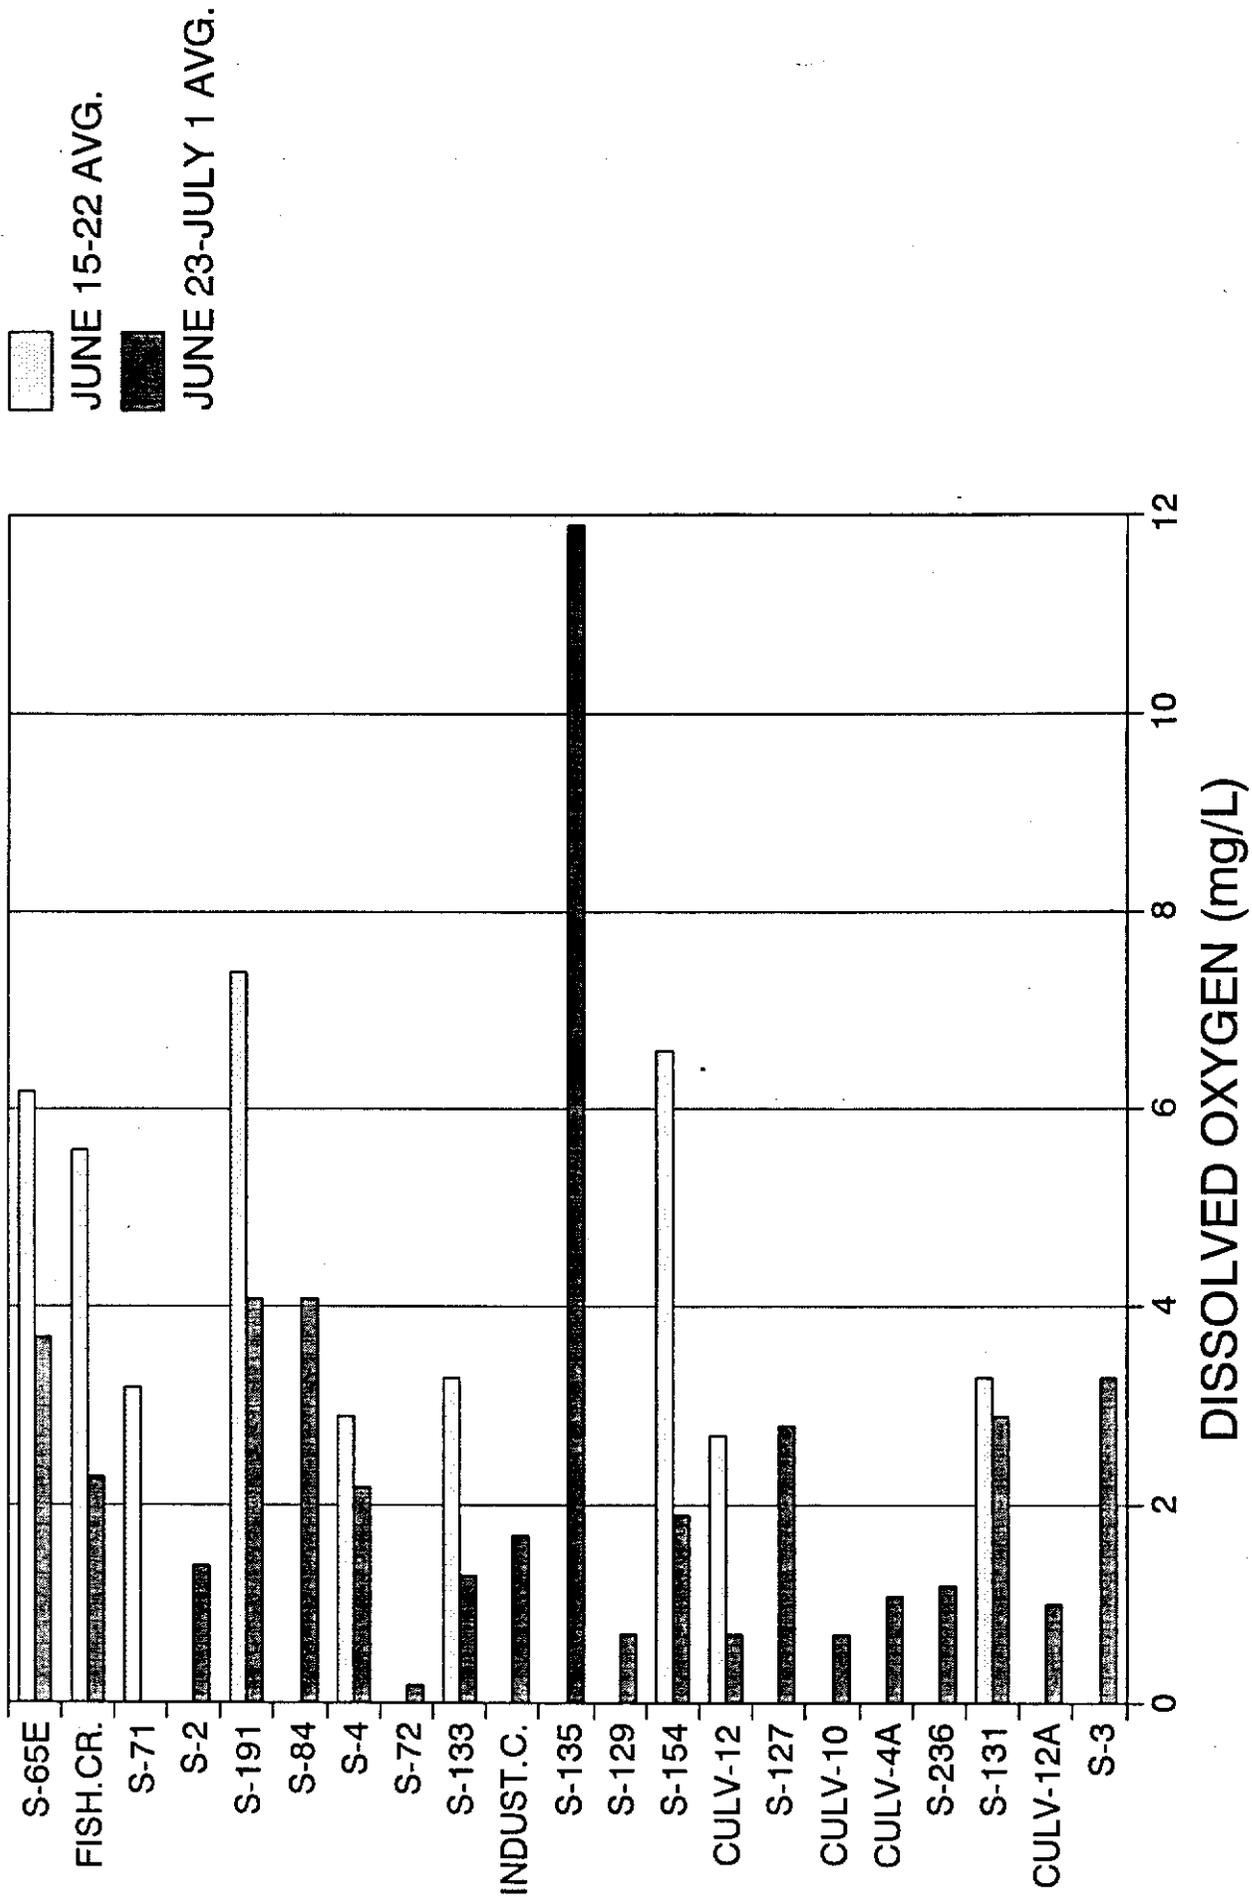
Figure 14. Stormwater Impact on Dissolved Oxygen Concentrations

The cause of the fish kill appeared to be the extremely low dissolved oxygen (D.O.) concentrations associated with the large Lake inflows. These low D.O. levels, which lasted for more than a week in Lake Okeechobee and many of the tributary waters, suffocated the fish that were trapped near shore and in the tributary areas. SFWMD data collected during June 29-July 1 indicate that stormwater runoff caused D.O. levels to decline far below 5 mg/L at nearly all inflow points (Figure 14). During the week of July 5, the FGFWFC reported D.O. concentrations of less than 0.2 mg/l in Indian Prairie Canal, Harney Pond Canal, and near Sportsman's Village. Near Bird Island in Fisheating Bay, D.O. was measured at 0.5 mg/L. No fish kills were reported for populations farther offshore where D.O. concentrations were generally greater than 7 mg/L.

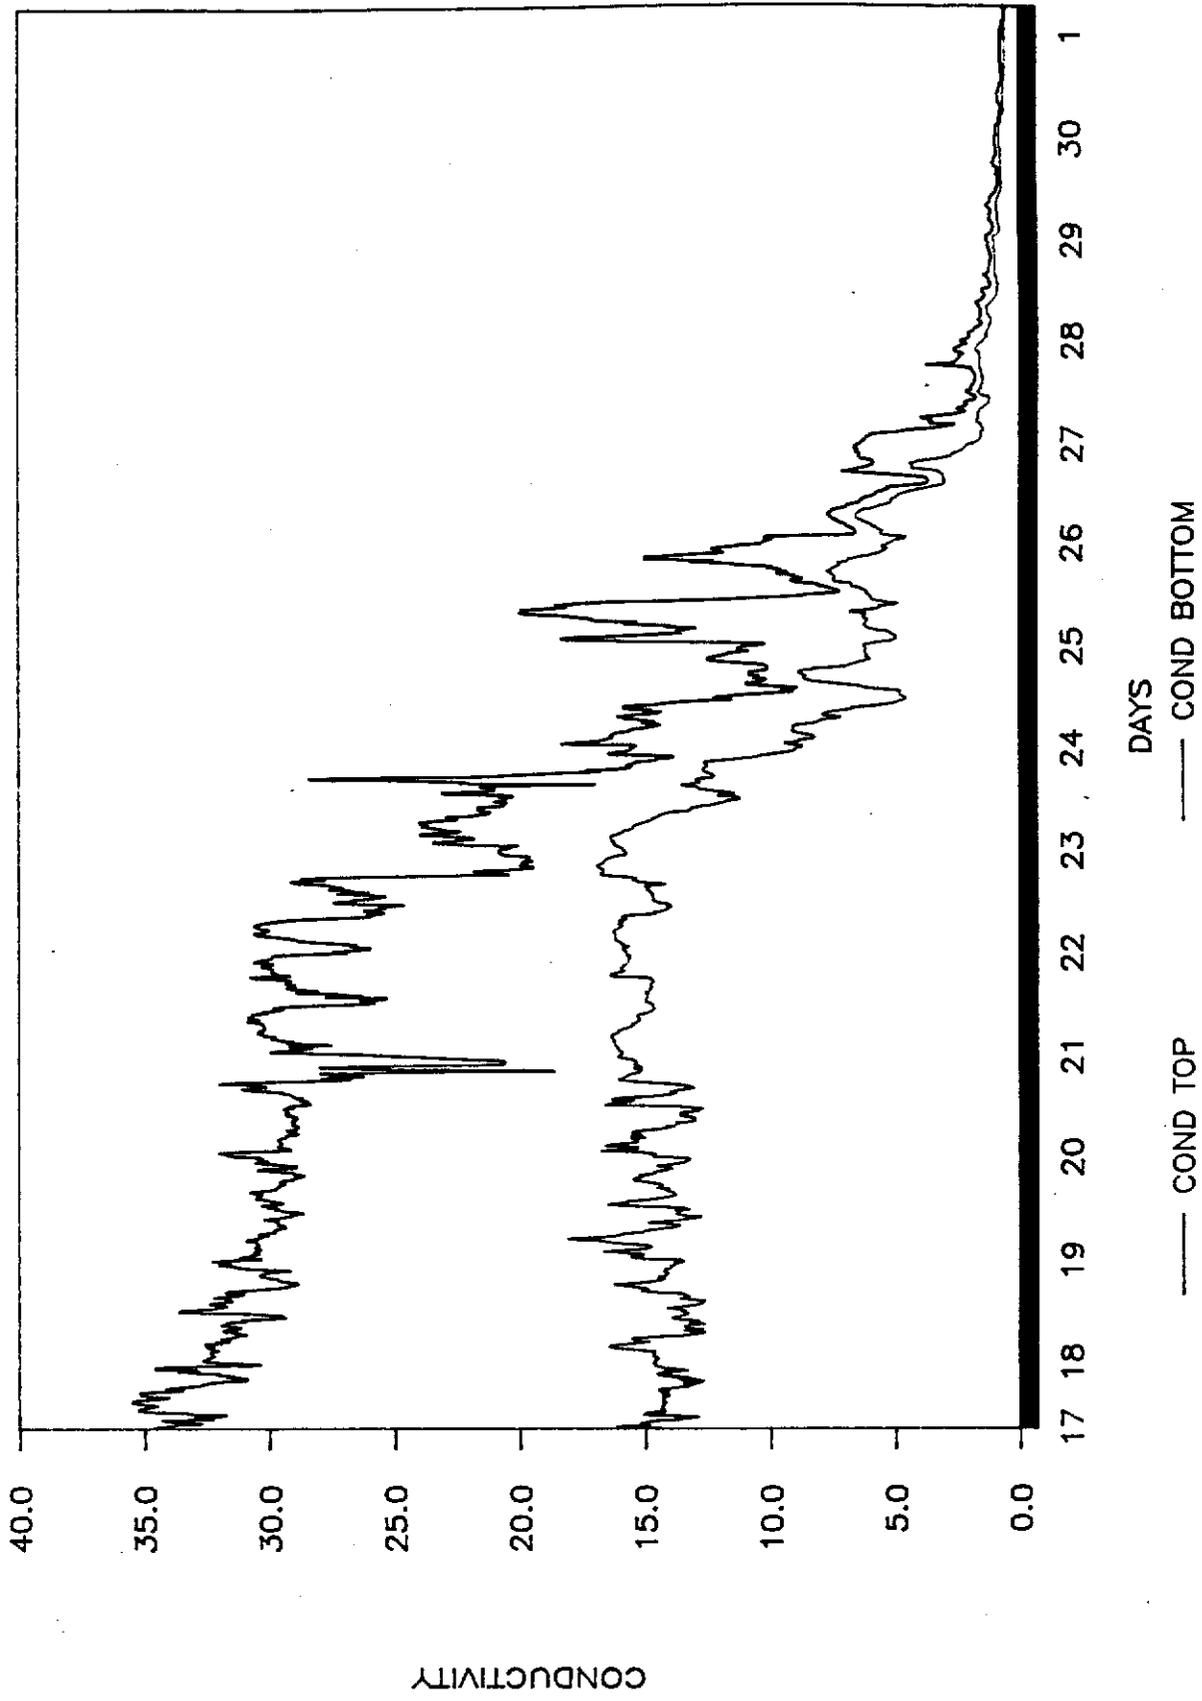
Figure 15. Conductivity (6/17-7/1), St. Lucie Estuary

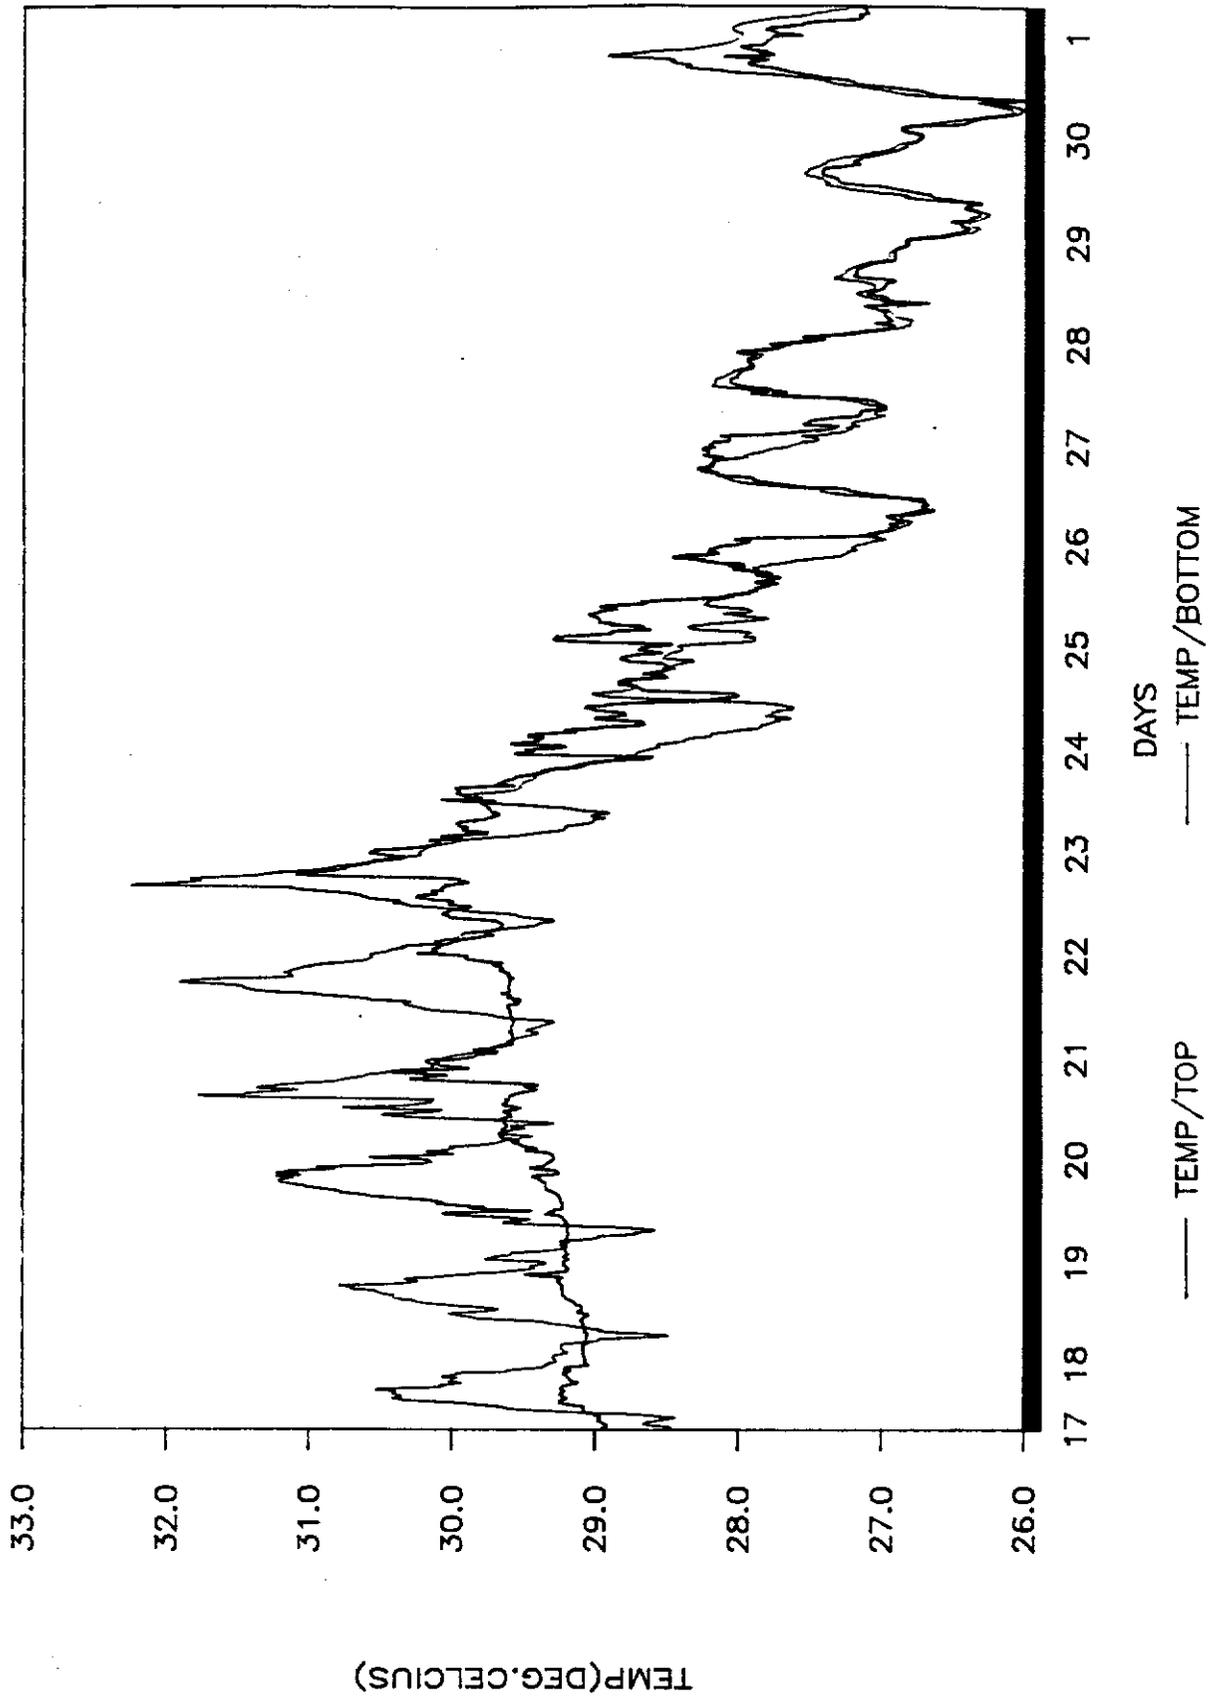
Figure 16. Temperature (6/17-7/1), St. Lucie Estuary

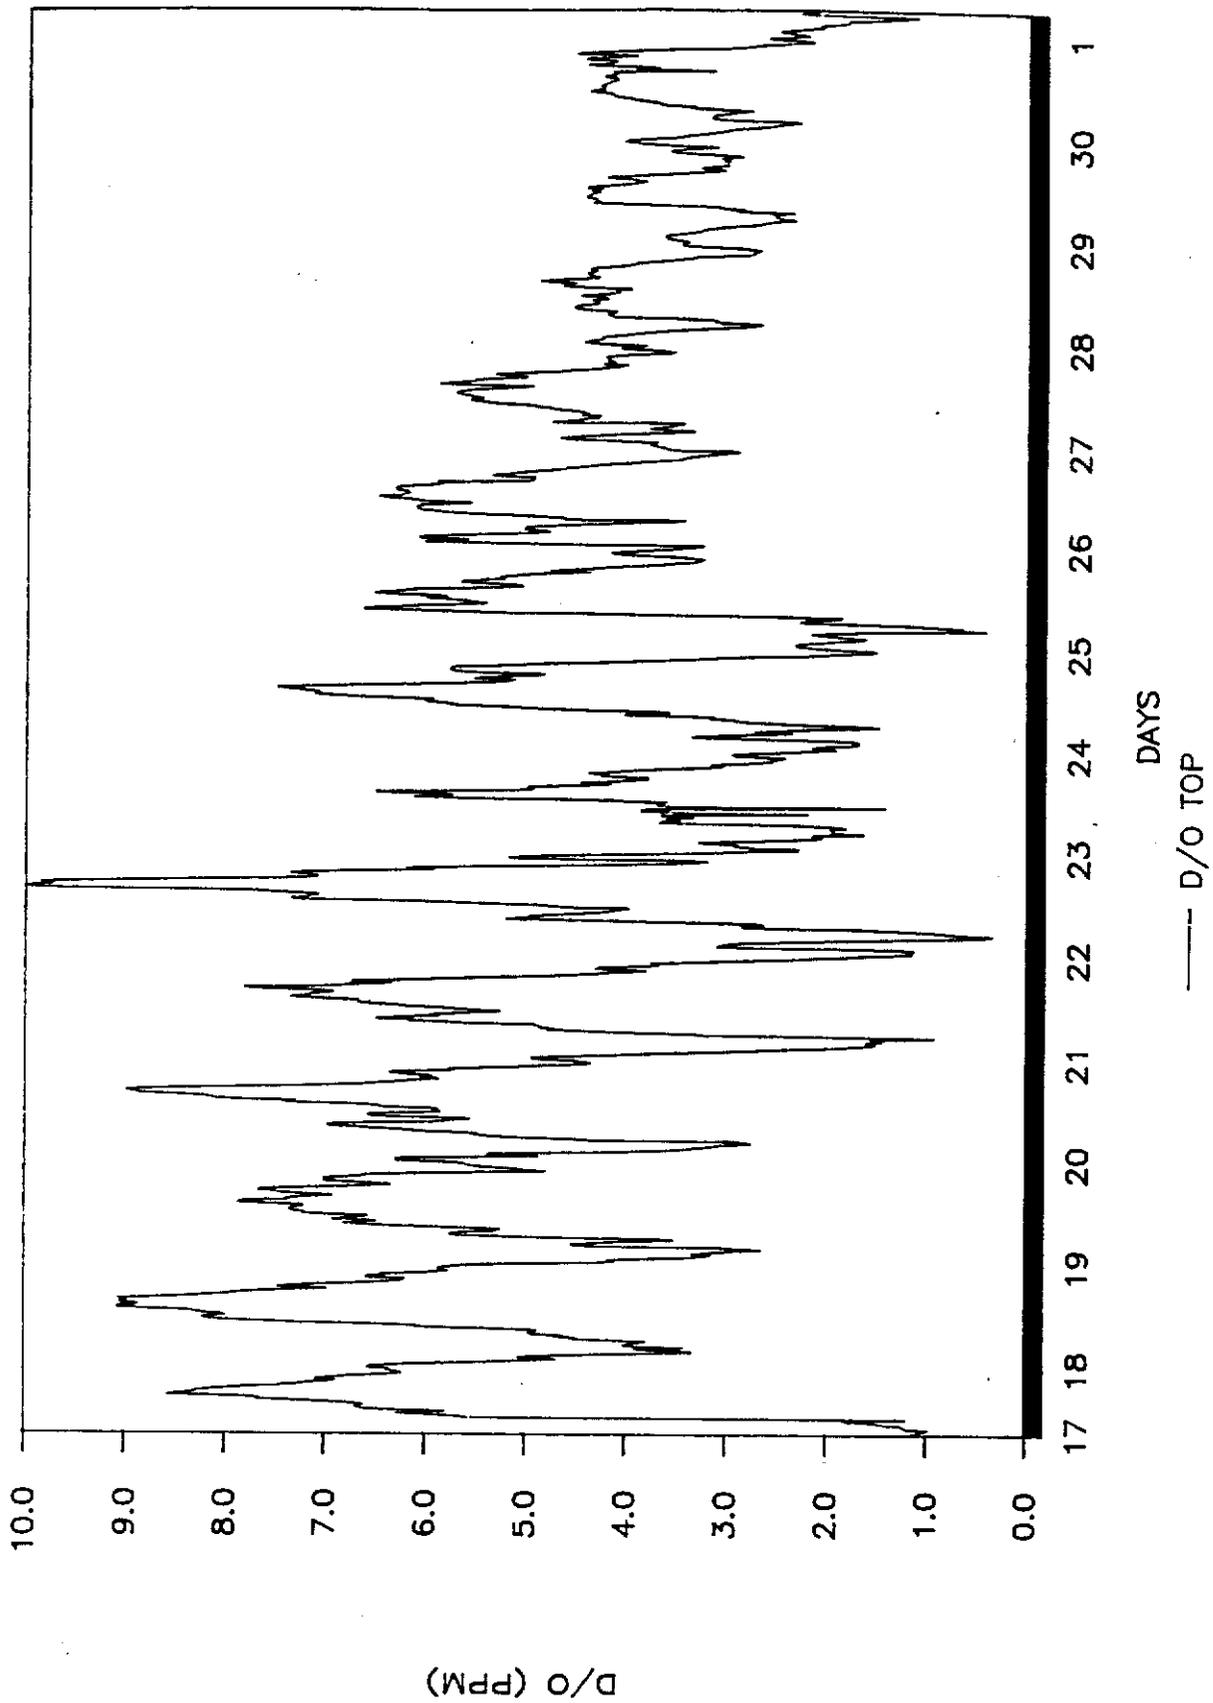
Figure 17. Dissolved Oxygen (6/17-7/1), St. Lucie Estuary

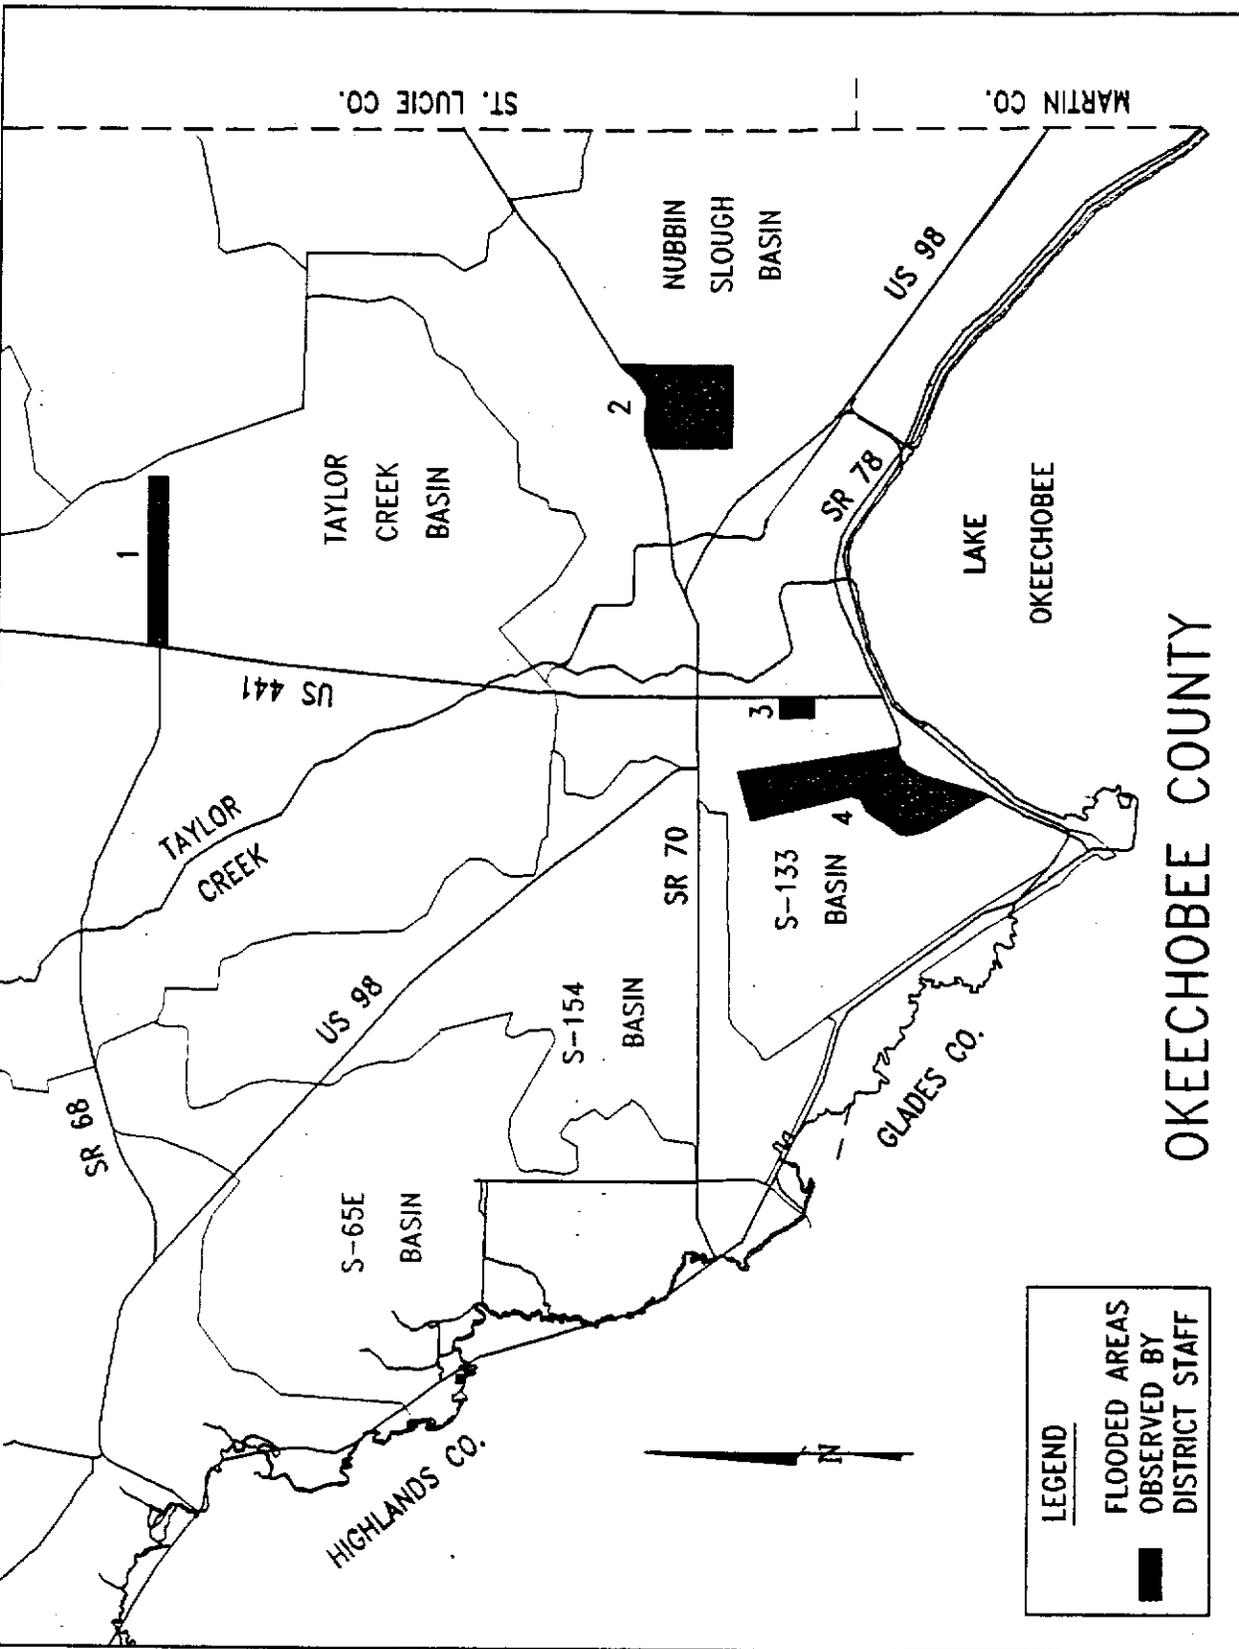
Figure 18. Flooded Area in Okeechobee County

Okeechobee Field Engineering personnel observed flooding in three areas of Okeechobee County (Figure 18). All three areas have historically experienced flooding problems during periods of heavy rain and there were no areas with severe, unusual flooding. The areas observed were:

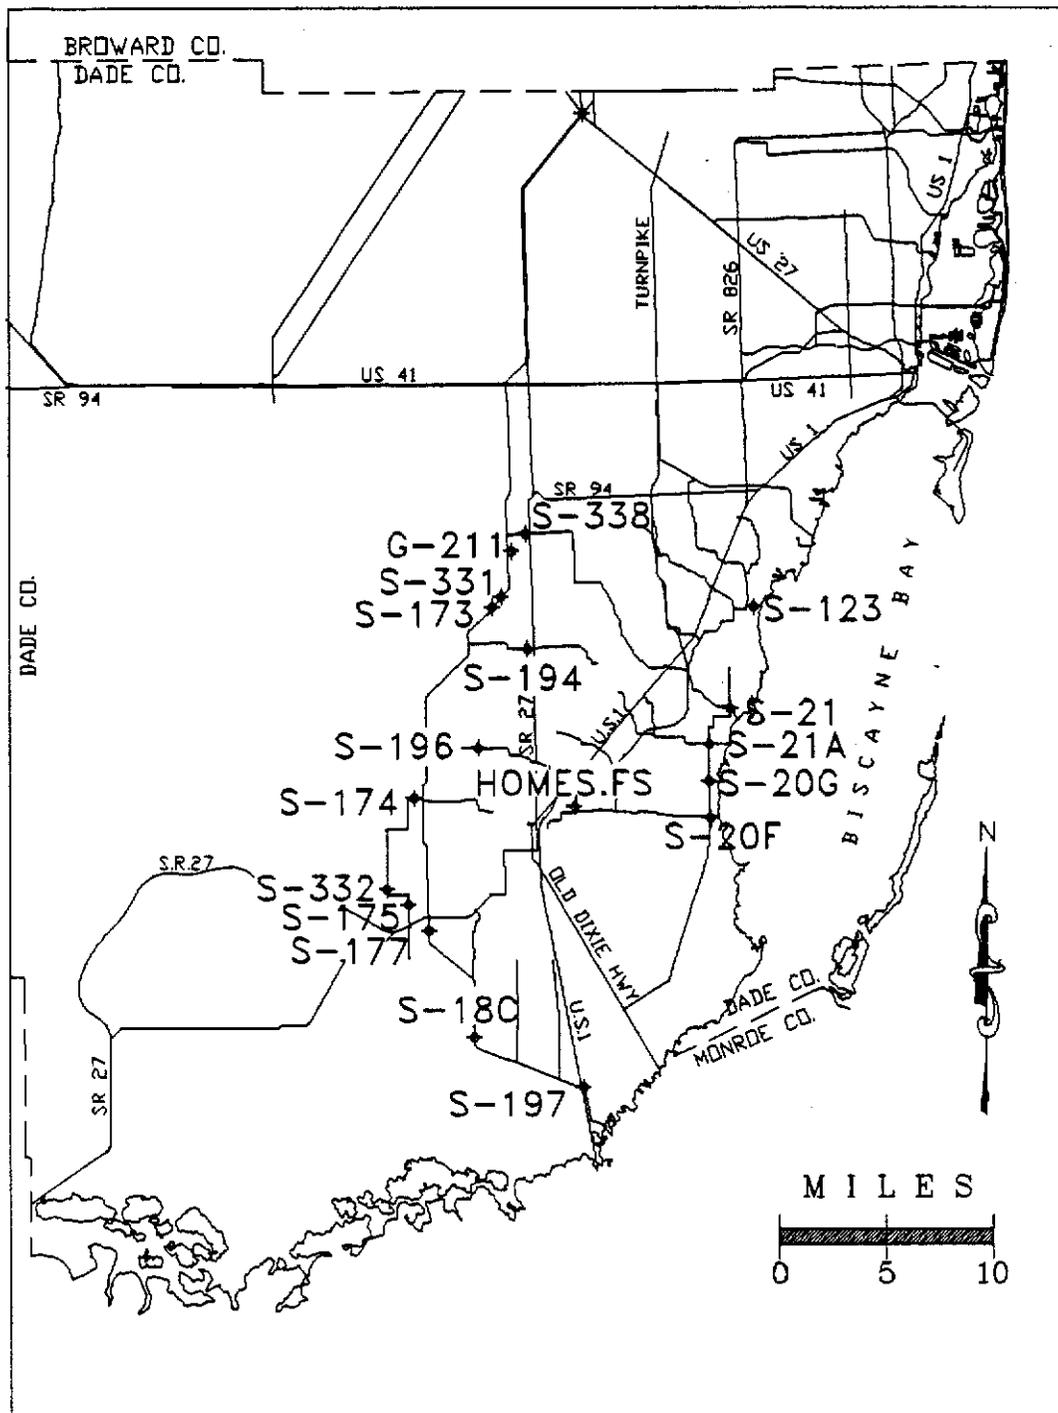
Figure 19. Control Structures around South Dade, Florida Bay and Biscayne Bay

There are 12 project control structures servicing the C-111 basin. They are structures S-331, S-173, S-194, S-196, S-174, S-332, S-175, S-177, S-178, S-18C and S-197. S-197 used to be an earthen plug which was recently replaced by 13 culverts with risers (Figure 19).

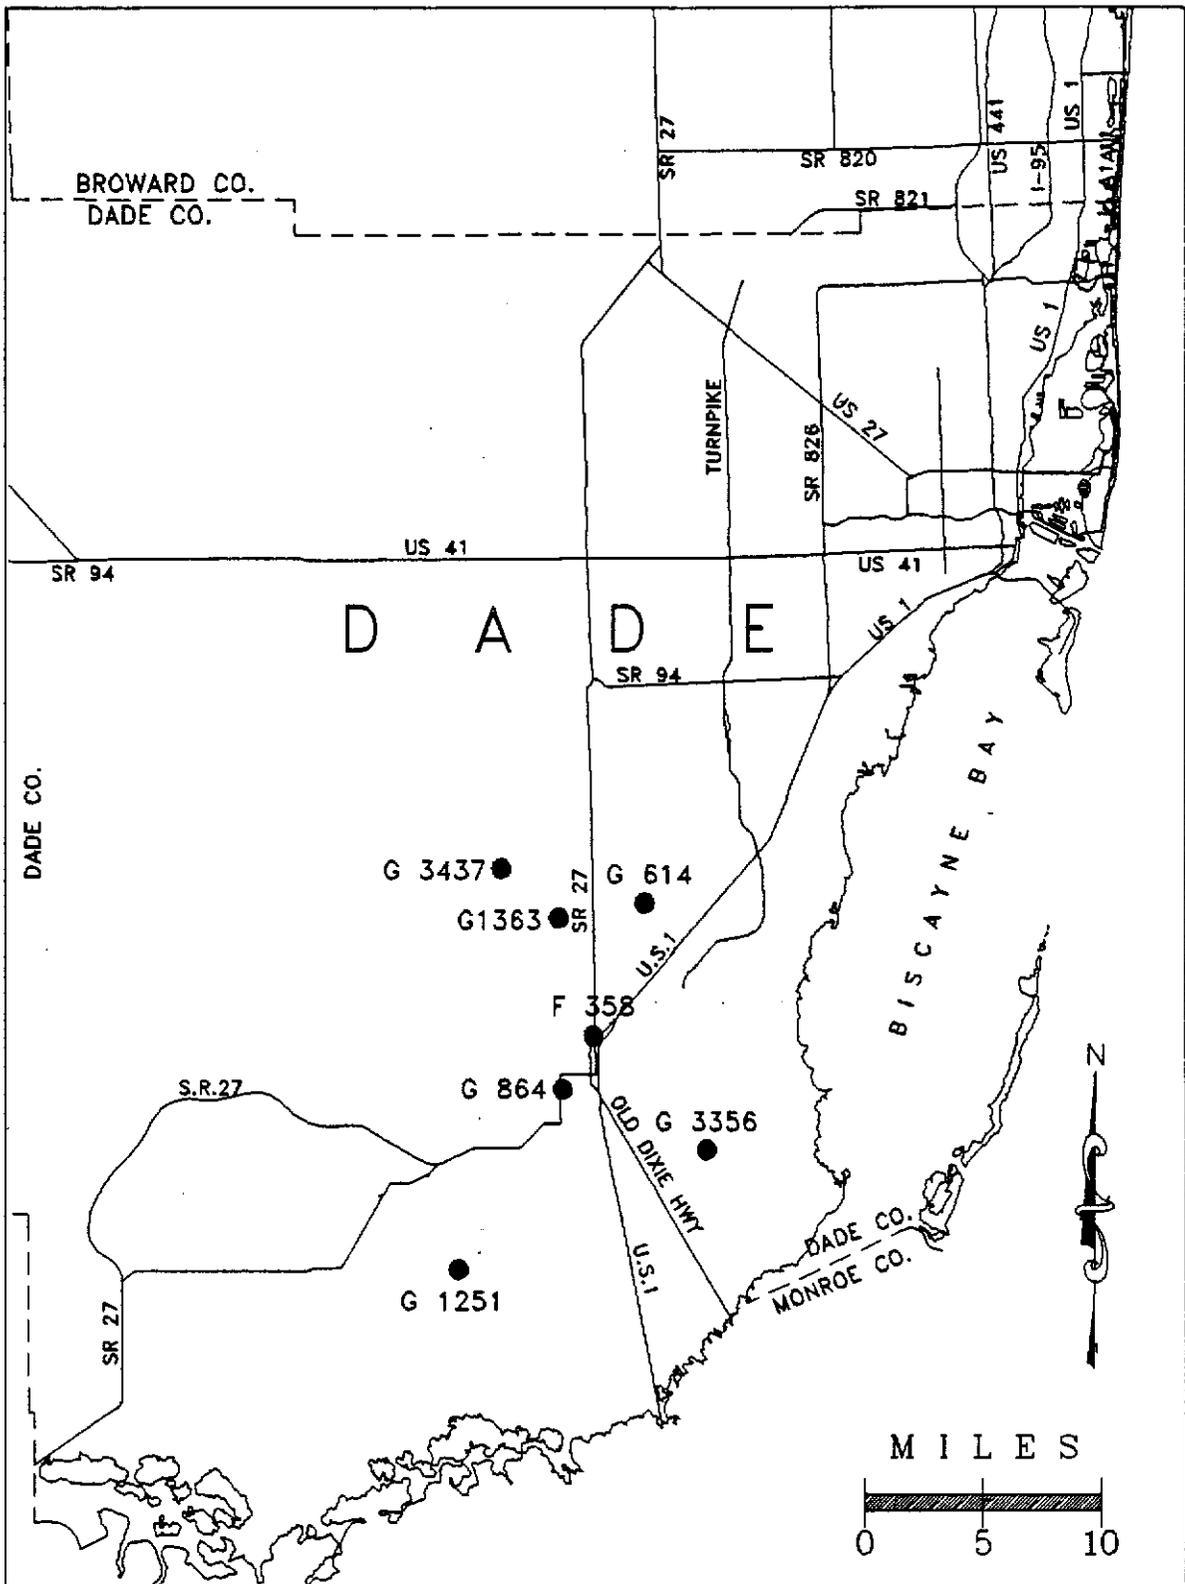
Figure 21. Groundwater Monitoring Wells in South Dade County

Figure 21 depicts the location of the south Dade monitor wells referenced in this report. Figures 22 through 25 show daily groundwater levels for these wells from June 20 through June 30. Included on the figures are mean groundwater levels in 1991, the maximum and minimum groundwater levels for the period of record, as well as the land surface elevation.

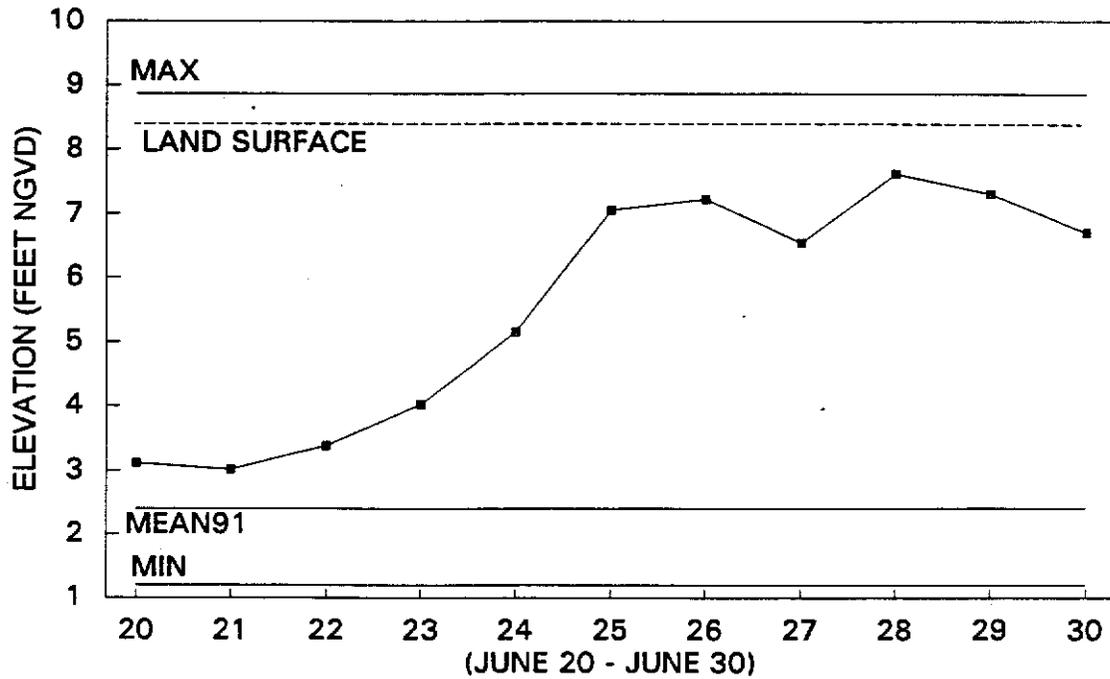
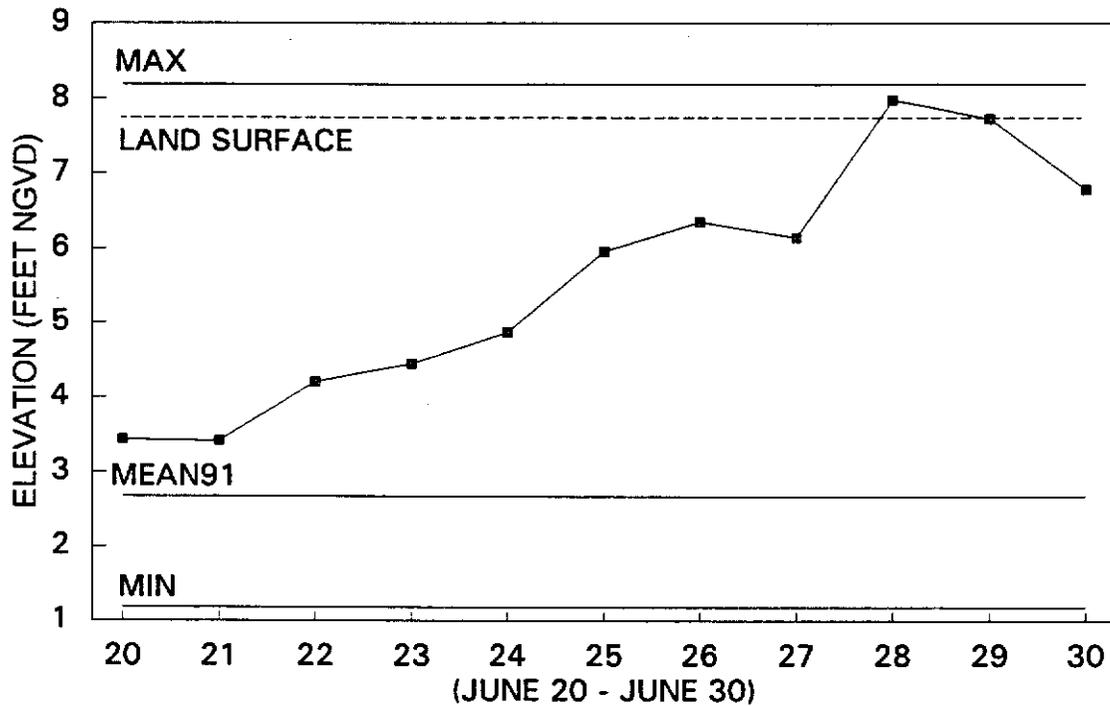
Daily Ground Water Levels near Florida City

Daily Ground Water Levels at Homestead

Figure 22. Daily Groundwater Levels Near Florida City and at Homestead

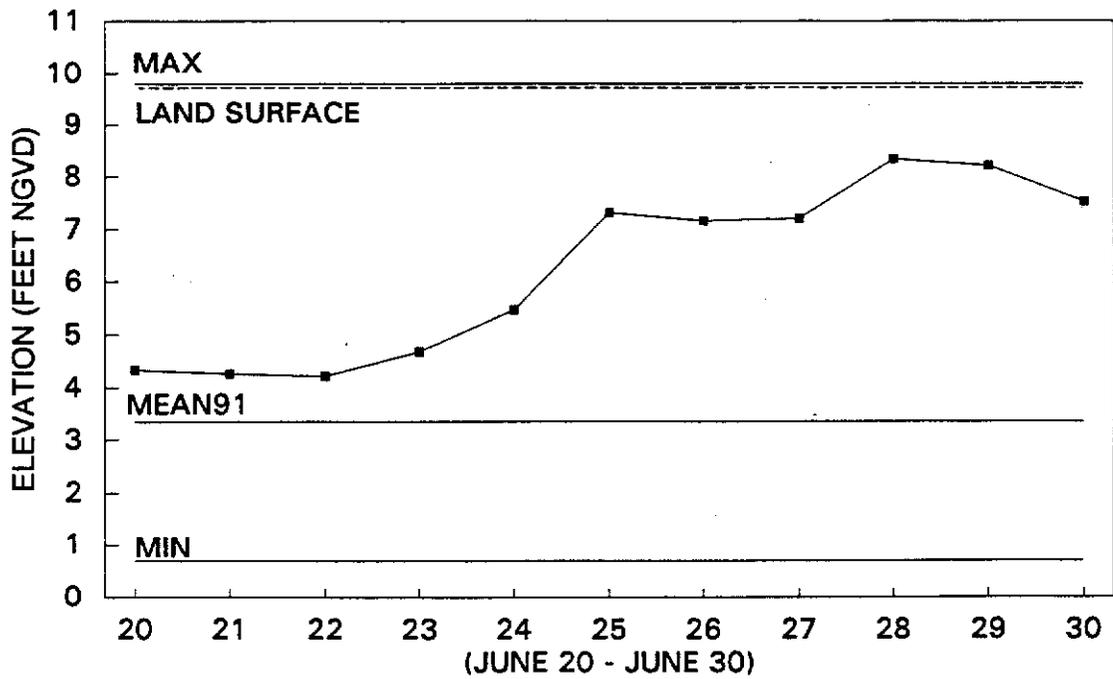
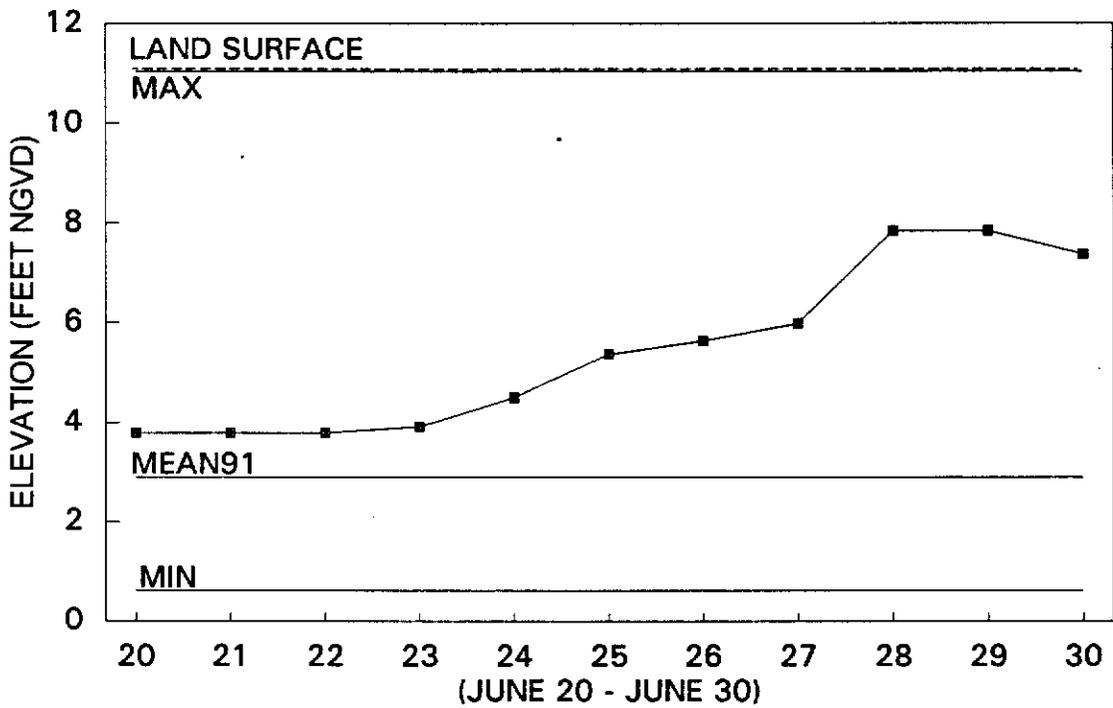
Daily Ground Water Levels 5 m NW of Homestead

Daily Ground Water Levels at Goulds

Figure 23. Daily Groundwater Levels 5 m NW of Homestead and at Goulds

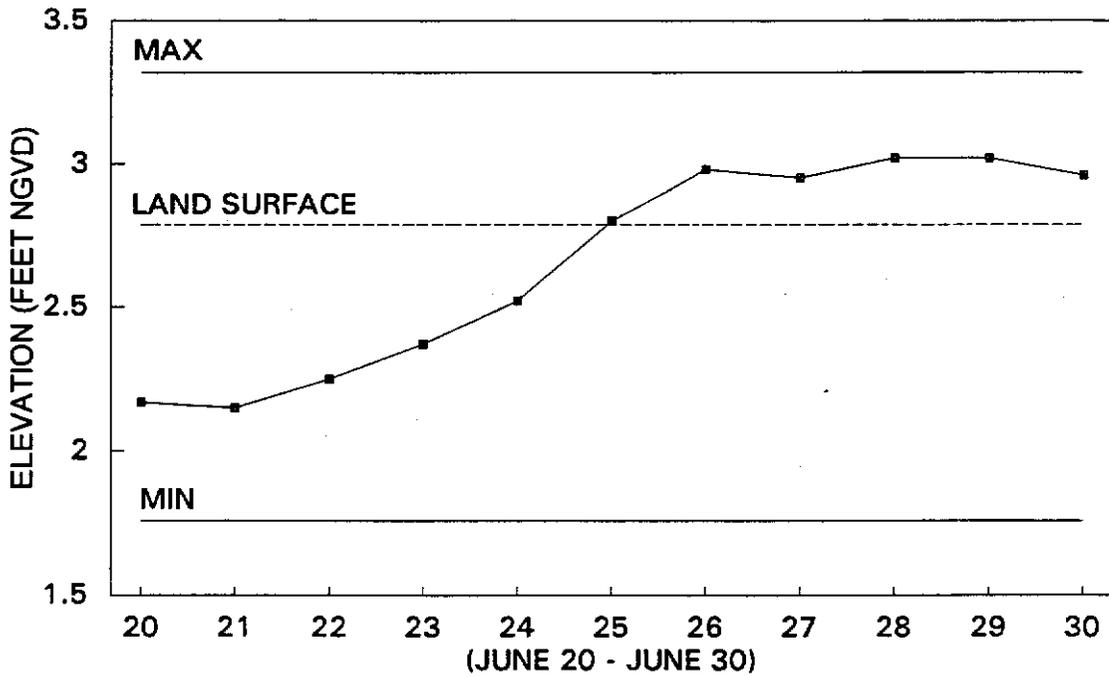
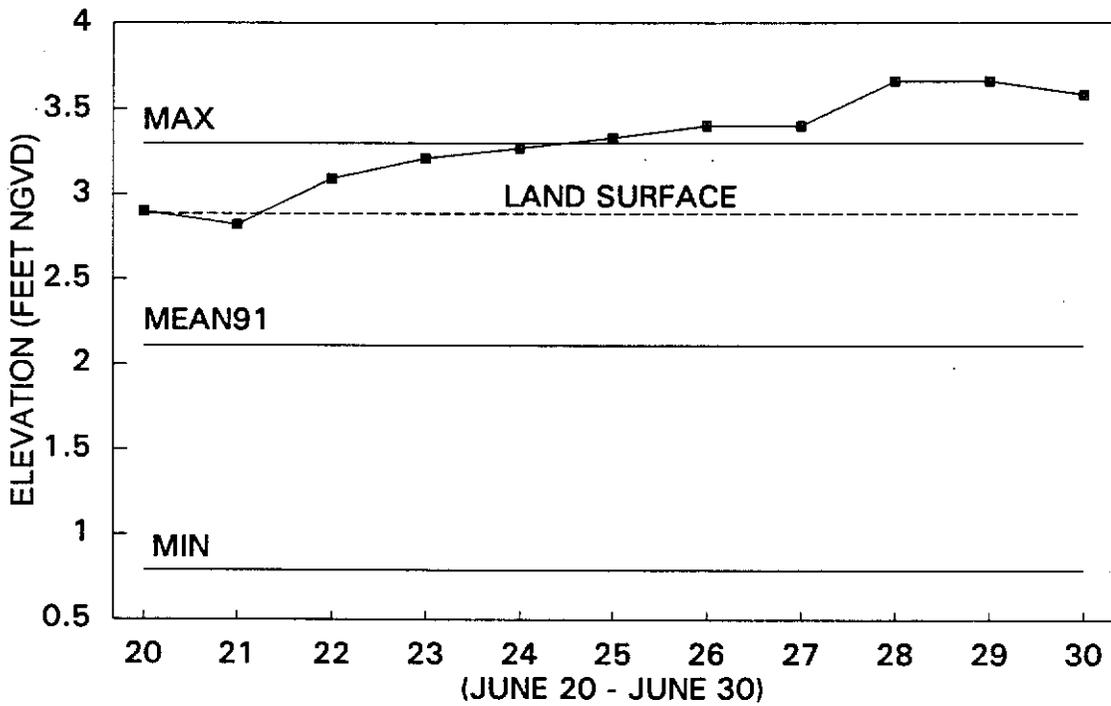
Daily Ground Water Levels 10 m SSW of Homestead

Daily Ground Water Levels 4 m SE of Florida City

Figure 24. Daily Groundwater Levels 10 m SSW of Homestead and 4 m SE of Florida City

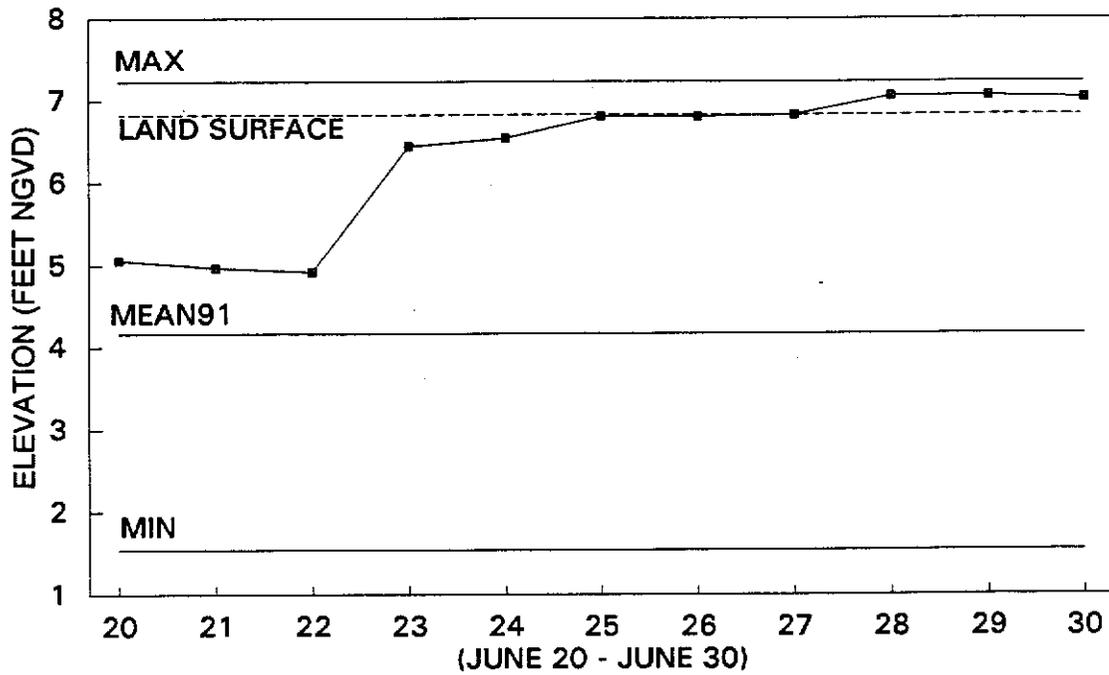
Daily Ground Water Levels 10 m NW of Homestead

Figure 25. Daily Groundwater Levels 10 m NW of Homestead
