**PRELIMINARY REPORT ON
RAINSTORM OF
JUNE 23-30, 1992**

December 1992

**South Florida Water Management District
West Palm Beach, Florida**

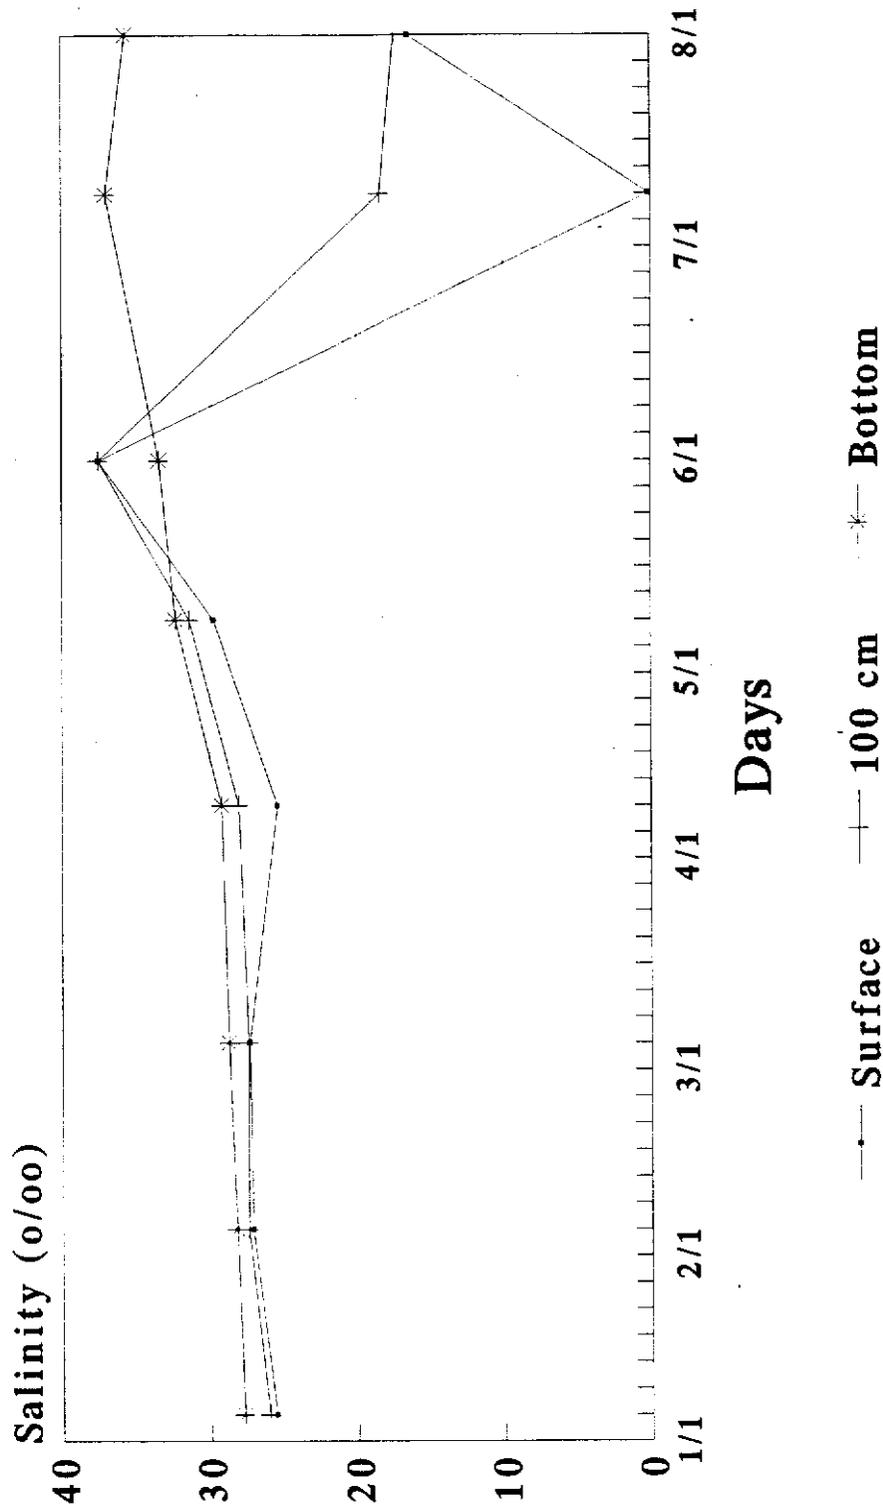
Figure 26. Salinity at C-111 Outlet

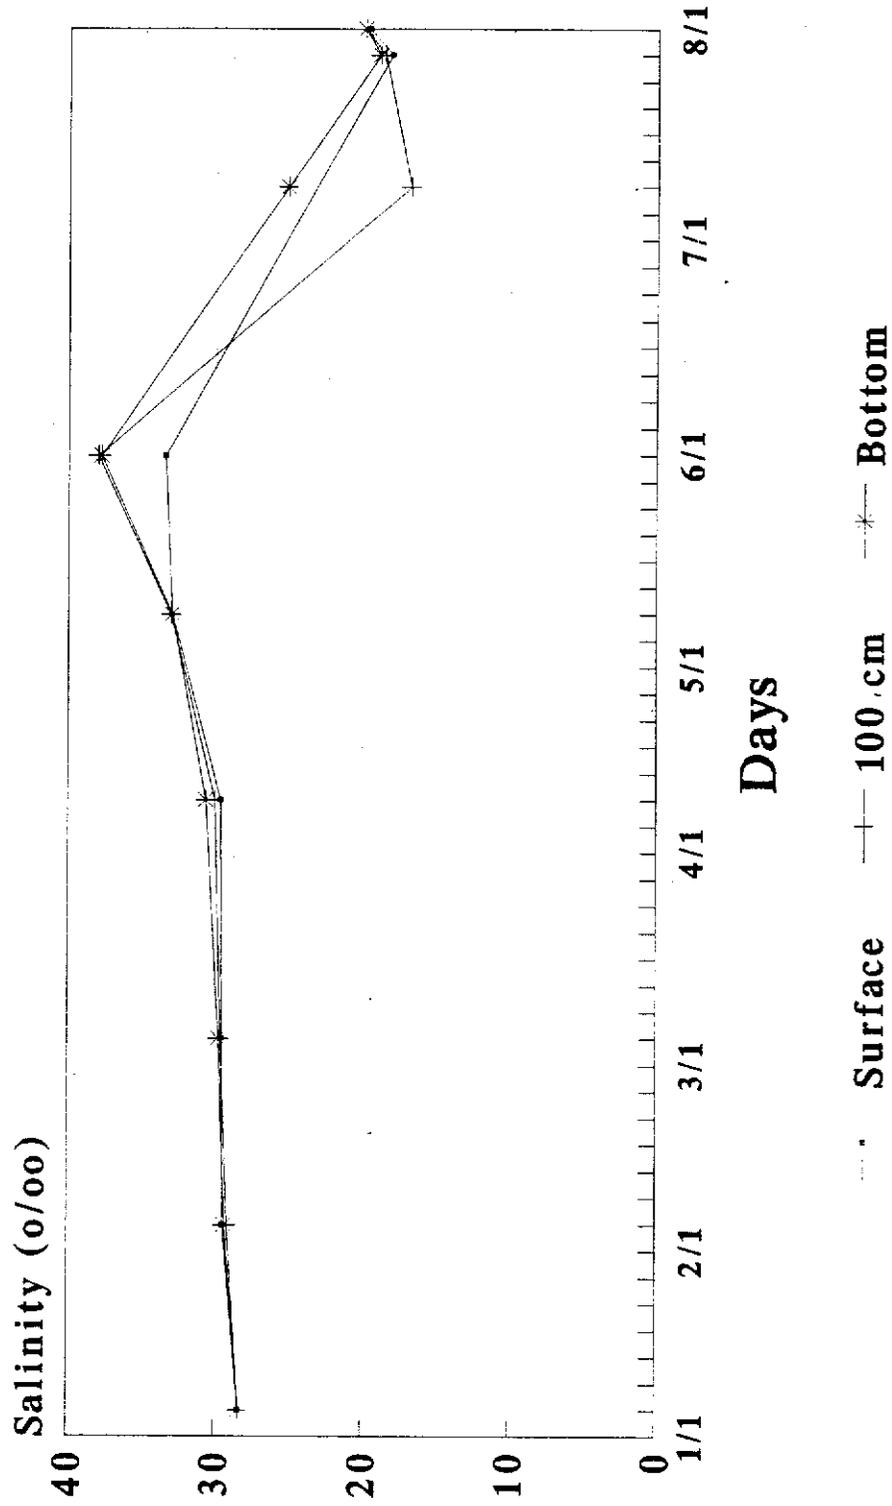
Figure 27. Salinity in Manatee Bay

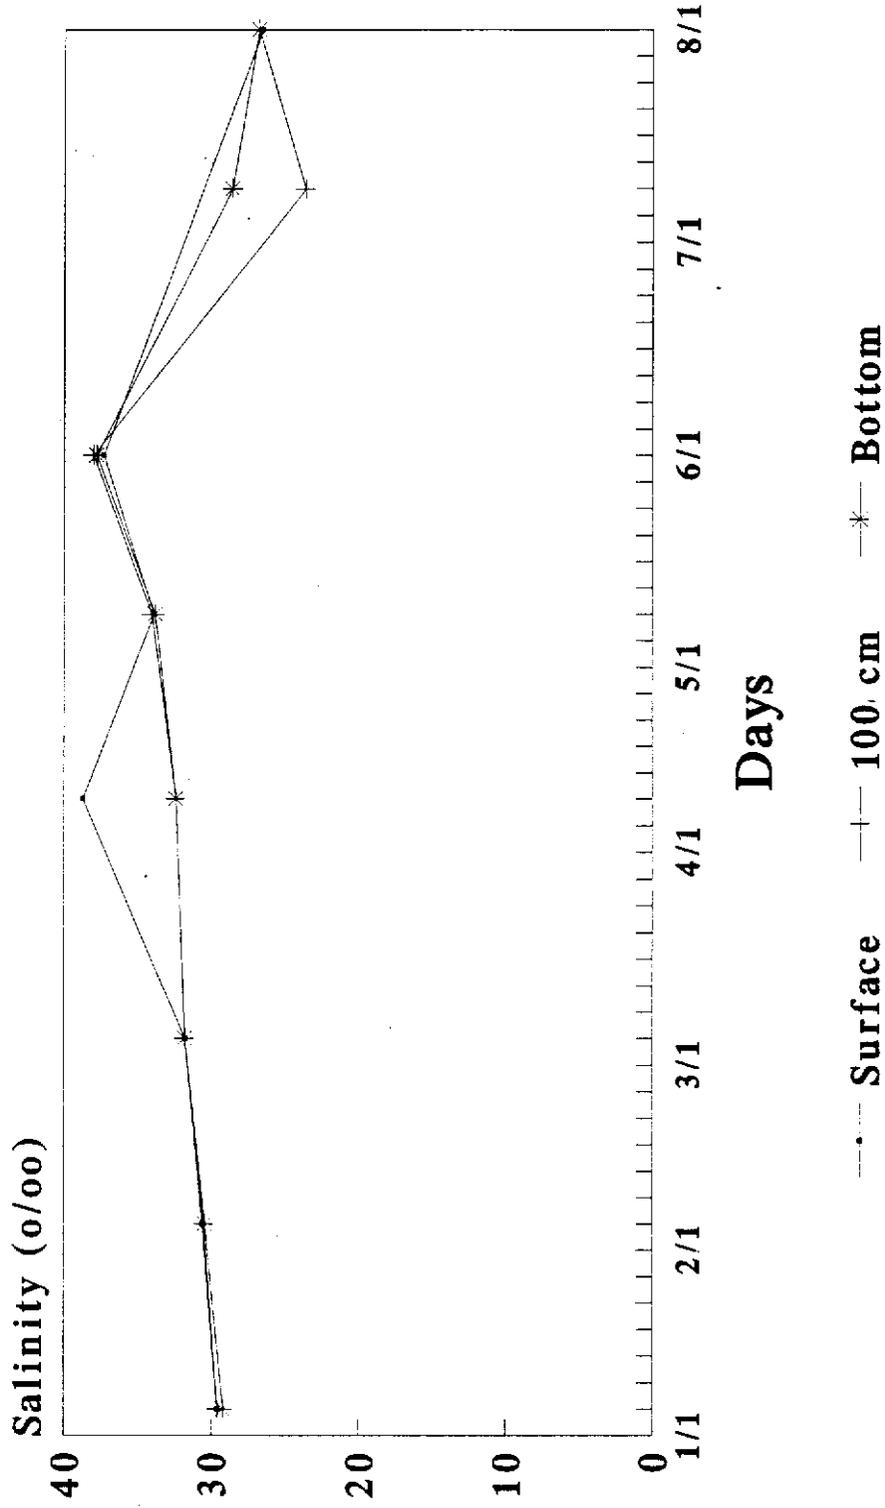
Figure 28. Salinity in Barnes Sound

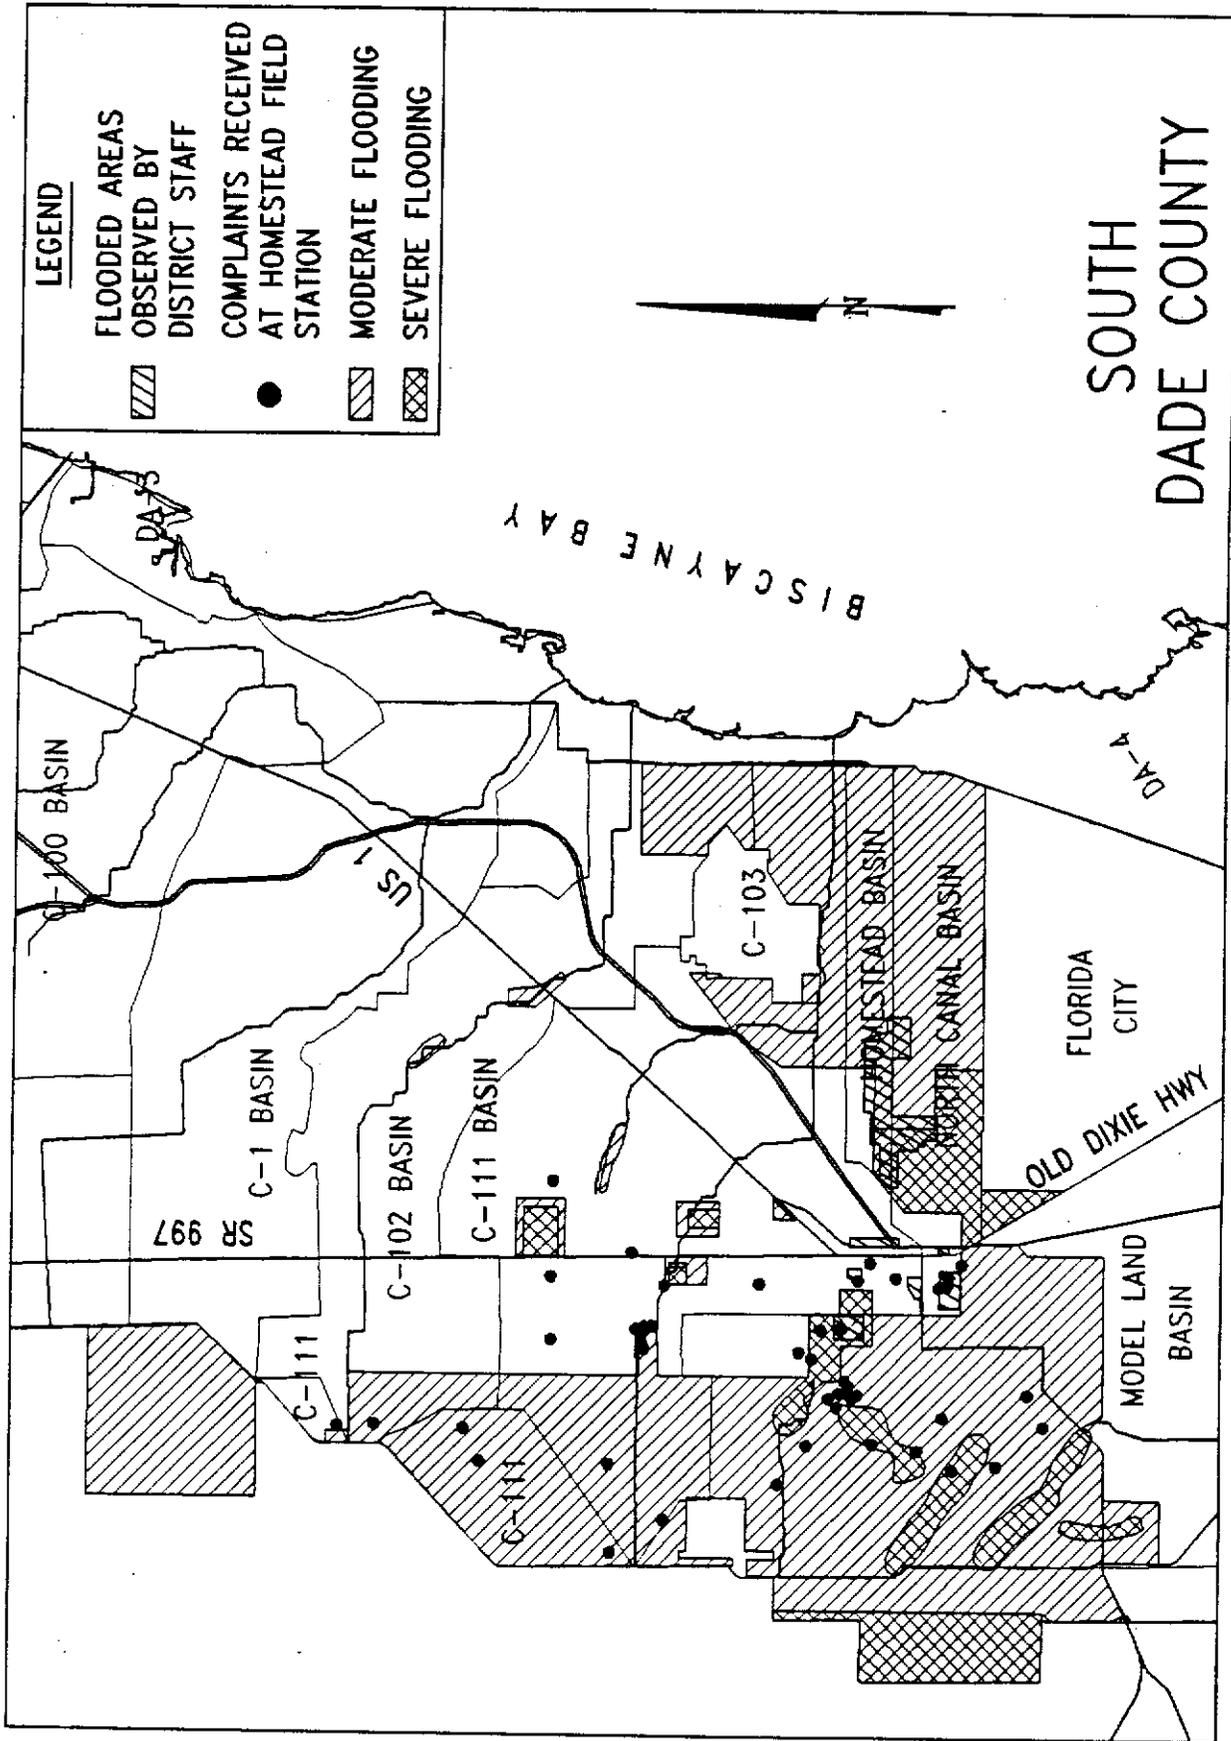
Figure 30. Flooded Area around South Dade County

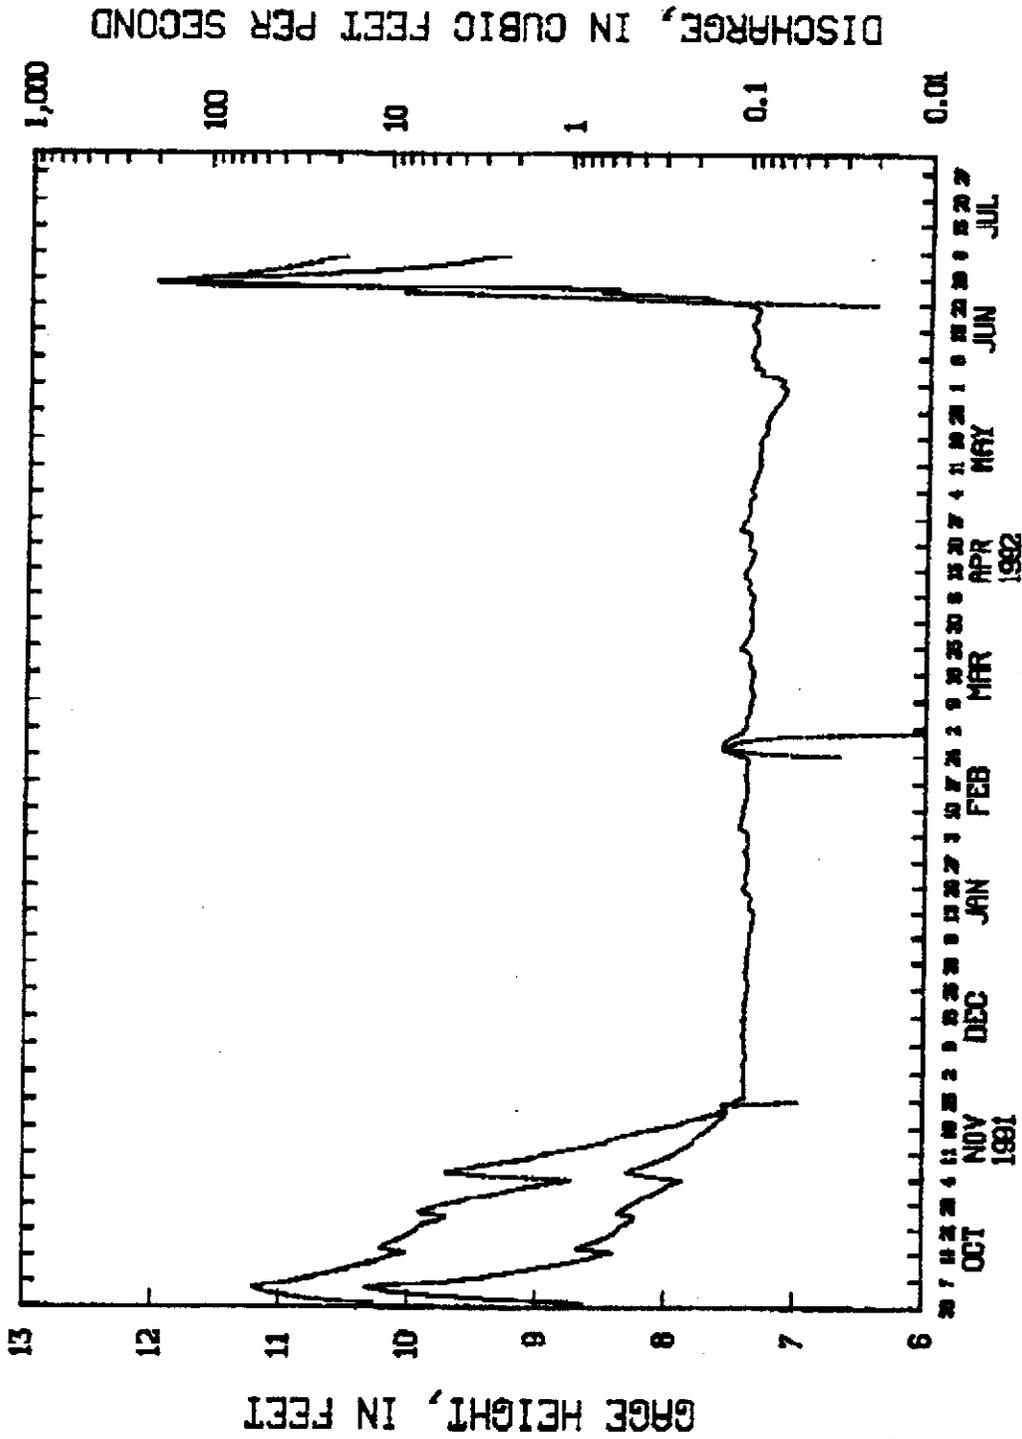
Figure 33. Mean Daily Gauge Height, Mean Daily Discharge, North Branch Estero River

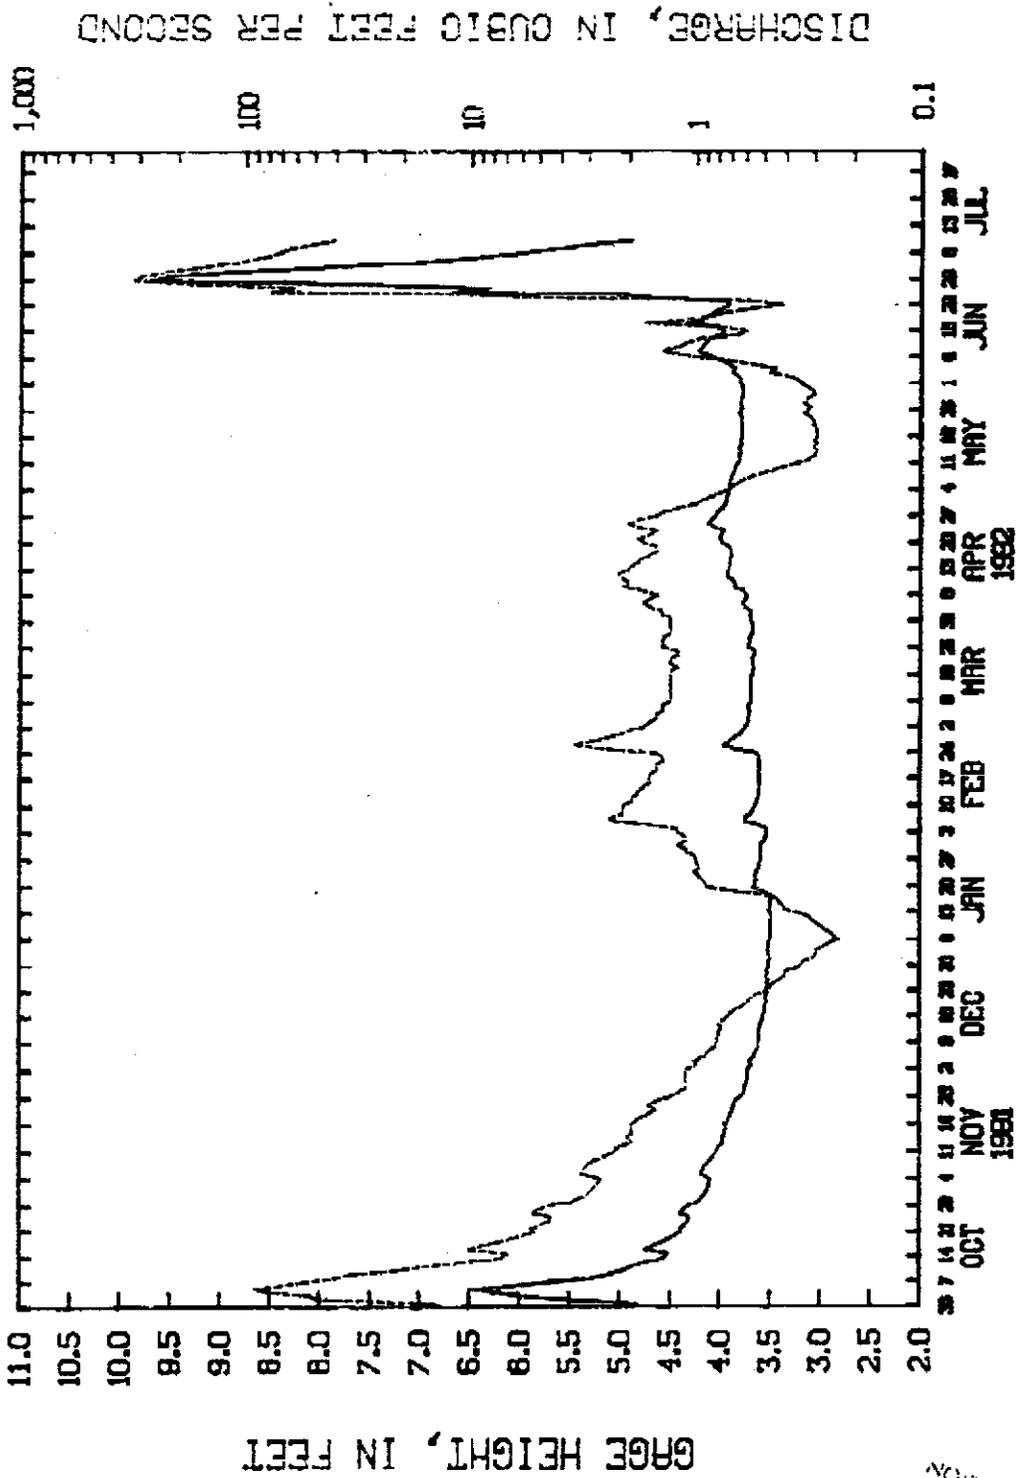
Figure 34. Mean Daily Gauge Height, Mean Daily Discharge, South Branch Estero River

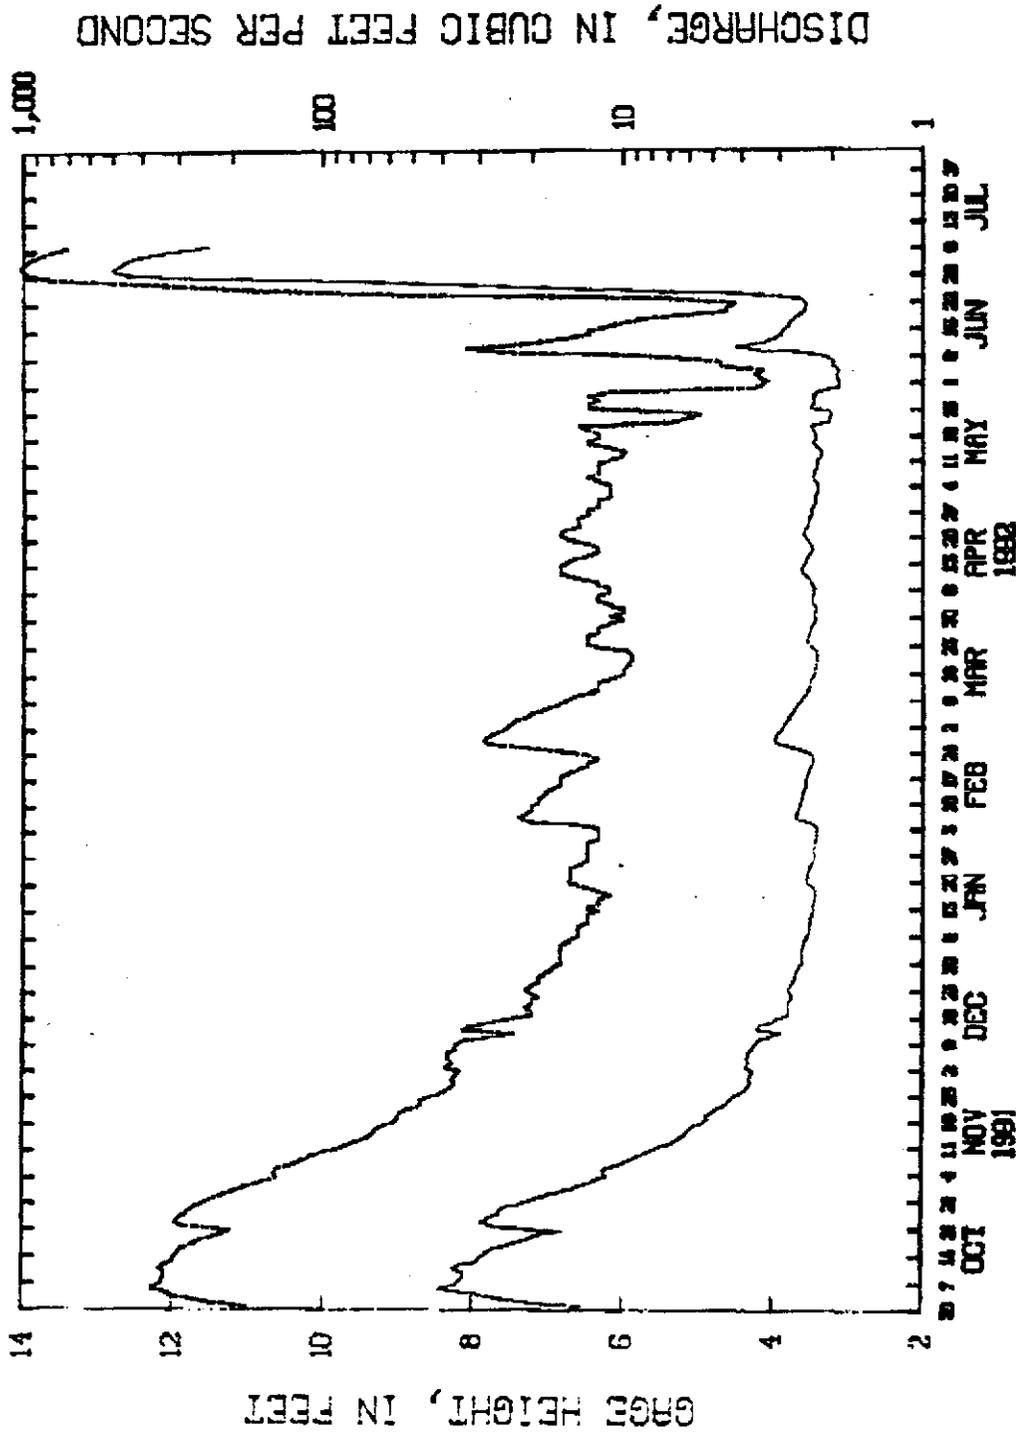
Figure 35. Mean Daily Gauge Height, Mean Daily Discharge, Imperial River

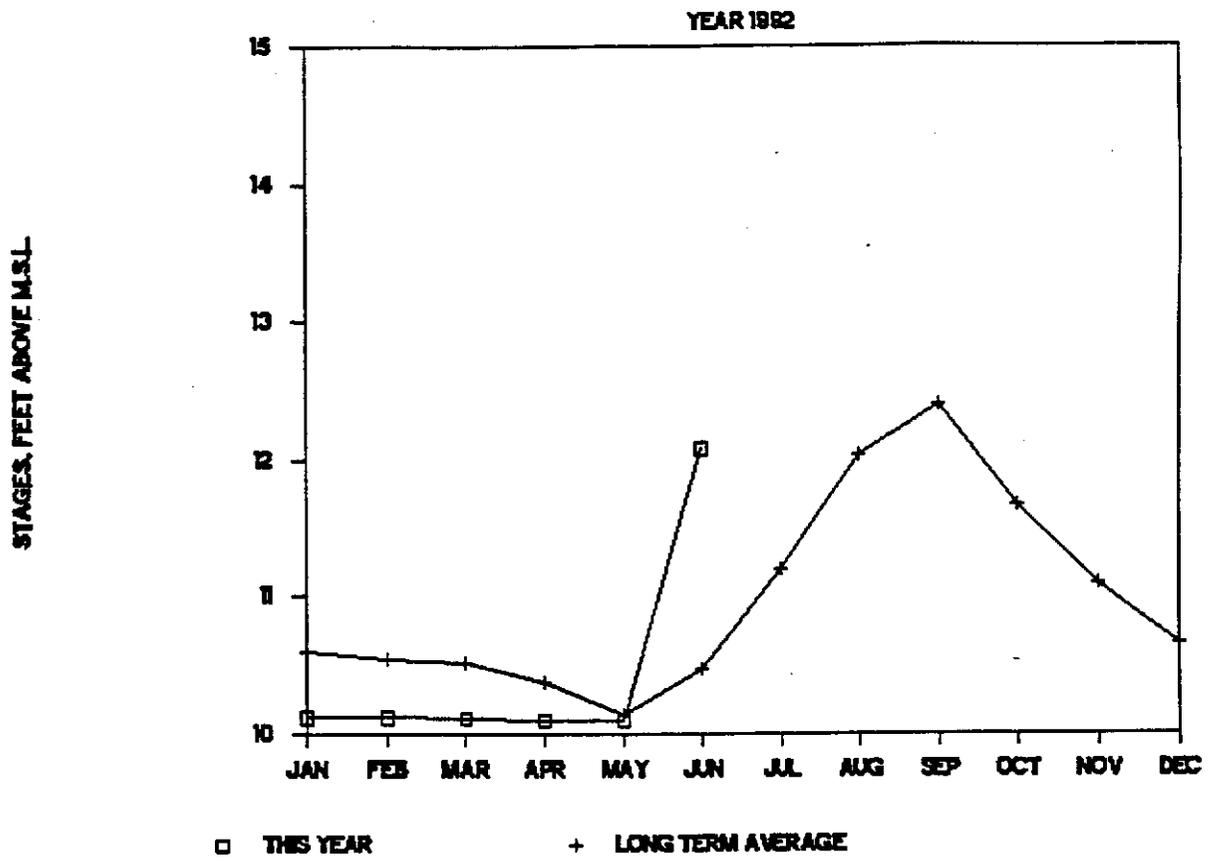
Figure 36. Cocohatchee Canal Stages at CR 951

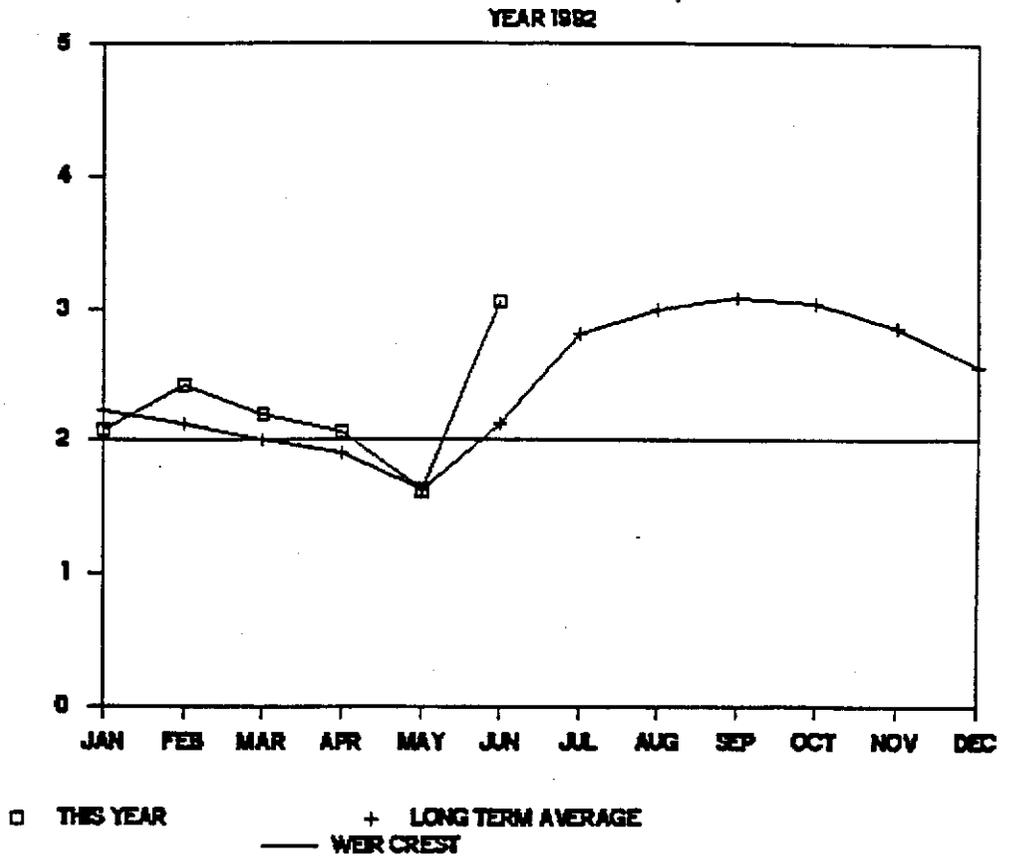
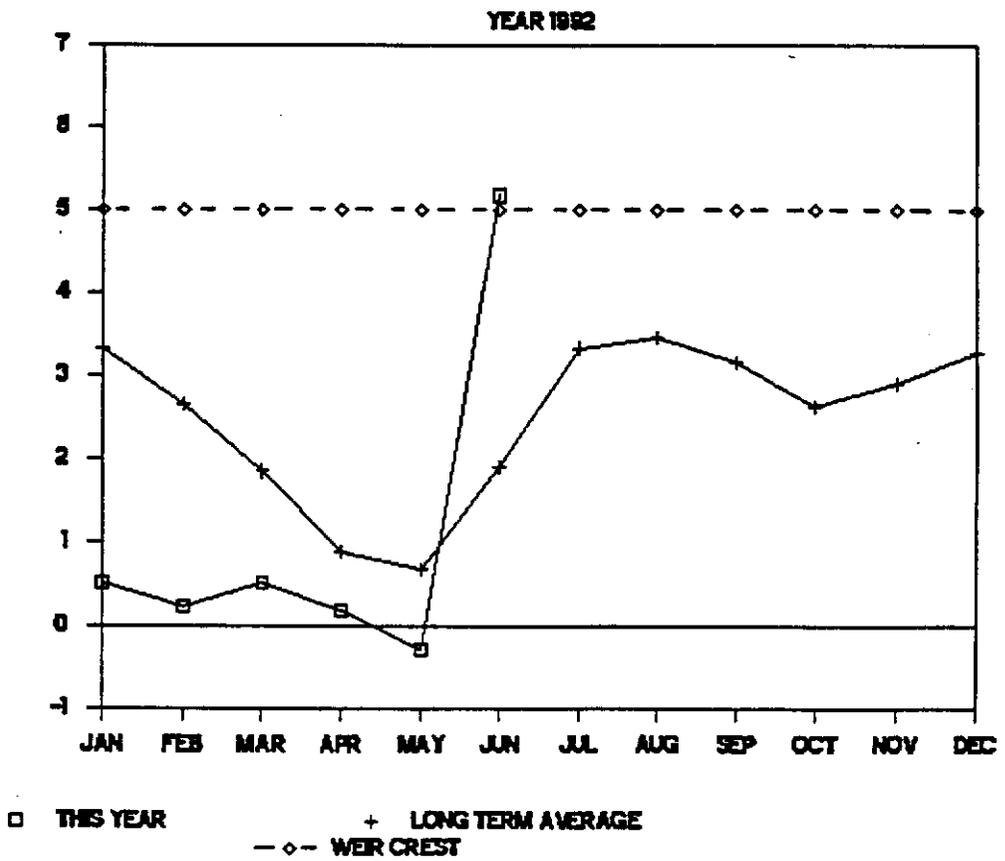
Figure 37. Faka Union Canal Stages at U.S. 41 and Henderson Creek Canal Stages at U.S. 41

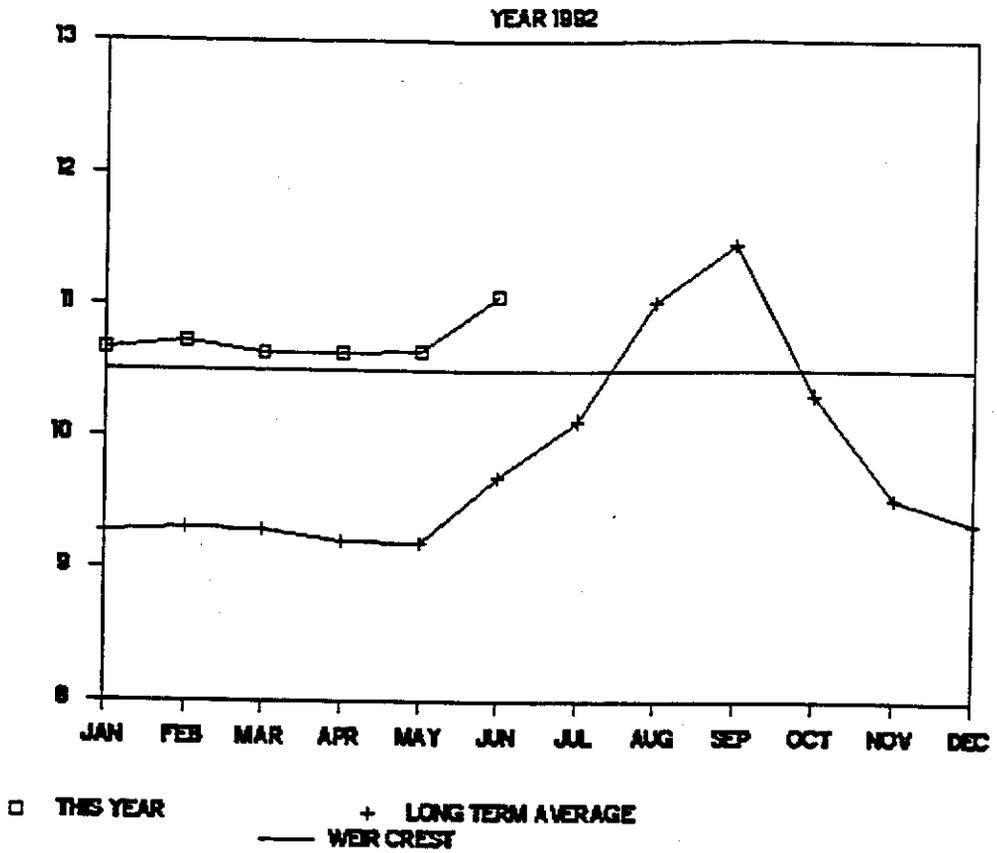
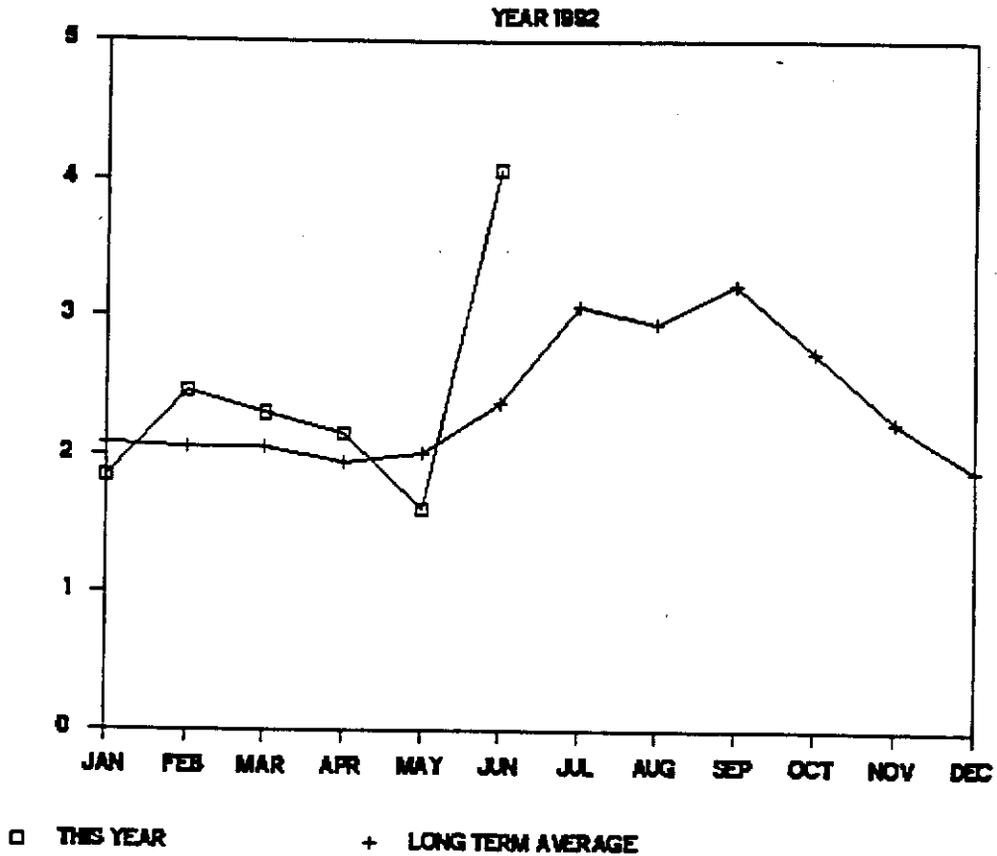
Figure 38. Golden Gate Canal Stages at Weir #5 and Cocohatchee Canal Stages at Willoughby Acres

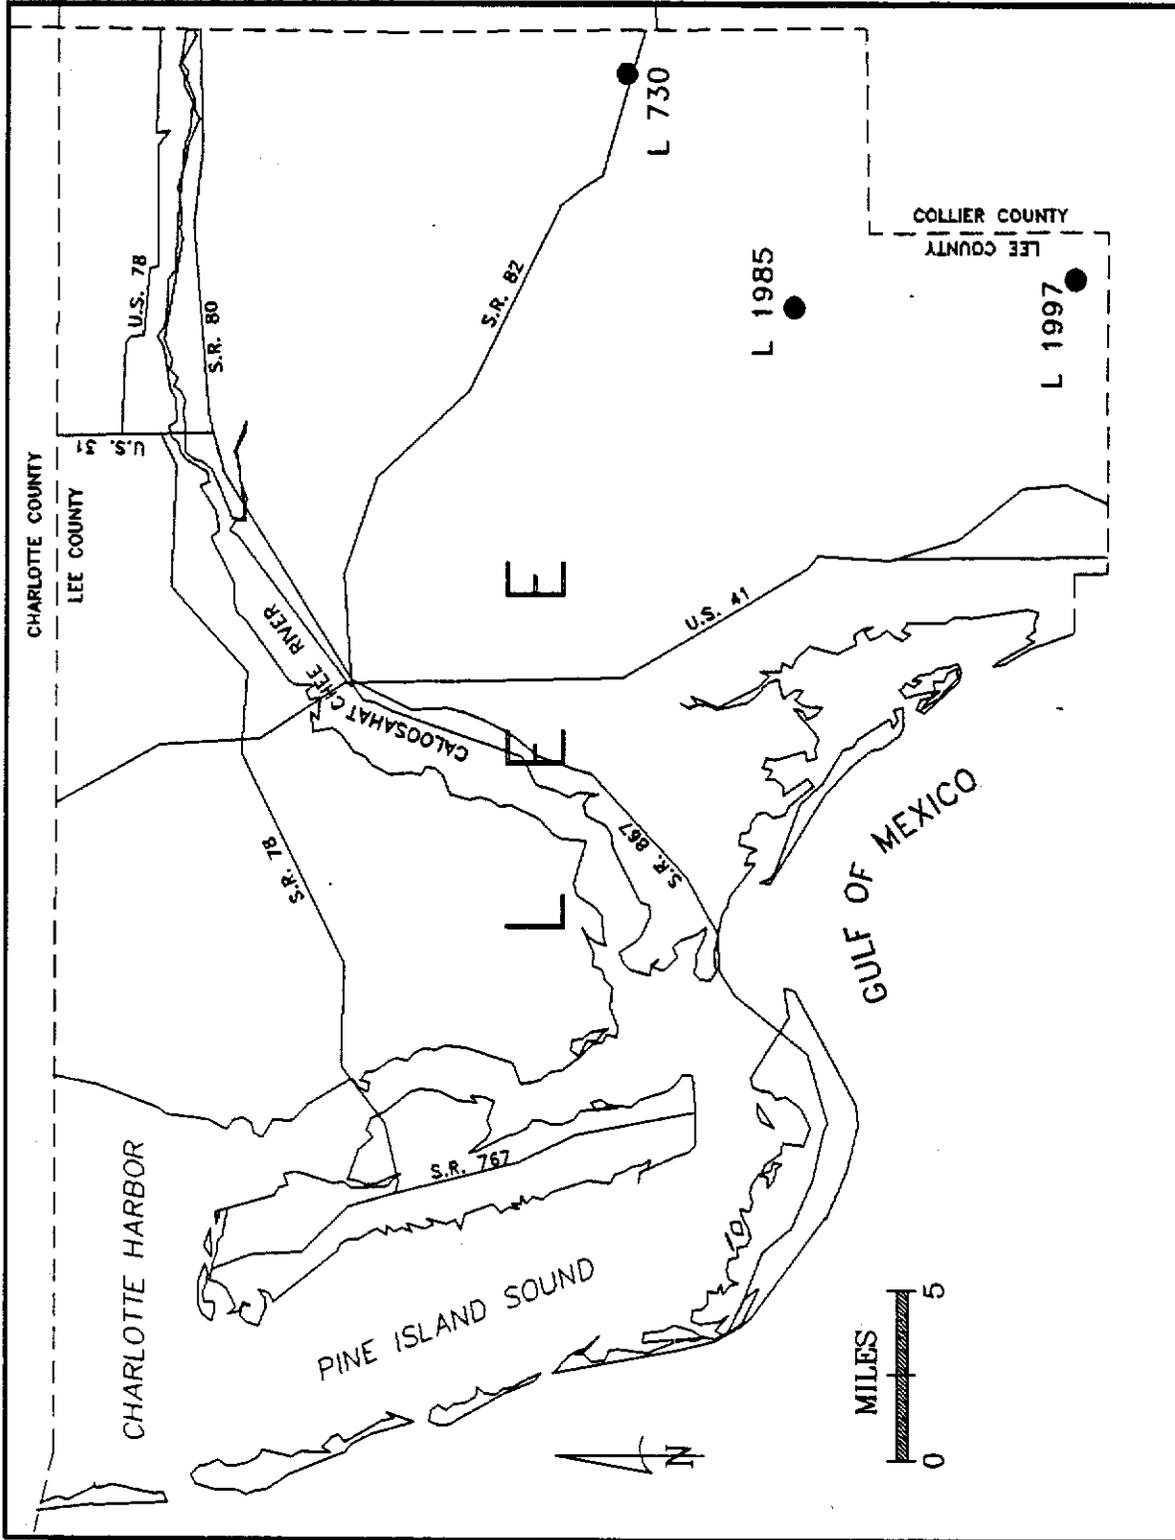
Figure 41. Groundwater Monitoring Wells in Lee County

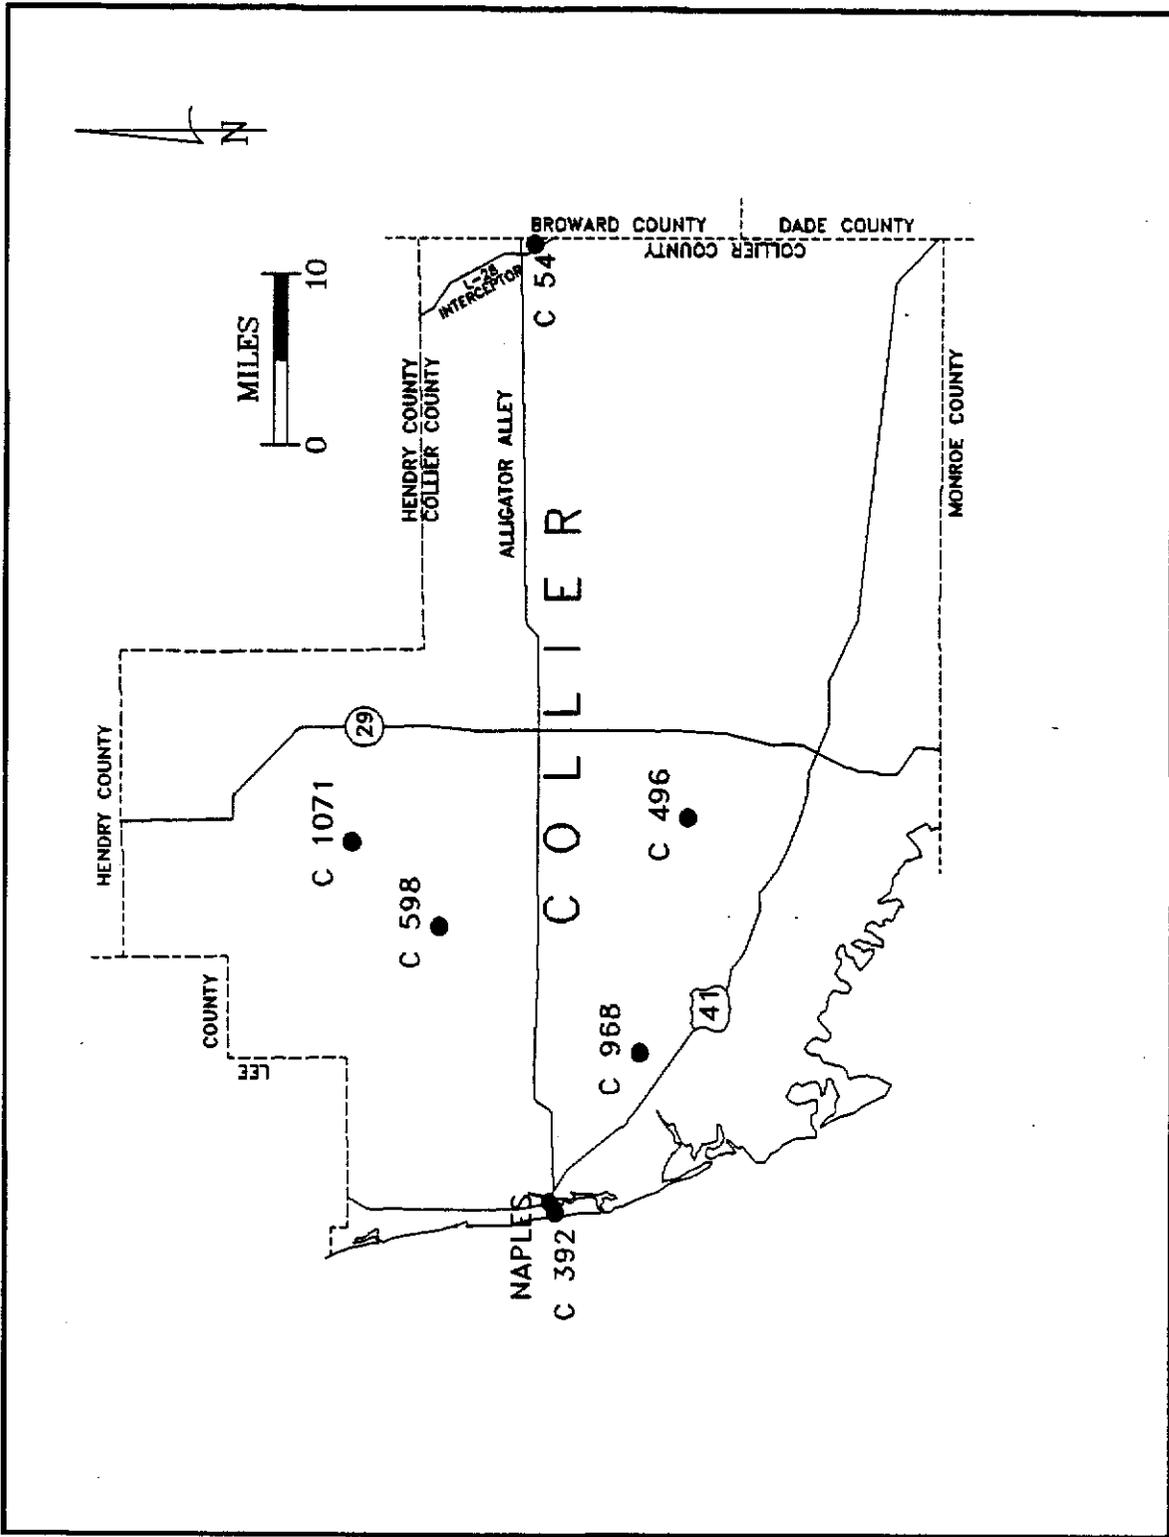
Figure 42. Groundwater Monitoring Wells in Collier County

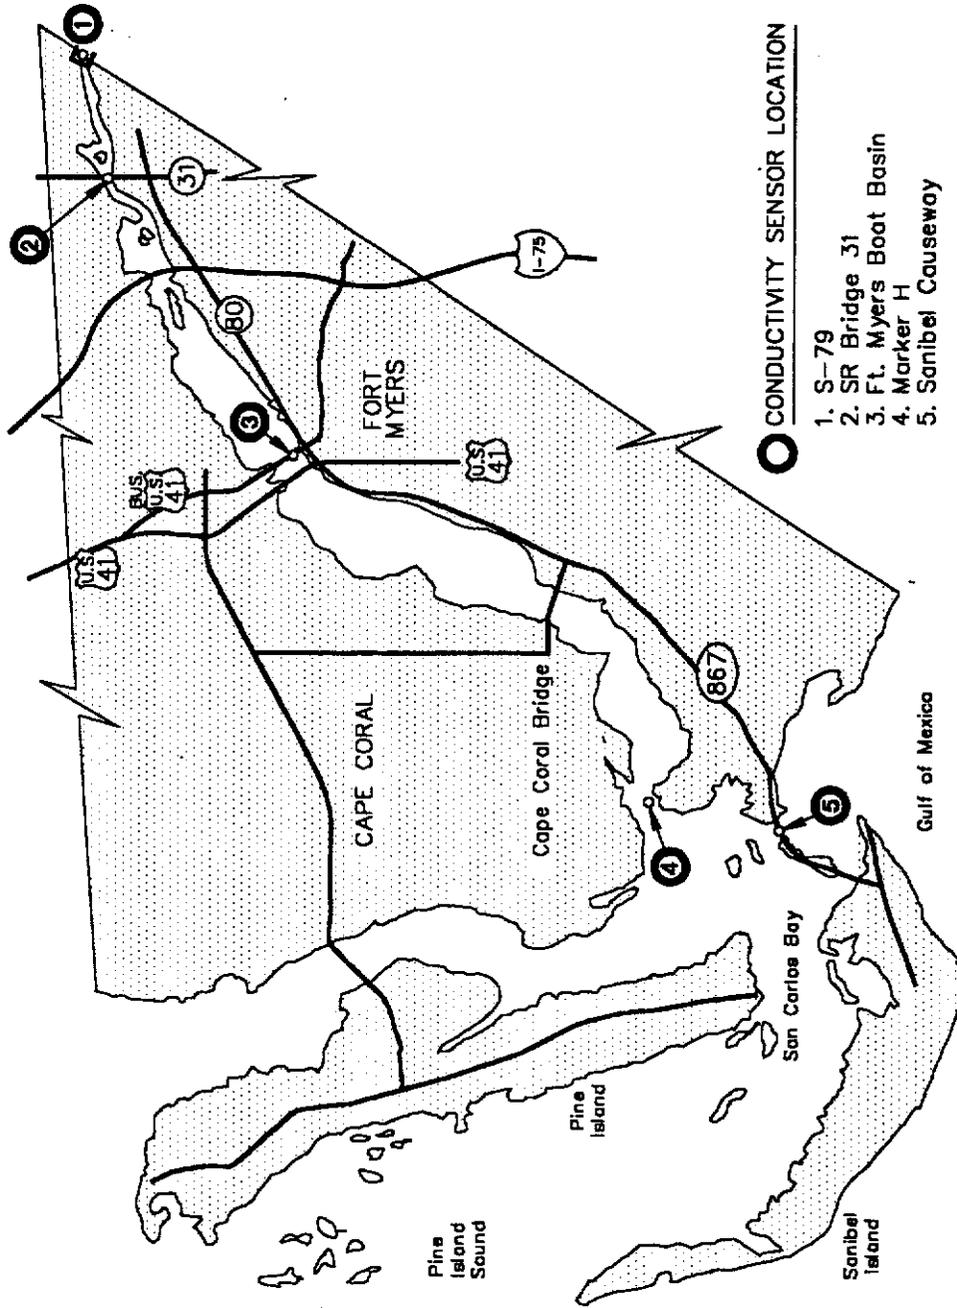
Figure 48. Conductivity Sensor Locations in the Caloosahatchee Estuary

Five sets of continuous conductivity probes are located in Caloosahatchee Estuary (Figure 48). The probes record conductivity and store the information until it is remotely retrieved by Data Management Division staff at the West Palm Beach Field Office via cellular telephone. The data collected by these probes and each station's periodic calibration report were used to determine the impact to conductivity/salinity caused by the storm's freshwater runoff. The conductivity/

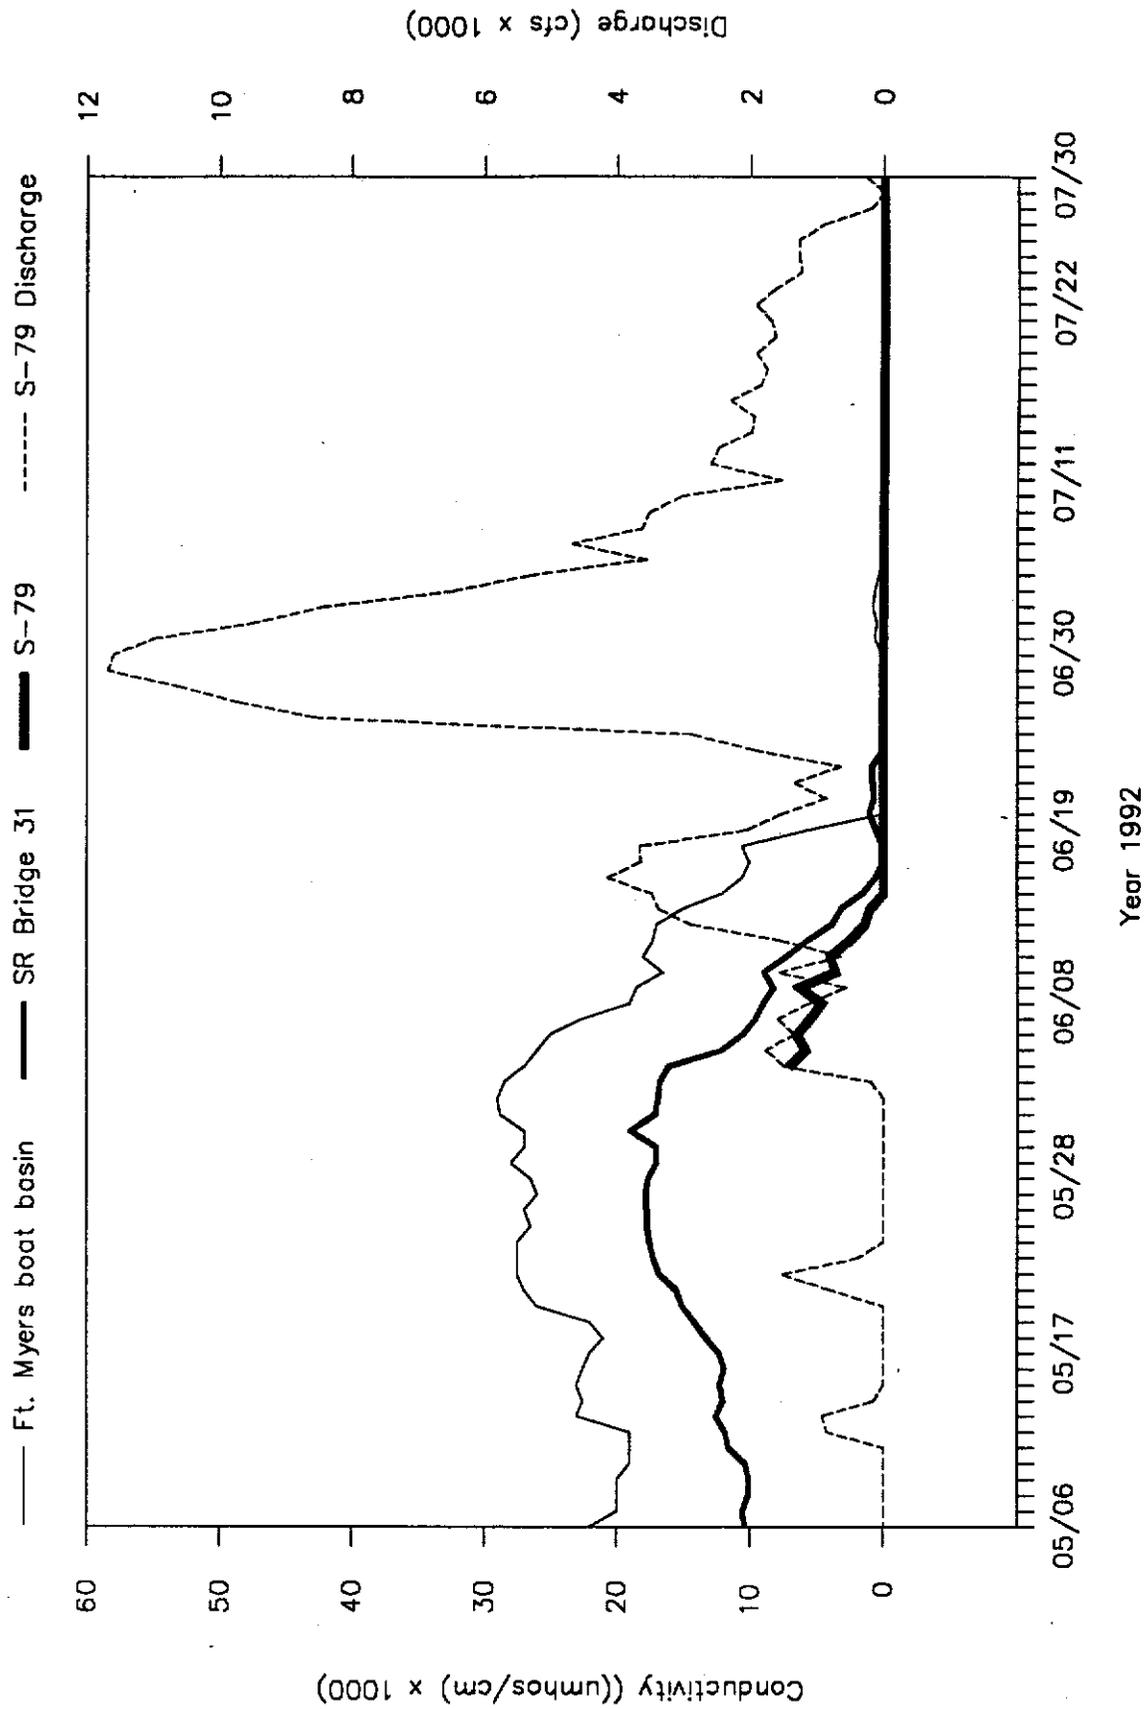
Figure 50. Conductivity at 3 Stations and Freshwater Inflow through S-79, Caloosahatchee Estuary

Prolonged exposure of estuarine benthic invertebrates to conductivity below 1000 mhos/cm for a week causes death, as does exposure to conductivity below 32,000 mhos/cm for some marine benthos. Sea grasses are also adversely impacted when conductivity remains below the 32,000 mhos/cm to 39,000 mhos/cm range. Freshwater conditions below 1000 mhos/cm in the estuary are common from S-79 downstream to just below the Fort Myers Boat Basin during the wet season. The benthic community that inhabits this area are tolerant of these changing conditions and were probably not seriously impacted by this storm. Marine and freshwater intolerant invertebrates begin to predominate in the lower Caloosahatchee Estuary below the Cape Coral Bridge. This lower estuarine area also supports sea grasses that become very dense in the San Carlos Bay area. Therefore, estuarine benthic invertebrates and sea grasses were probably seriously impacted downstream of the Cape Coral Bridge since freshwater conditions prevailed for more than two weeks between the Cape Coral Bridge and Marker H. Marine benthic invertebrates and sea grasses between Marker H and the Sanibel Causeway recorder were probably also adversely influenced by the freshwater discharge associated with the storm since conductivity in this area dropped below 32,000 mhos/cm for almost a week.
