**PRELIMINARY REPORT ON
RAINSTORM OF
JUNE 23-30, 1992**

December 1992

**South Florida Water Management District
West Palm Beach, Florida**

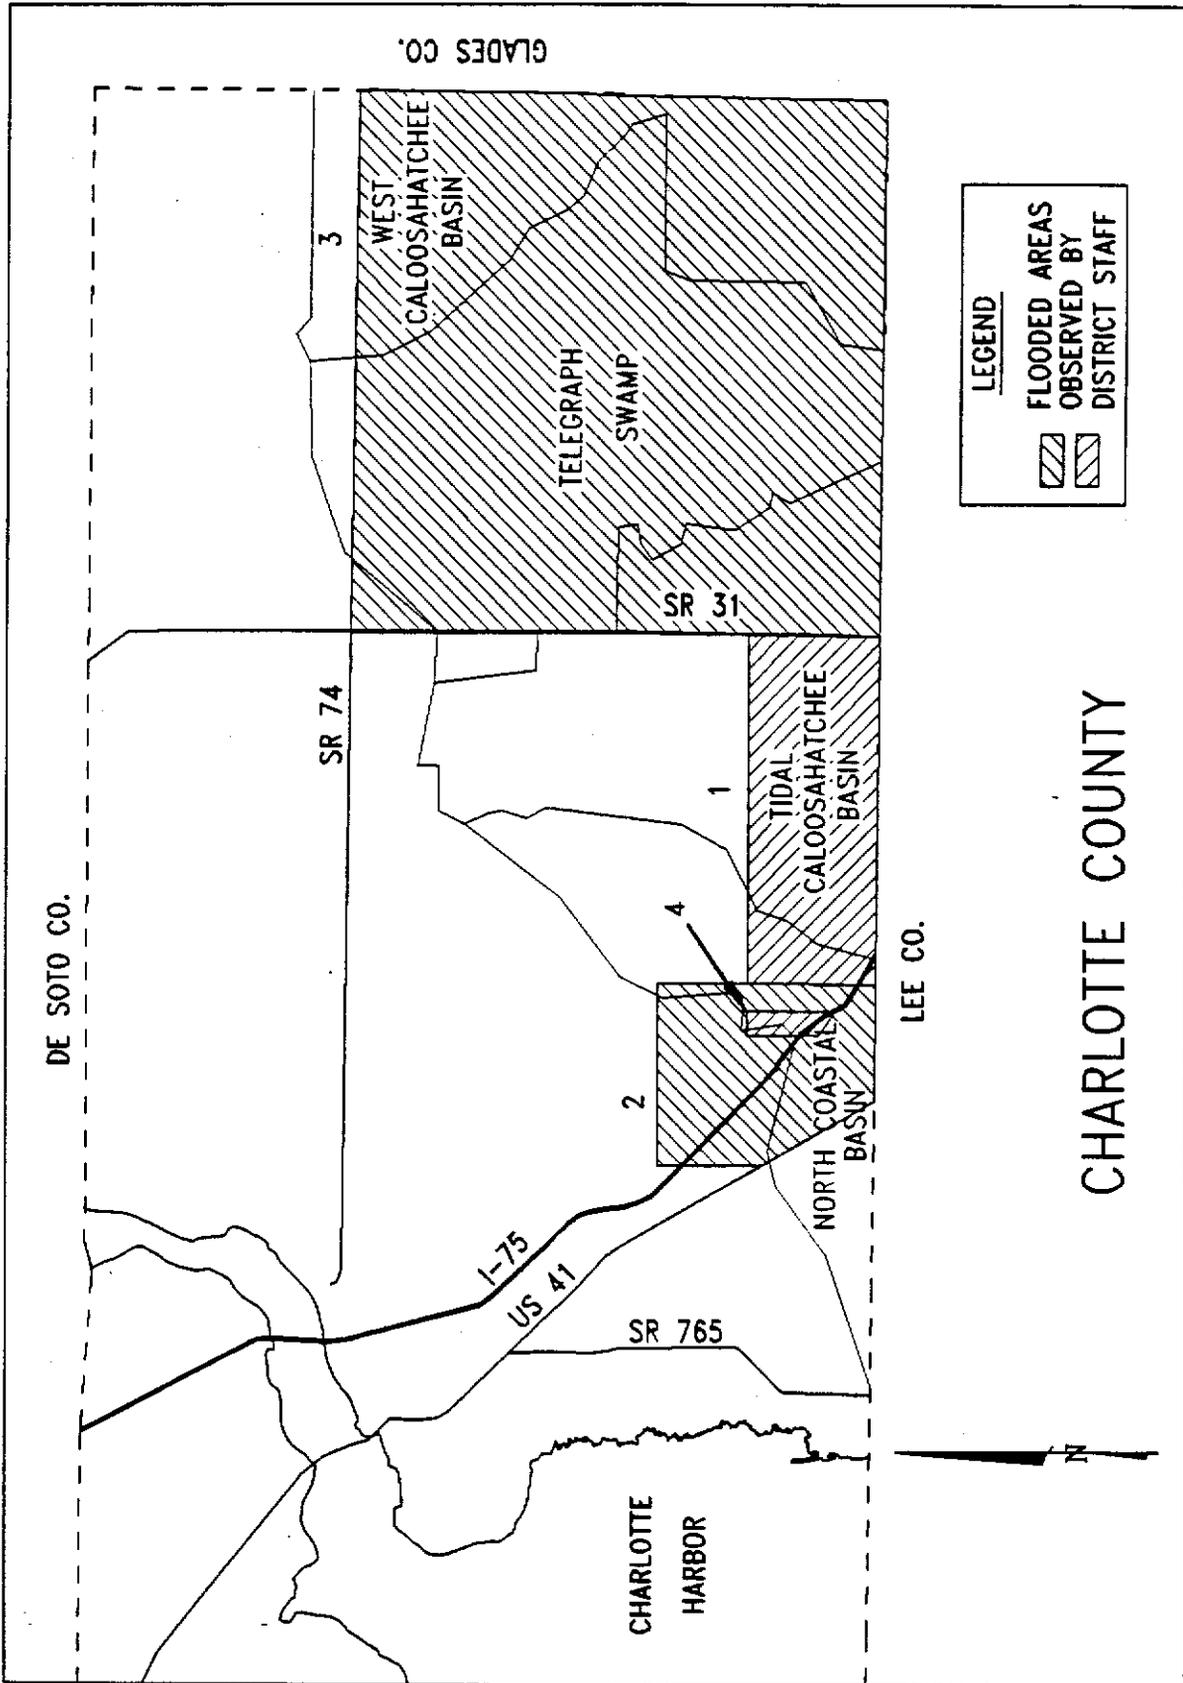
Figure 51. Flooded Areas, Charlotte County

Several areas of flooding were observed in these counties. In general, large portions of Hendry County had standing water on farm fields and wooded areas, which caused farming activities to cease for several days. Several permitted orange groves had 8-12 inches of water in the groves, and several emergency overflow

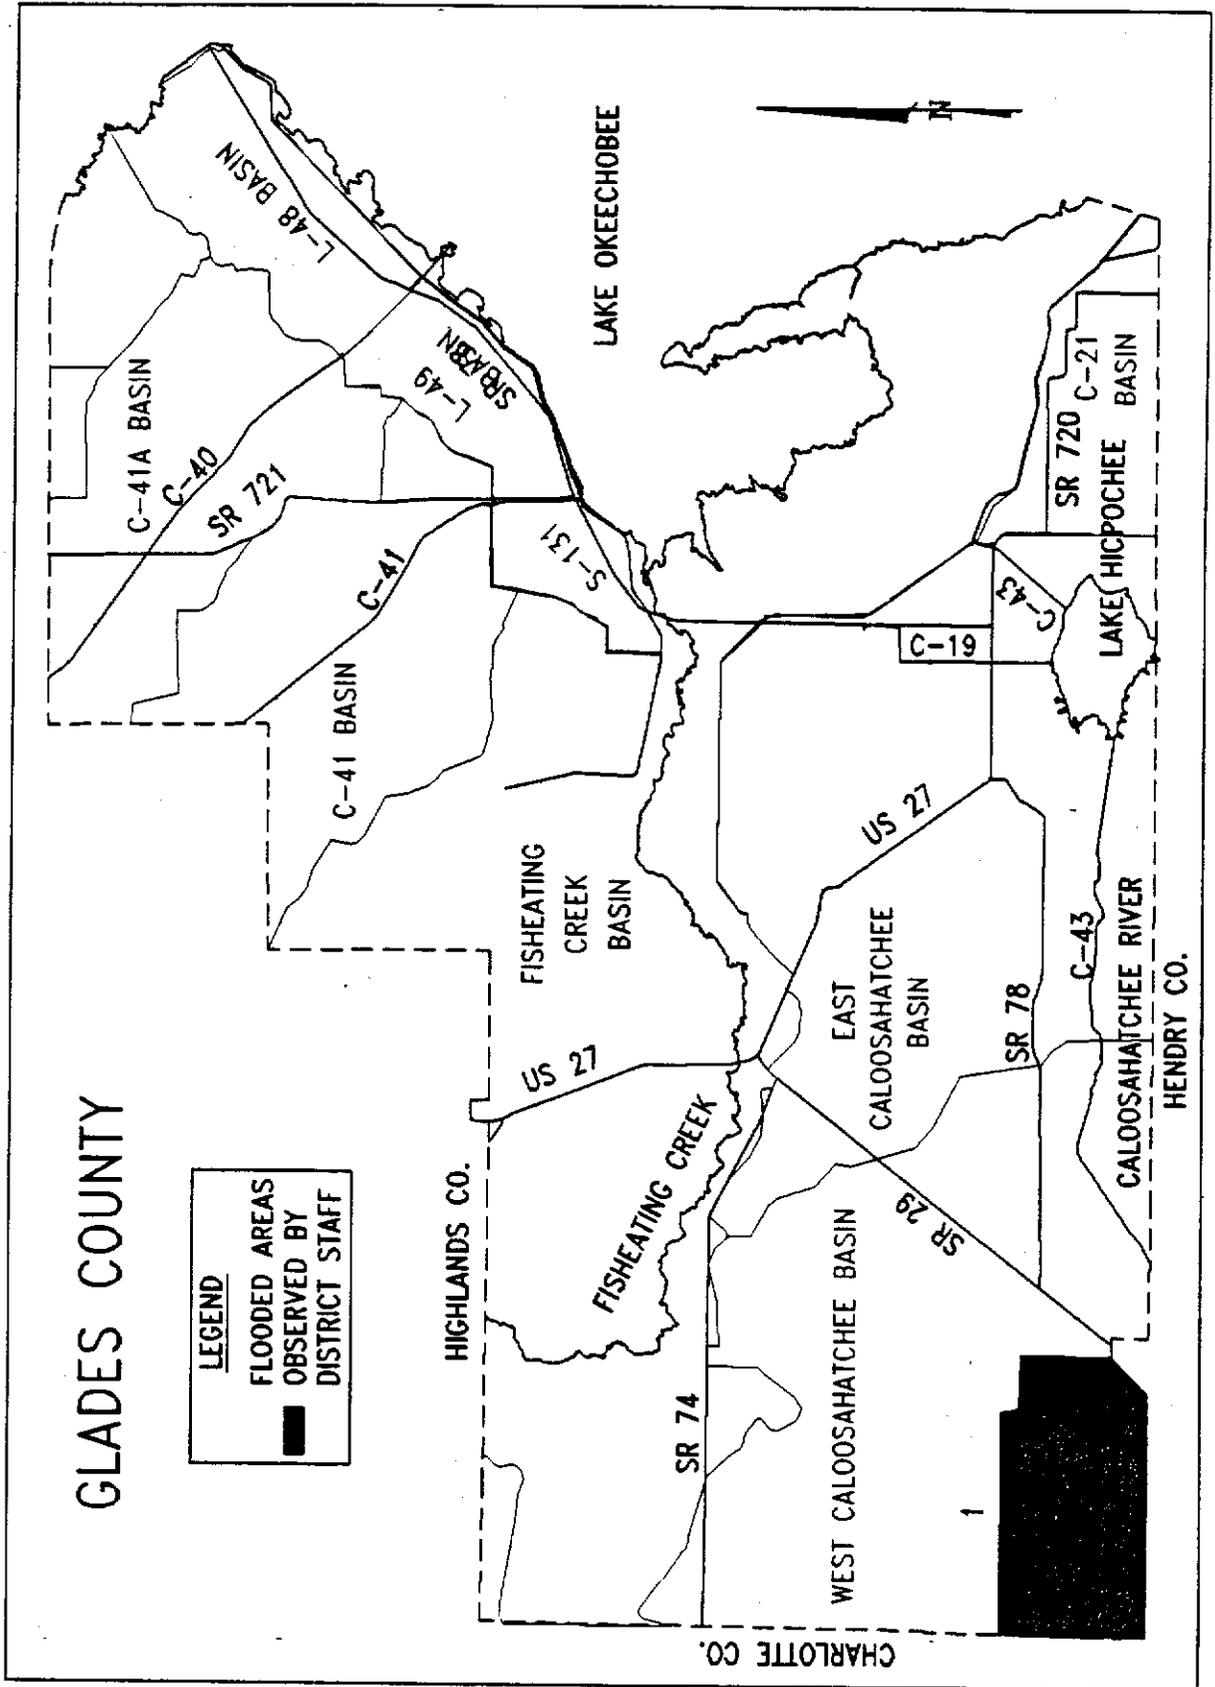
Figure 52. Flooded Areas, Glades County

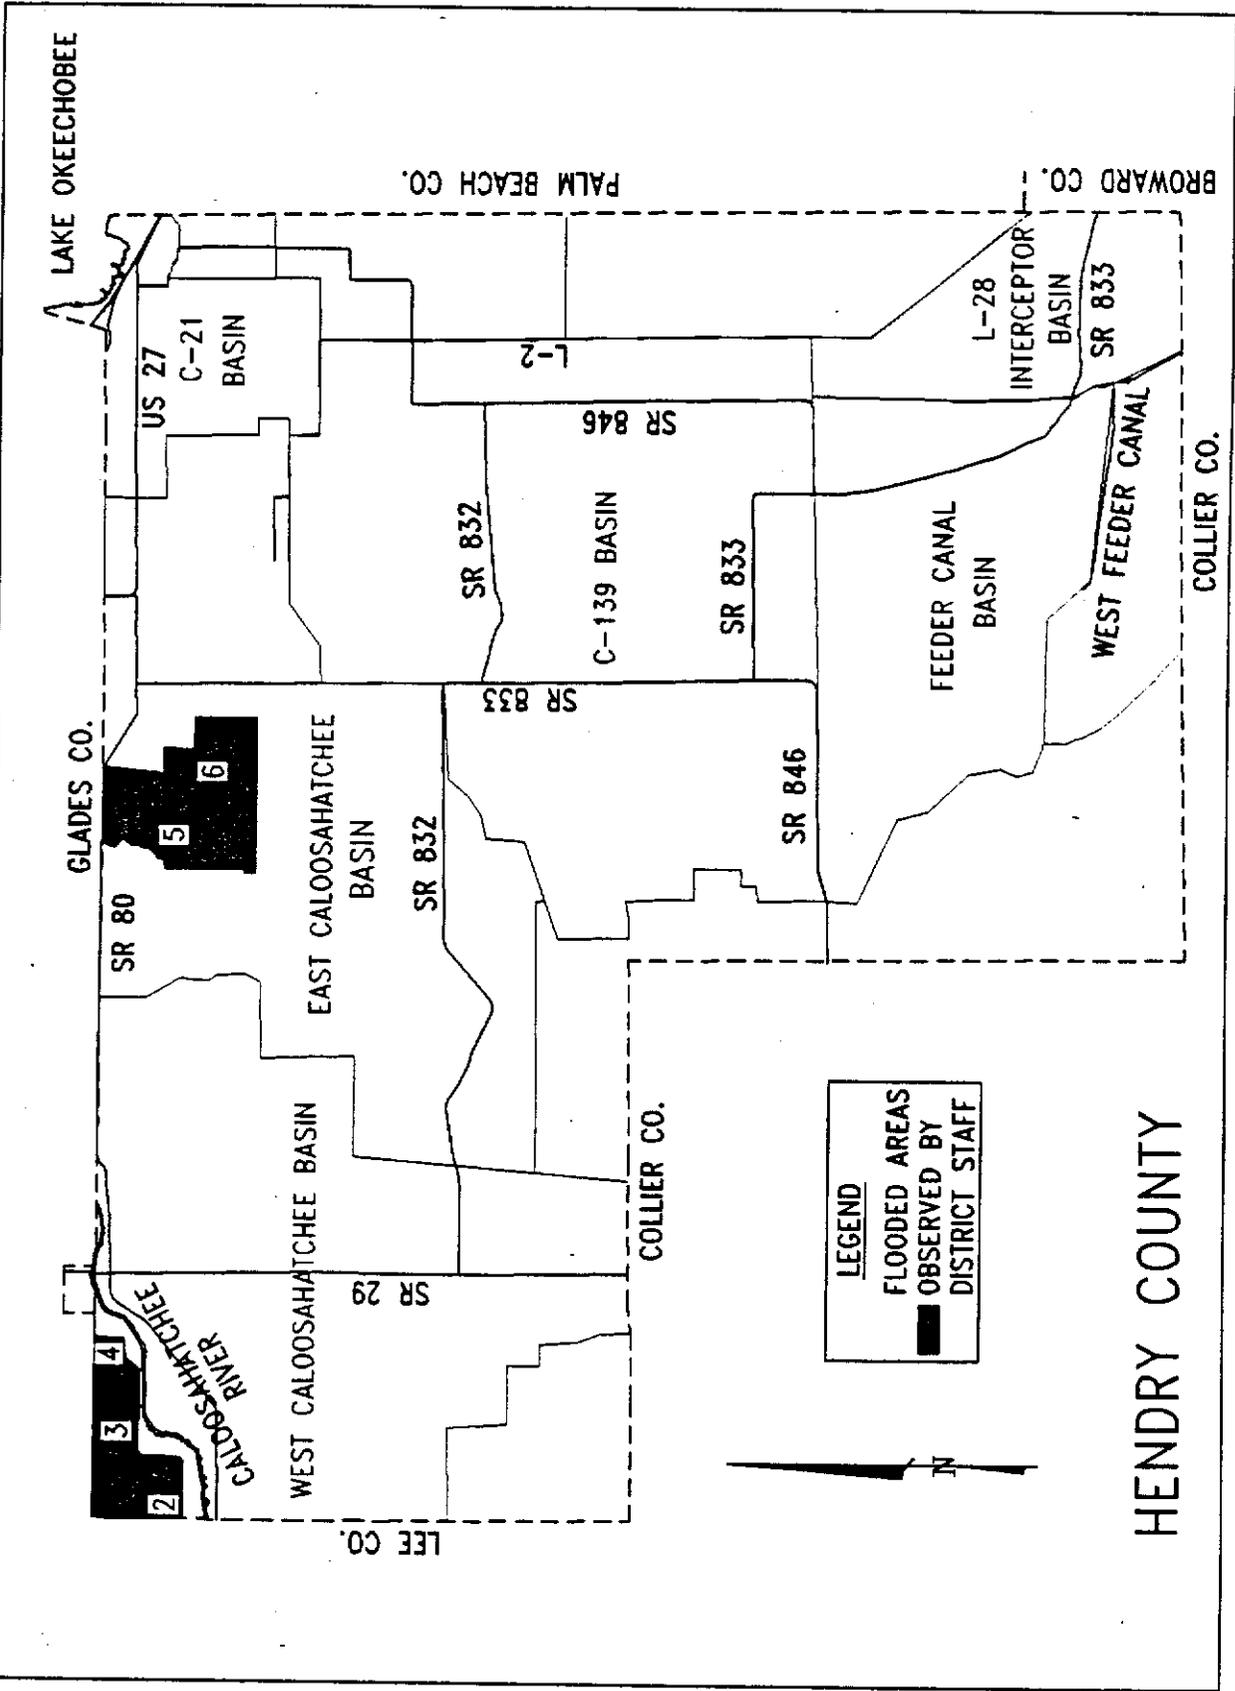
Figure 53. Flooded Areas, Hendry County

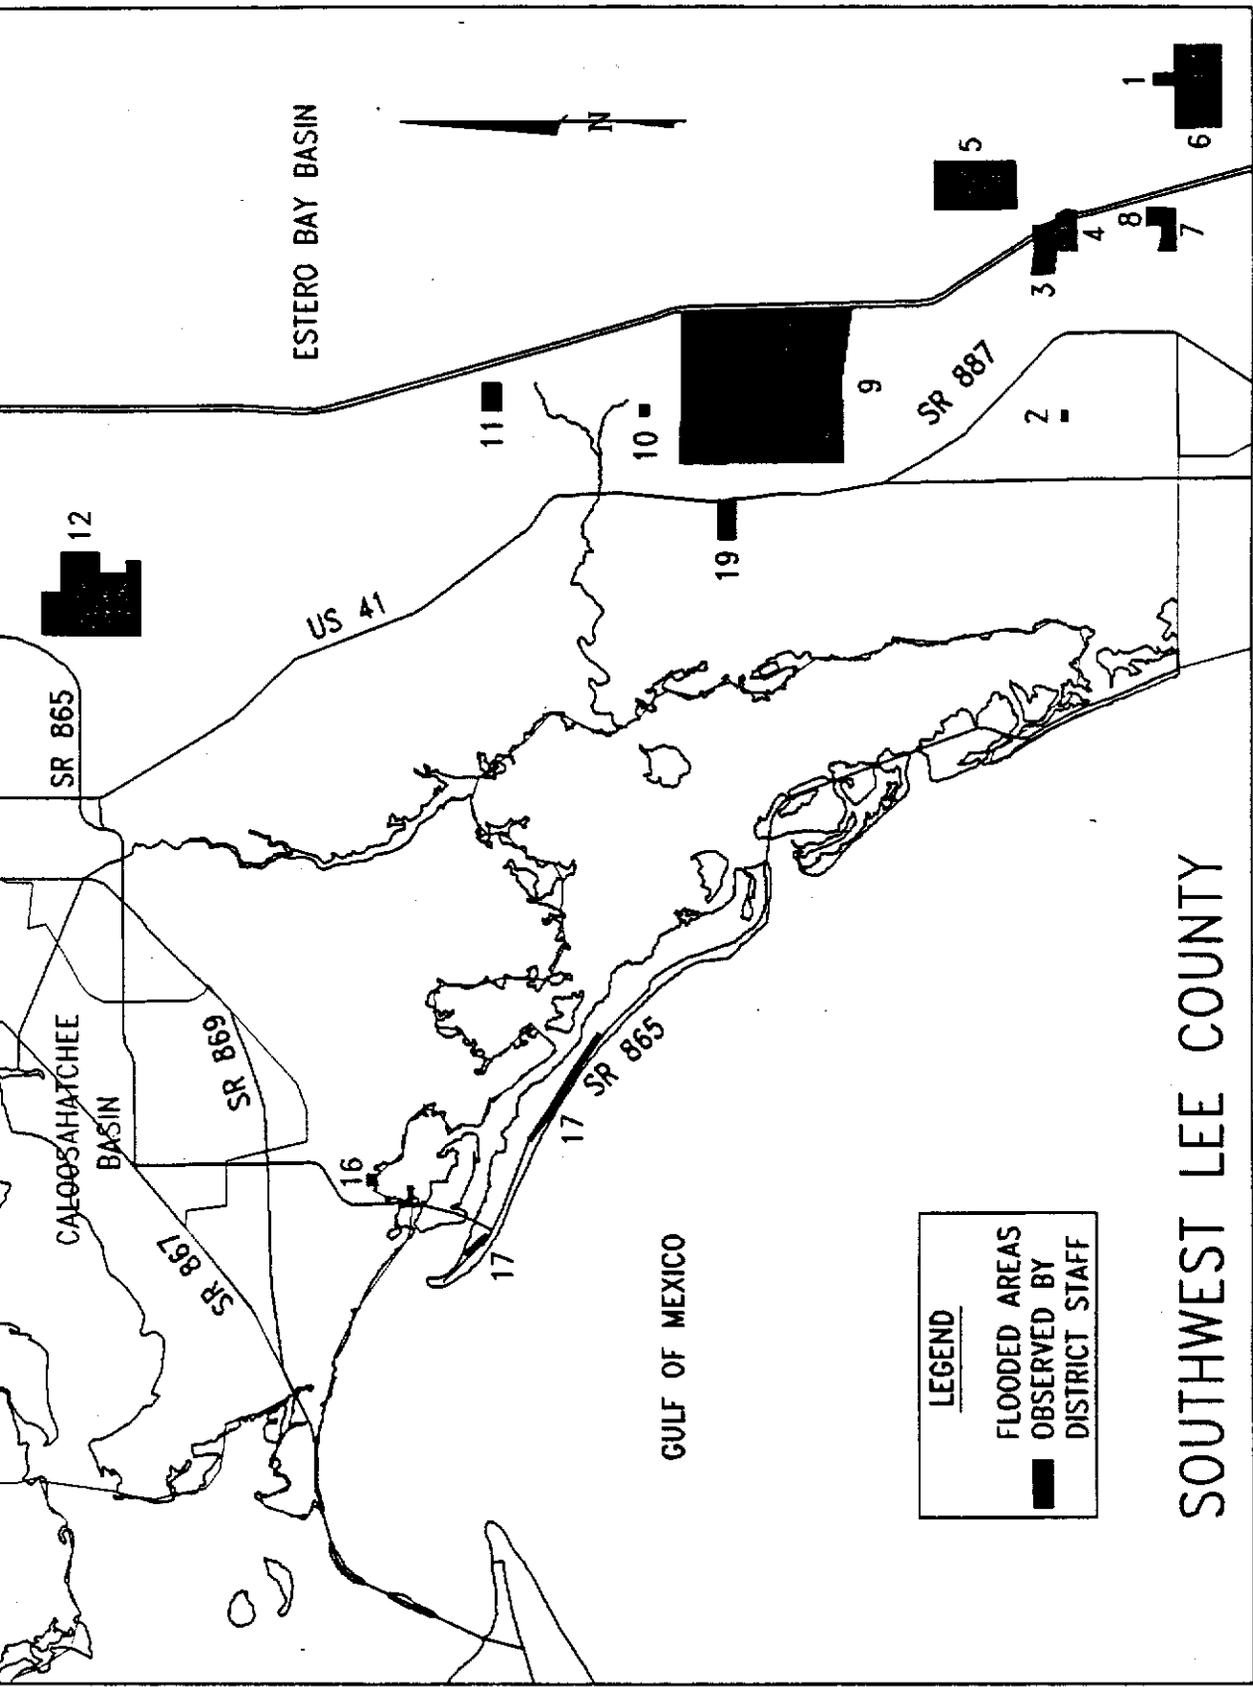
Figure 54. Flooded Areas, Southwest Lee County

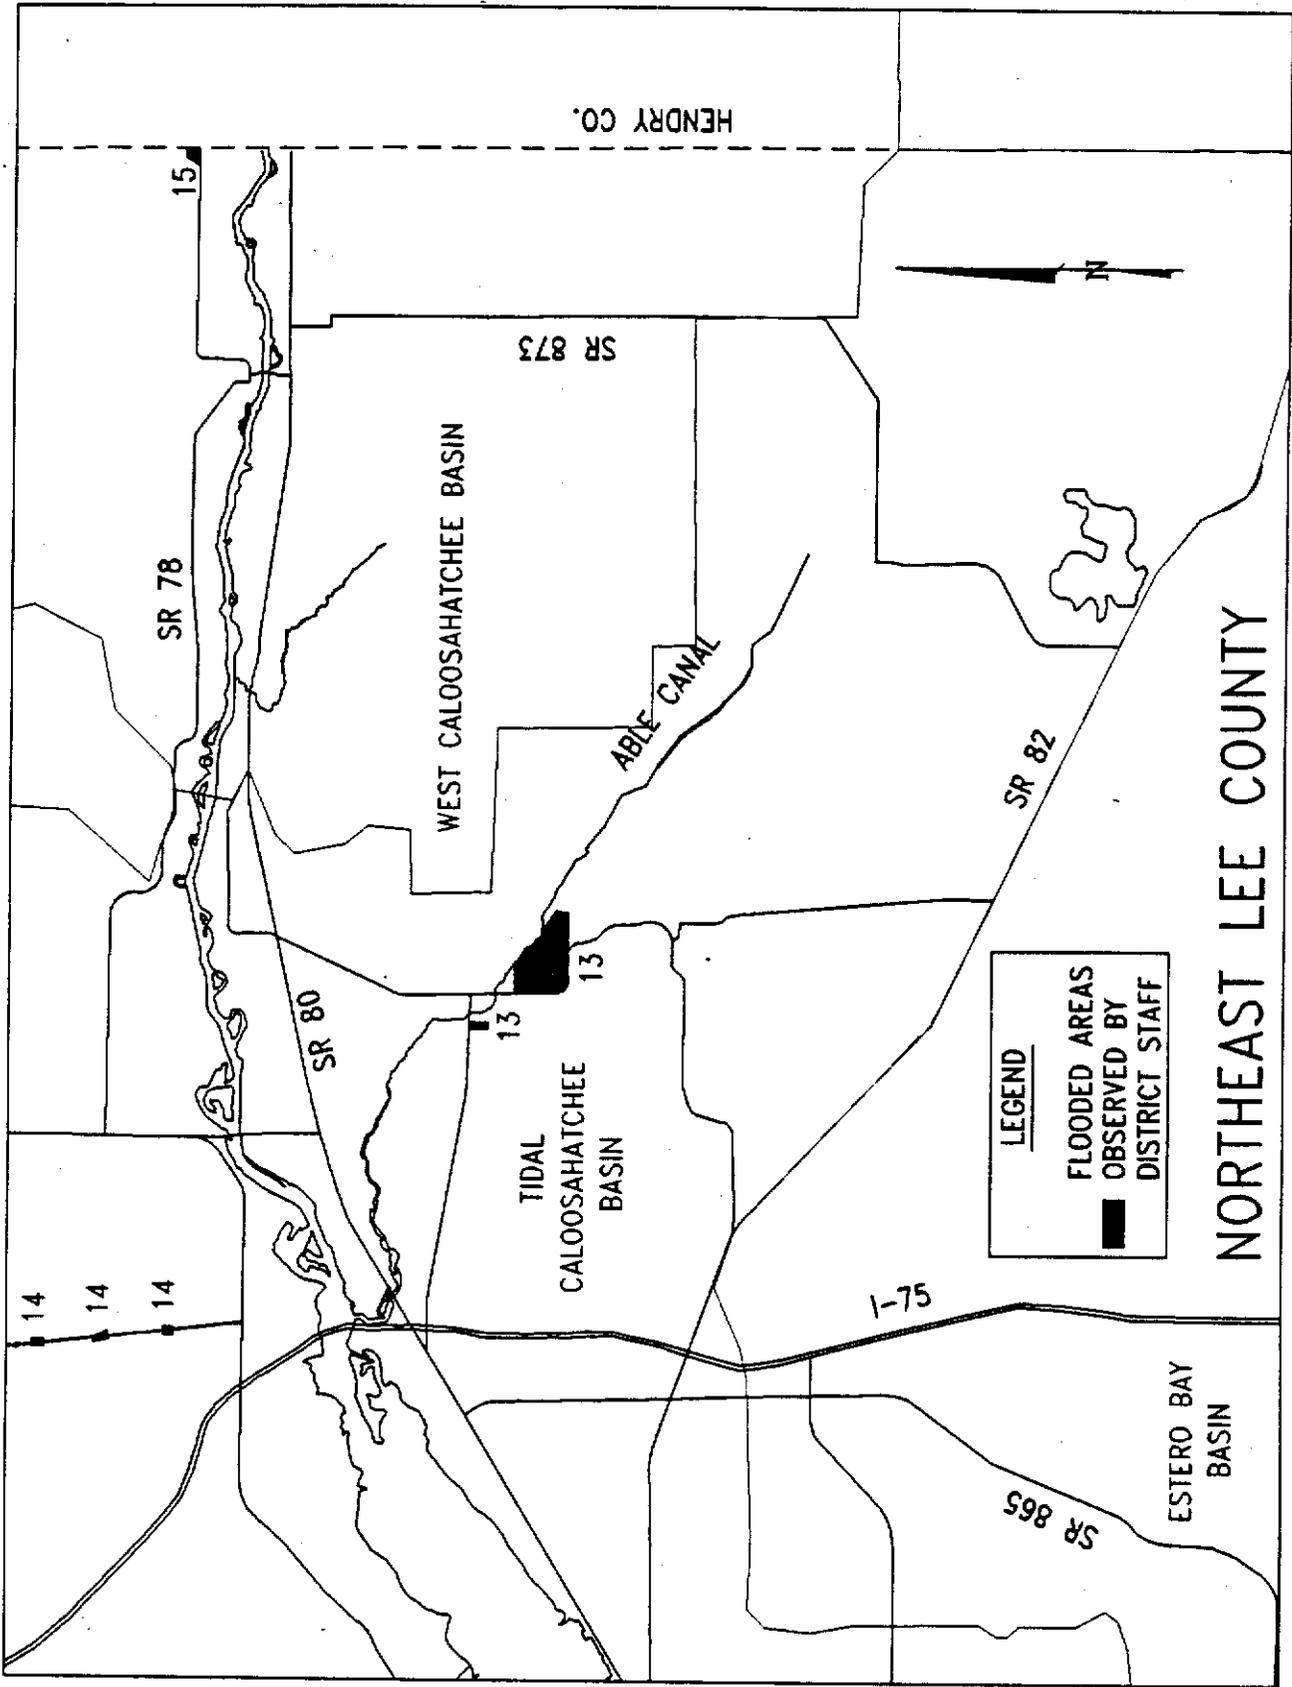
Figure 55. Flooded Areas, Northeast Lee County

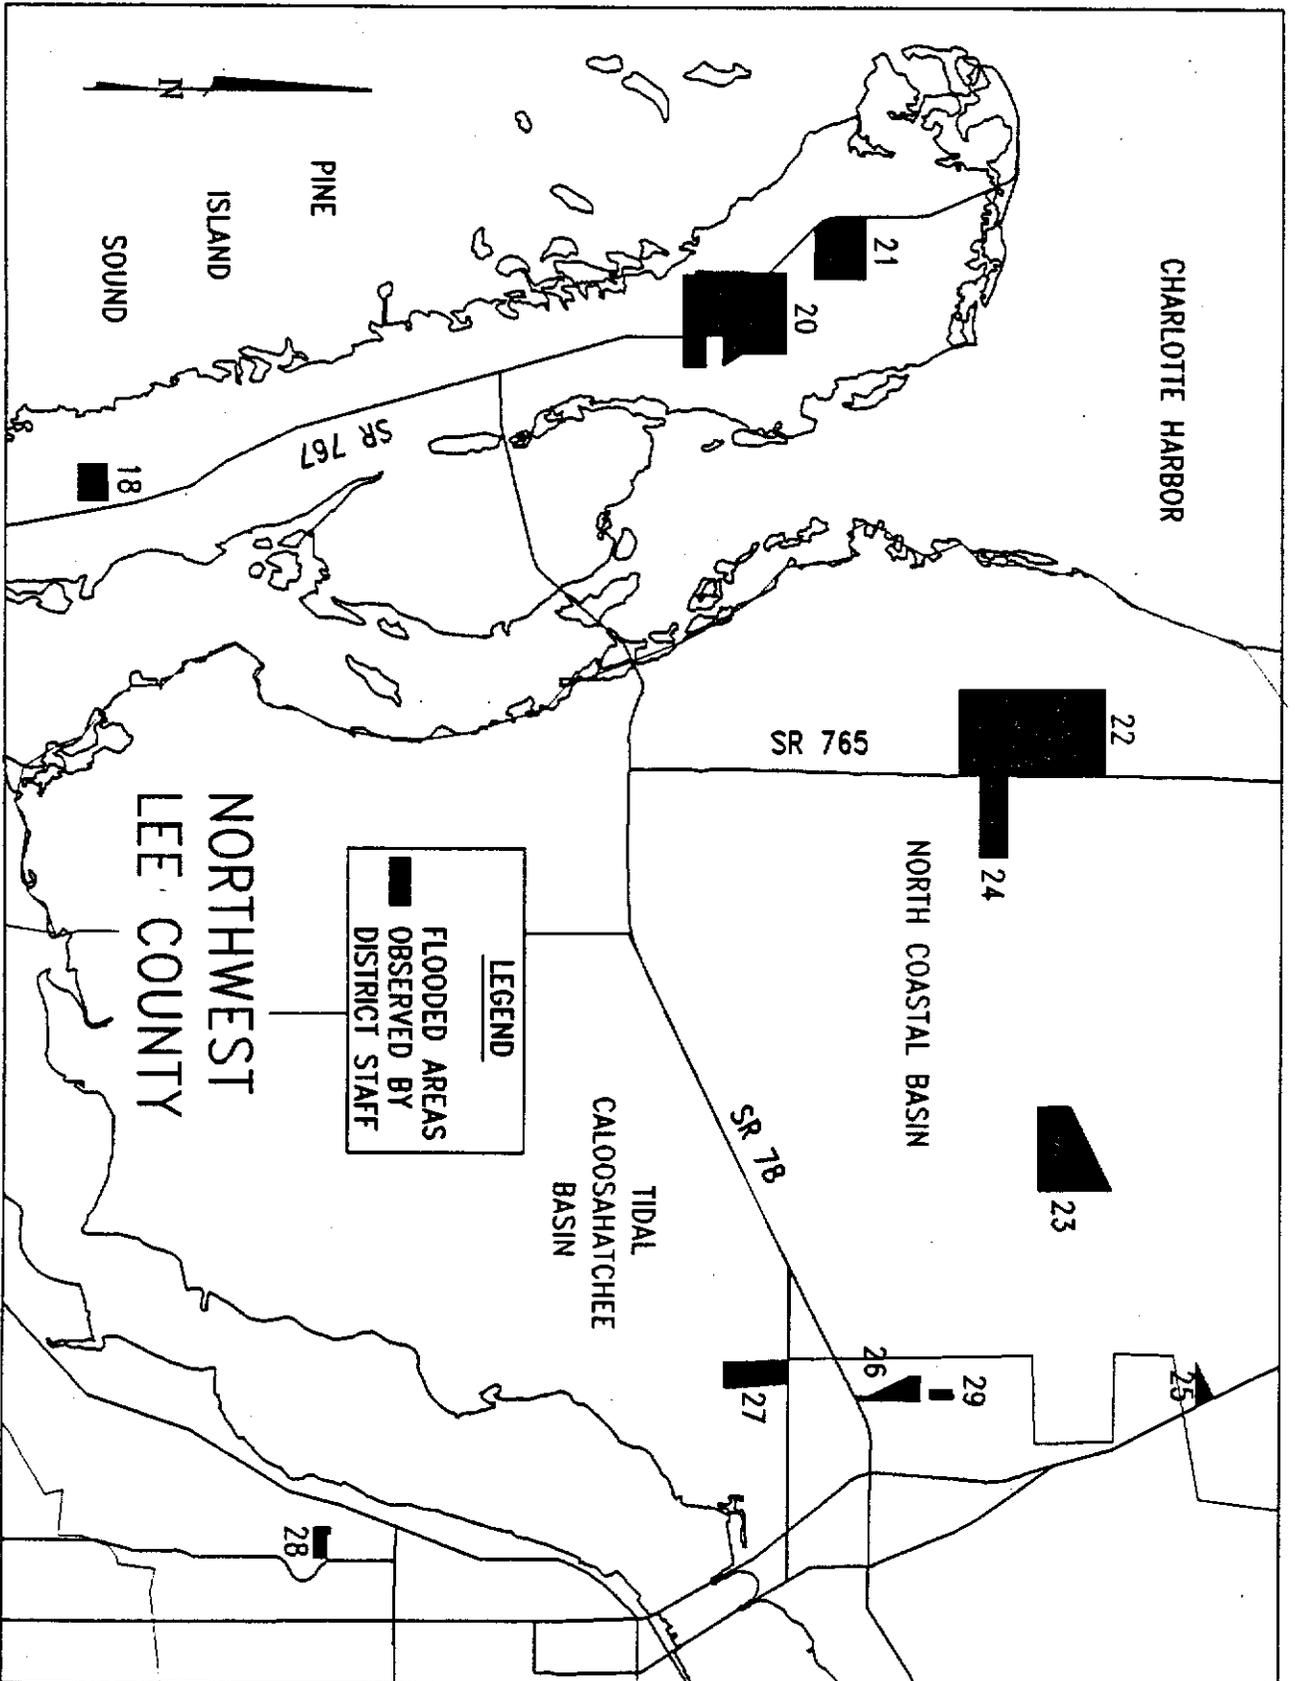
Figure 56. Flooded Areas, Northwest Lee County
