# **MARTIN COUNTY'S STORMWATER PROGRAM**

# STORMWATER COMPONENTS

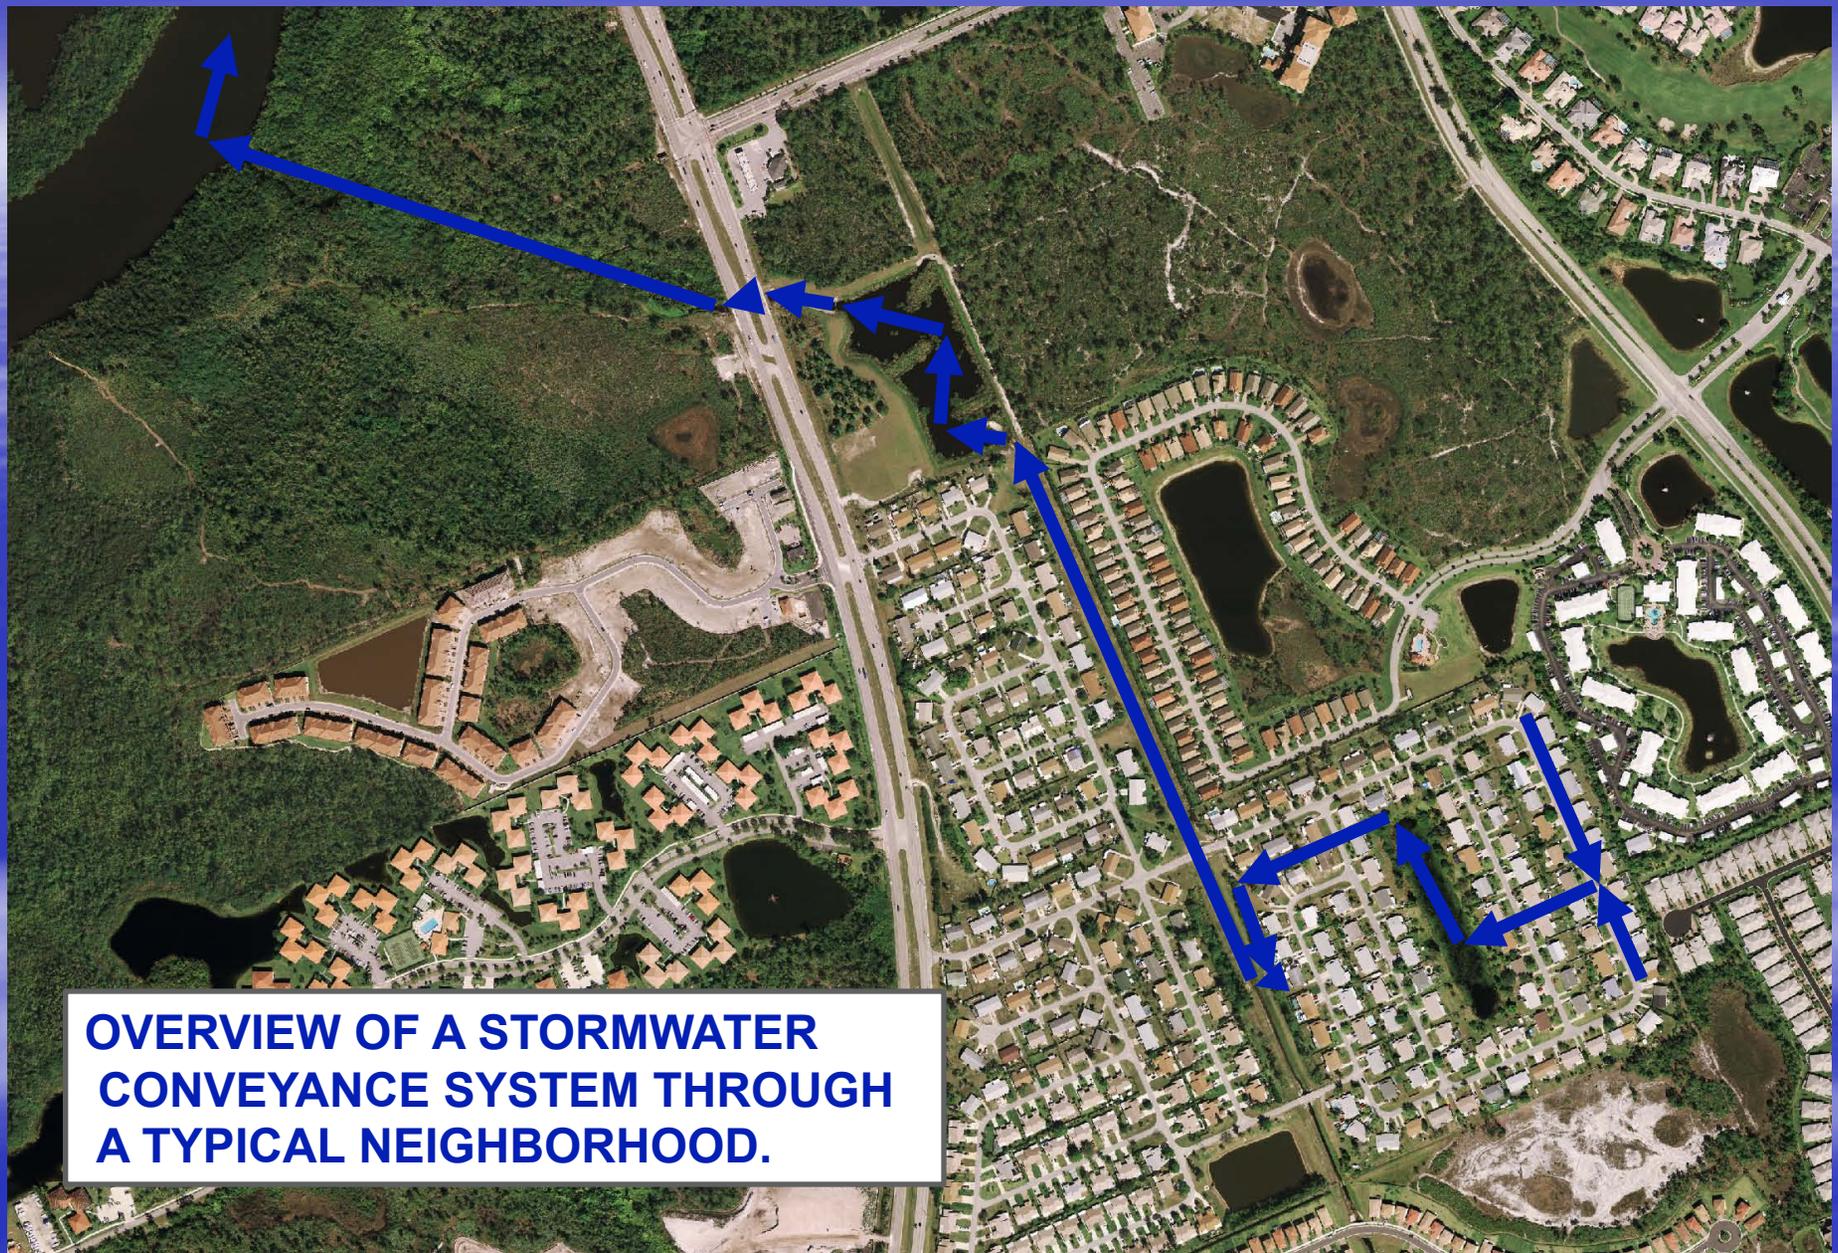
**OVERVIEW OF A STORMWATER  
CONVEYANCE SYSTEM THROUGH  
A TYPICAL NEIGHBORHOOD.**

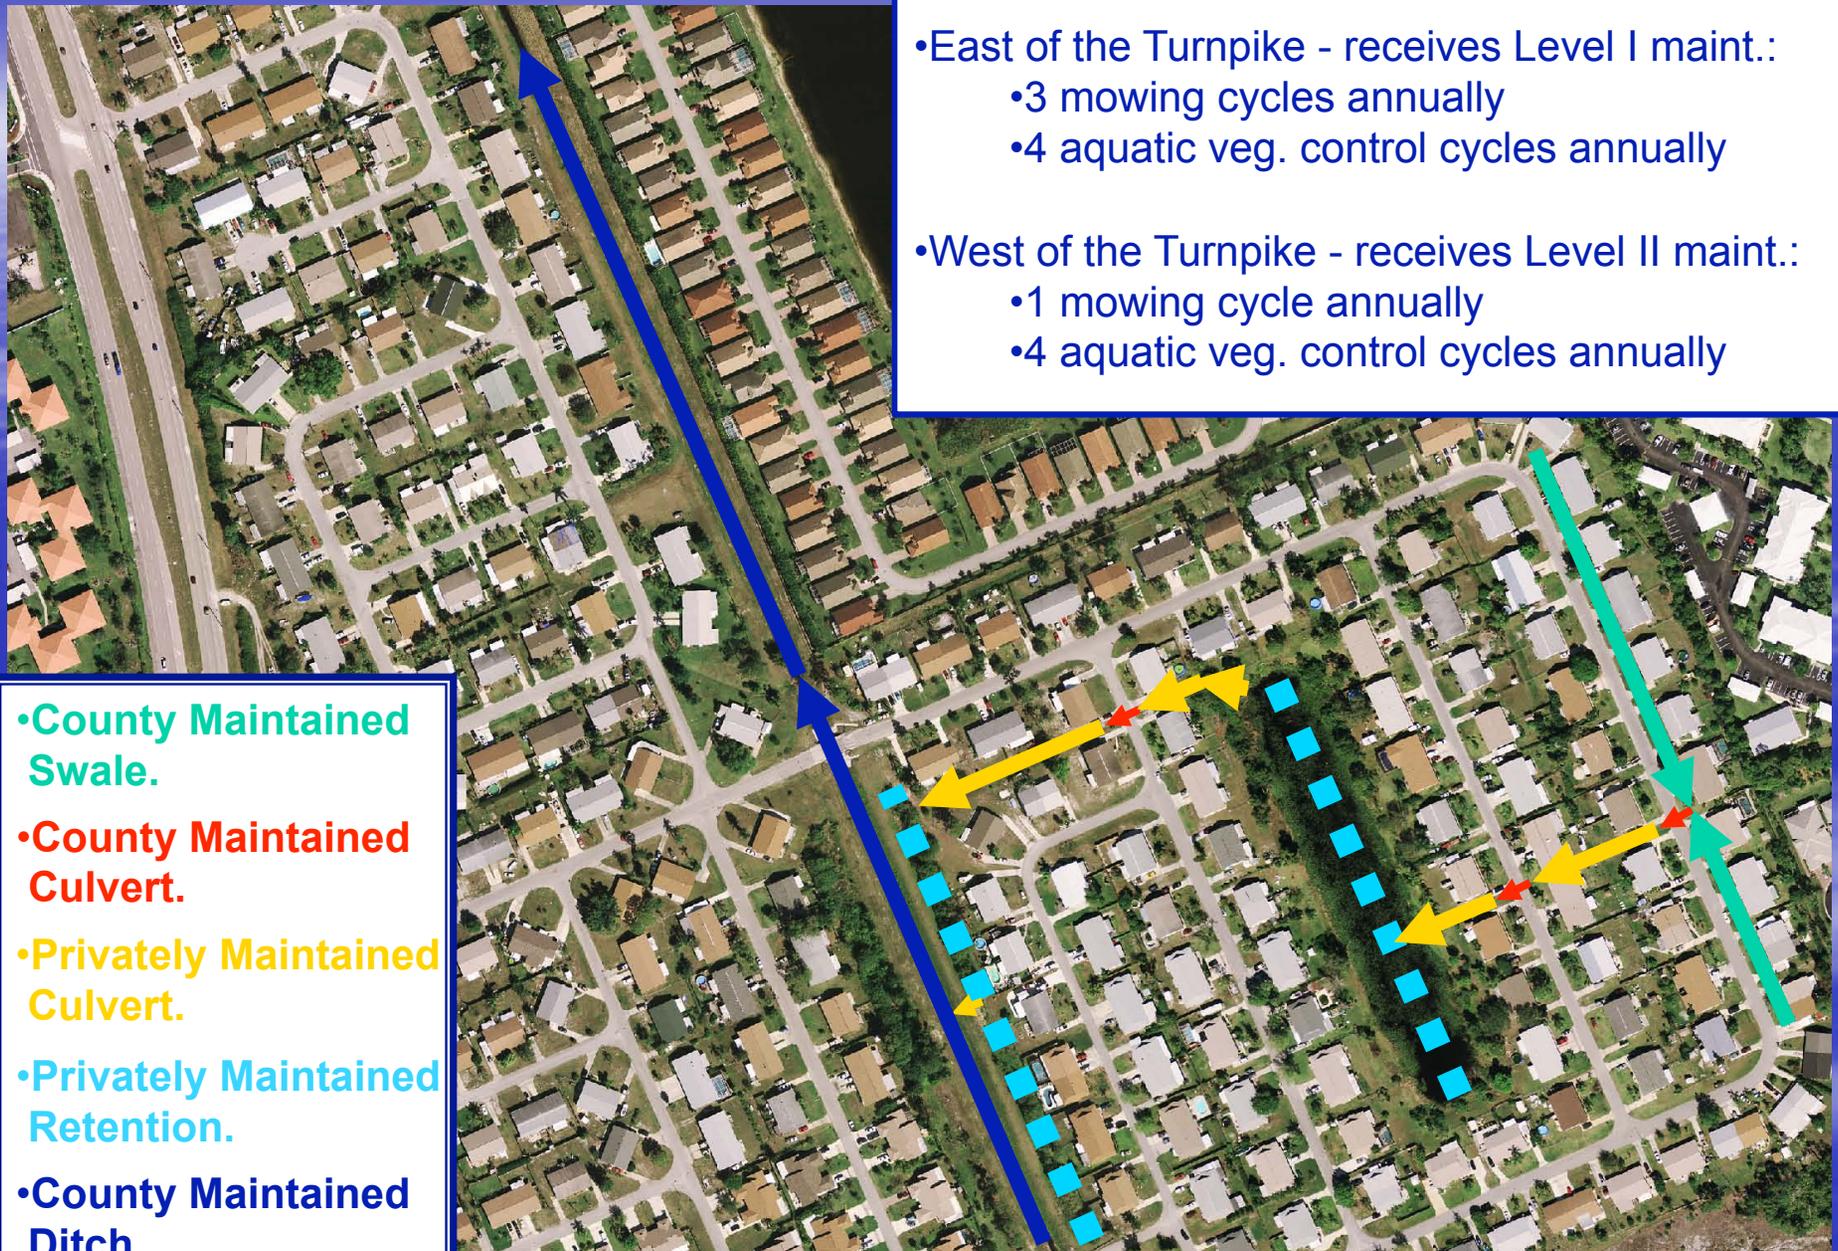
**County Maintained Ditches:**

- East of the Turnpike - receives Level I maint.:
  - 3 mowing cycles annually
  - 4 aquatic veg. control cycles annually
- West of the Turnpike - receives Level II maint.:
  - 1 mowing cycle annually
  - 4 aquatic veg. control cycles annually

- County Maintained Swale.
- County Maintained Culvert.
- Privately Maintained Culvert.
- Privately Maintained Retention.
- County Maintained Ditch.

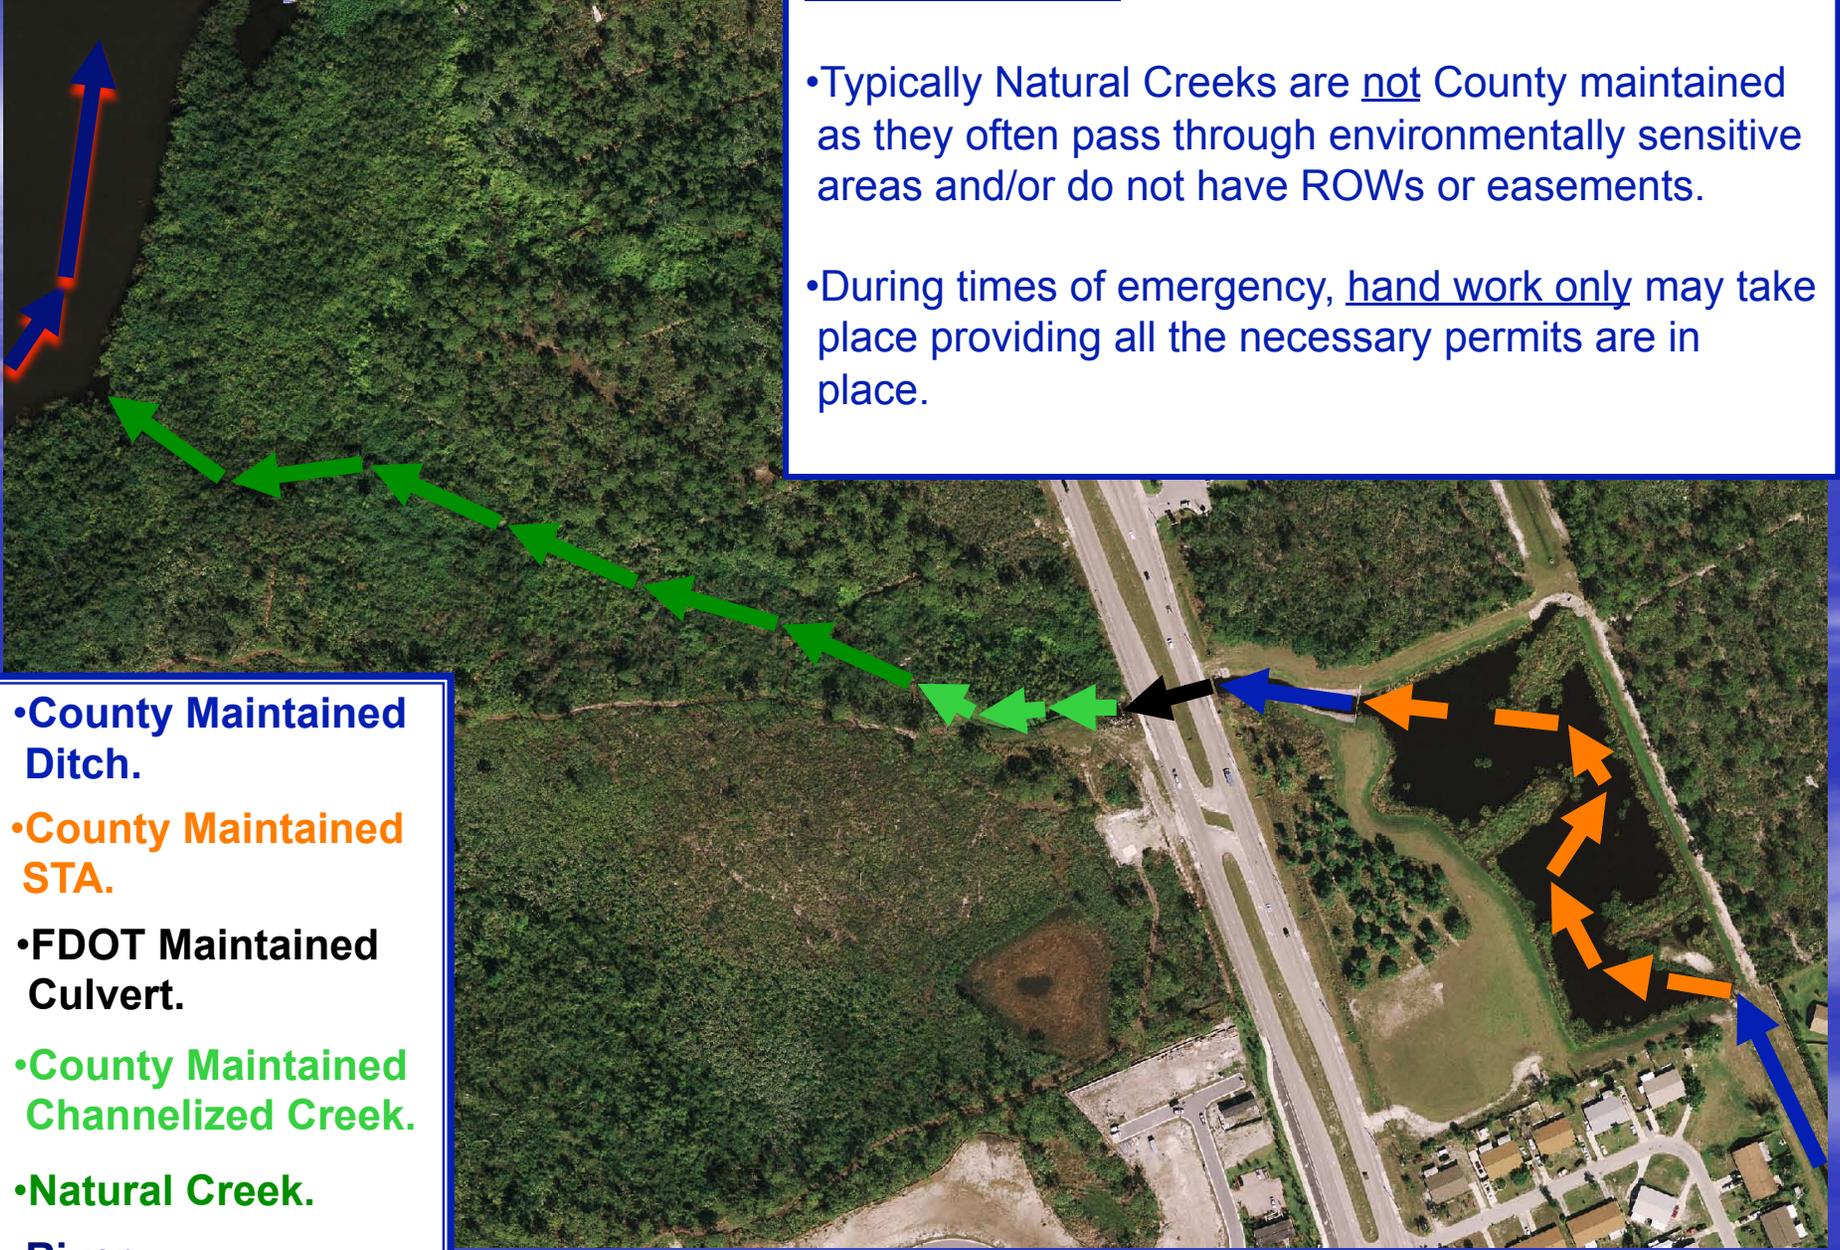
- The aerial photograph shows a network of waterways. A river is at the top left, indicated by a blue arrow pointing up. A green arrow points from the river down through a wooded area. A black arrow points from the wooded area to a road. An orange arrow points from the road to a pond. A blue arrow points from the pond to a residential area. A legend in the bottom left corner identifies these waterways: County Maintained Ditch (black), County Maintained STA (orange), FDOT Maintained Culvert (black), County Maintained Channelized Creek (green), Natural Creek (green), and River (blue).
- County Maintained Ditch.
  - County Maintained STA.
  - FDOT Maintained Culvert.
  - County Maintained Channelized Creek.
  - Natural Creek.
  - River.

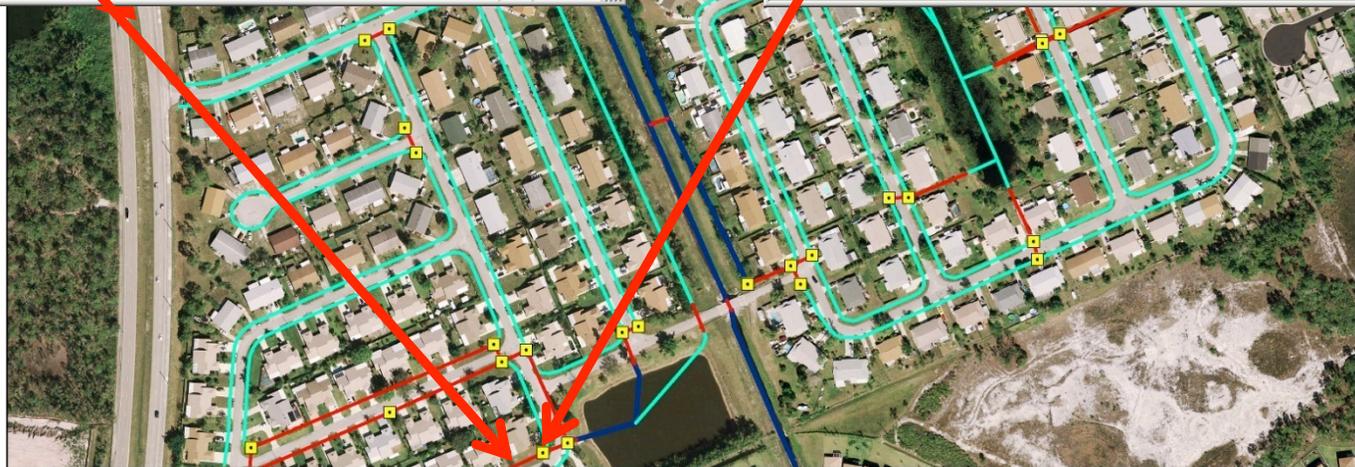
# GIS MAP OF INVENTORY

**Storm Main Inventory**

Main Line Type	STRM	Dir From Ups		Joint Type	
Manufacturer		Dir From Dwn		Joint Length	0.000
Surface Cover		Ups Depth	3.880	Design Flow	0.00
Critical Rating	GOOD	Dwn Depth	3.930	Friction Factor	0.000
Pipe Type	CHP	Ups Invert Elev	0.000	Ground Water Level	0.000
Pipe Shape	RND	Dwn Invert Elev	0.000	Incoming Mains	2
Diameter	30.00	Length	0.000		
Height	0.00	Slope	0.00000

**Storm Inlet Inventory**

Inlet Type	INC
Material	CONCR
Grate Type	CAST
Length	3.00
Width	2.30
Inlet Depth	4.90
Outlet Depth	4.10

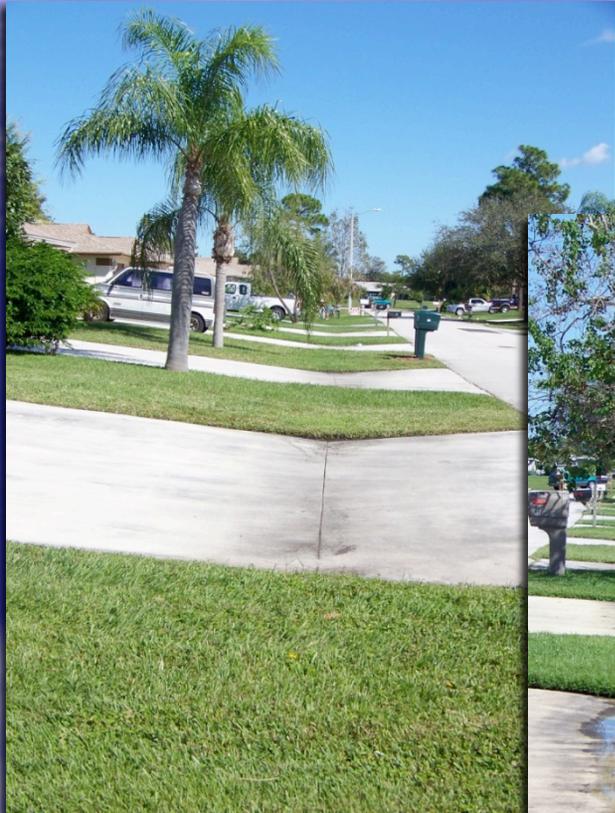
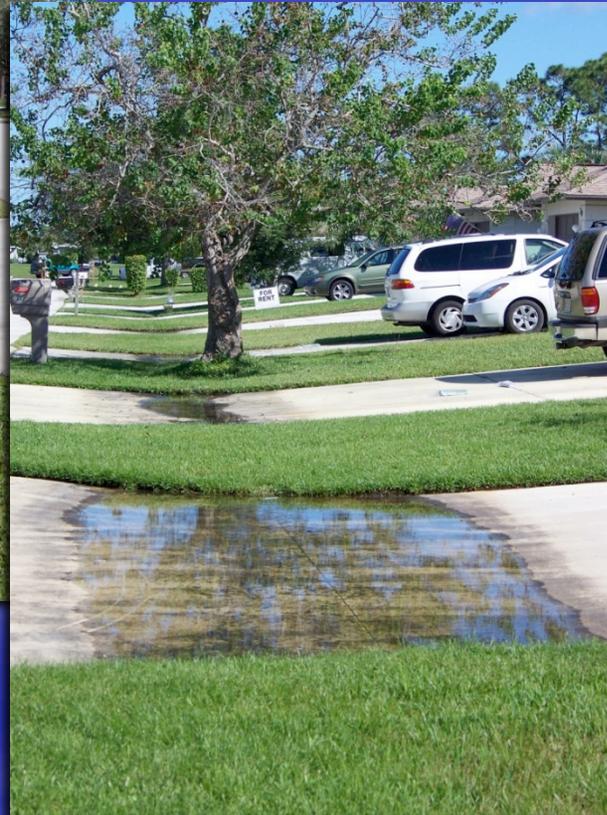
# ROADSIDE DRAINAGE

- Swales are the most common type of roadside drainage and provide the first level of protection against flooding.

- As swales age, buildup causes standing water.

- During rainy season, standing water may be present for several weeks or months.

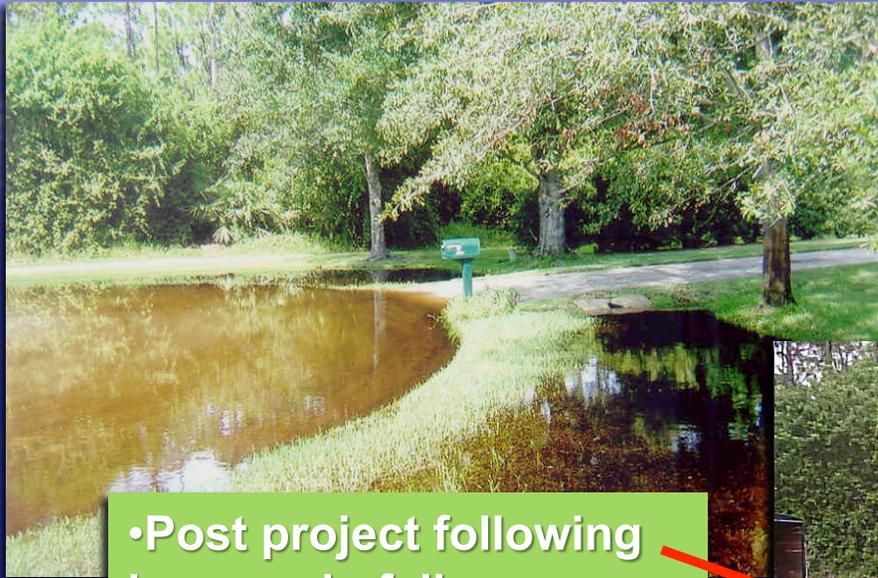
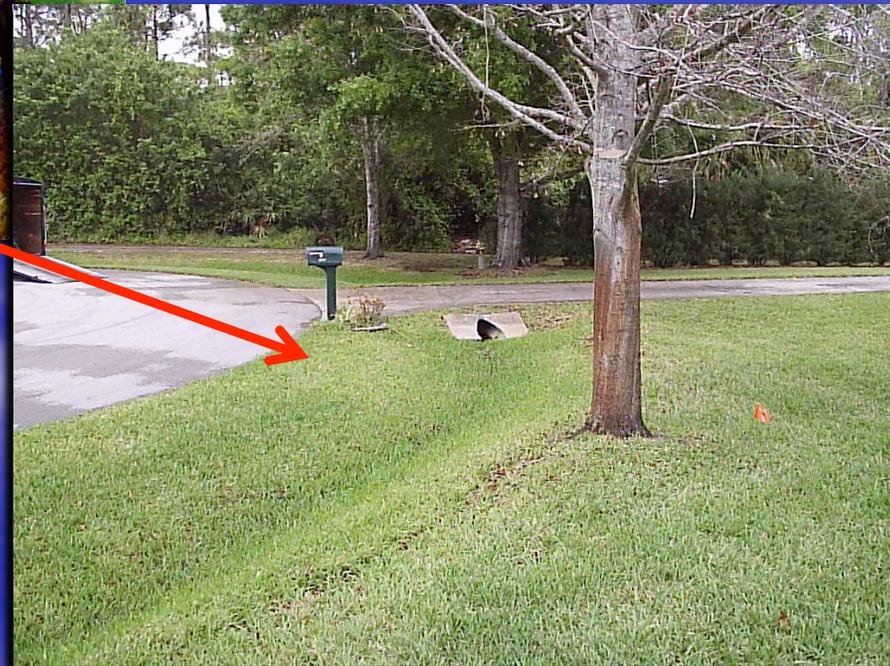
•Post project following heavy rain fall.

- Documented structure flooding.
- Notified summer 2007.
- Swale reconstructed fall 2007.

- Street flooding.
- On project list since mid 1990s.
- Regrade project completed 2007

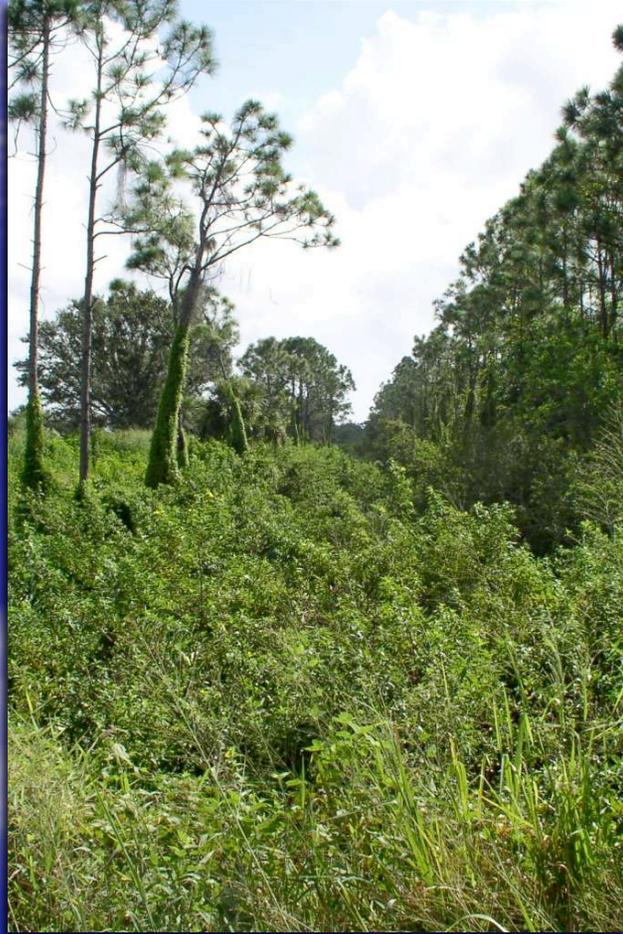
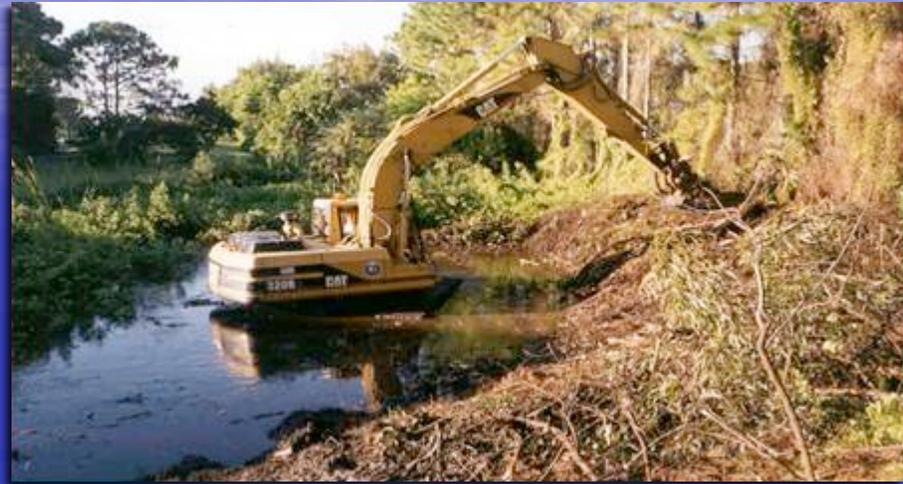
- **Overgrown FDOT Lateral Ditch.**
- **Vegetation contributed to upstream flooding.**
- **Joint restoration project with FDOT in 2001.**
- **Ongoing maintenance performed by MC.**
- **No upstream flooding since improvements.**

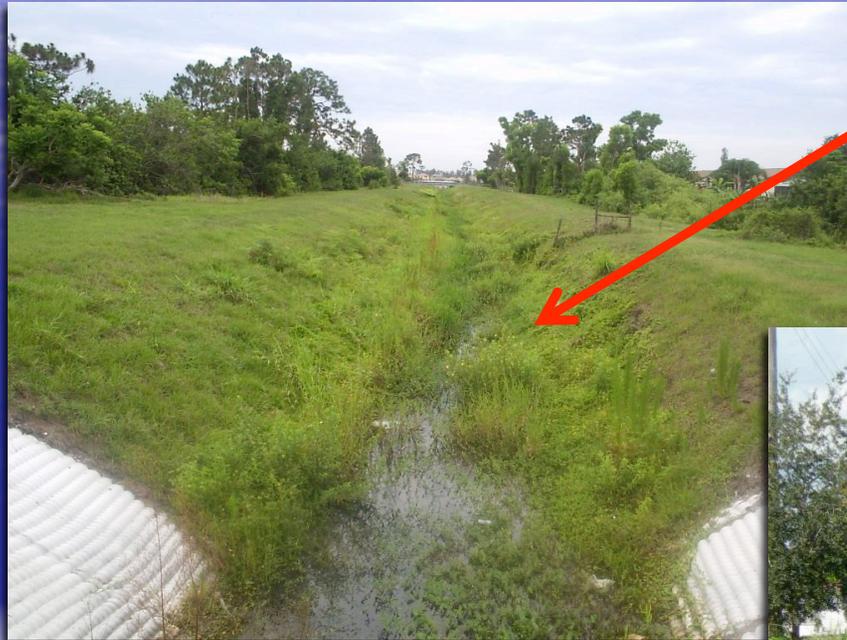
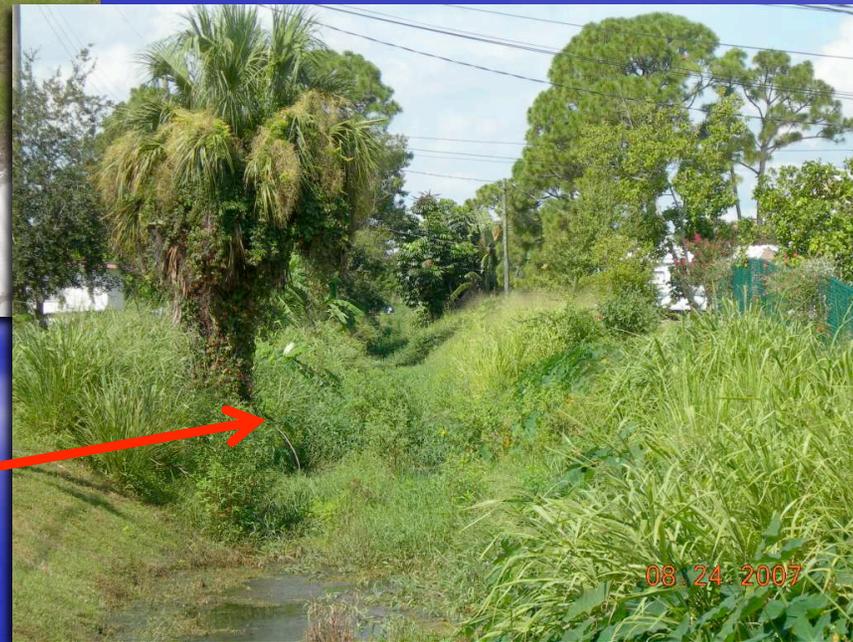
•Coral Gardens Ditch approximately 1 month after completing mow cycle.

•All American Ditch in Palm City approximately 3 months after mowing.

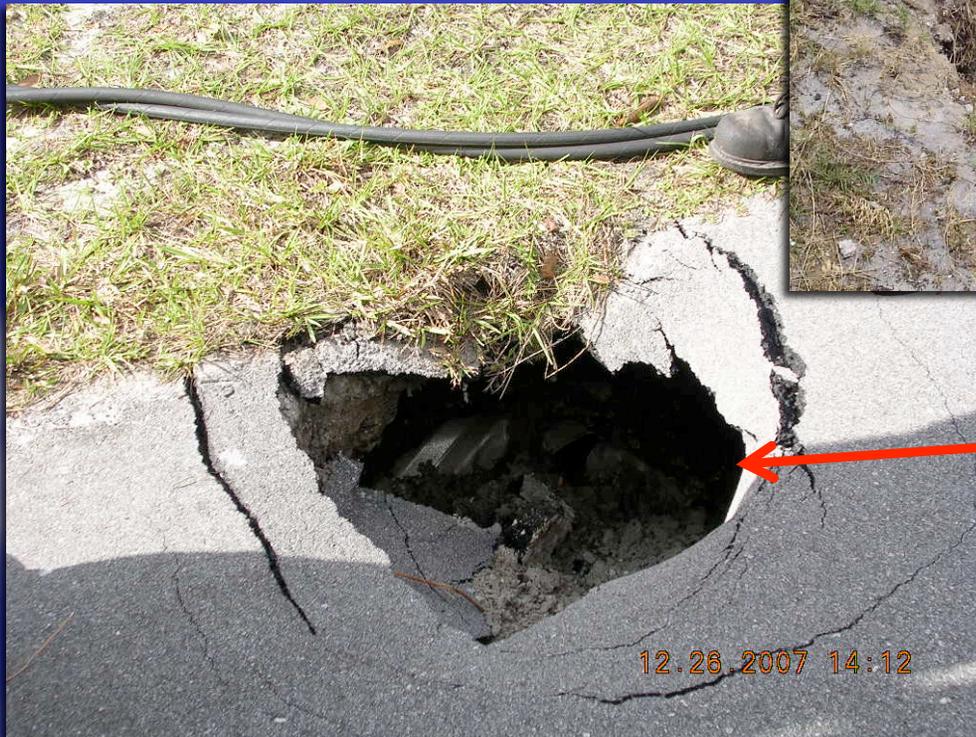
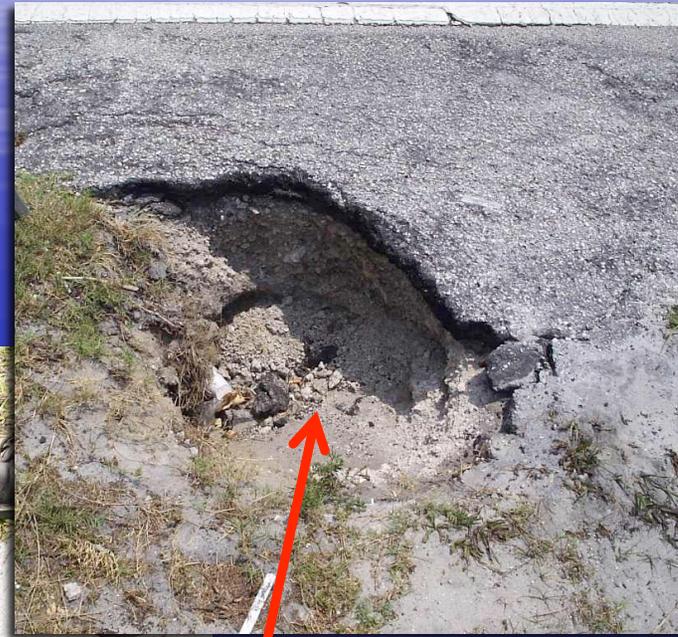
- Culvert failures under pavement require immediate emergency repairs.

- Permanent repairs are scheduled as necessary.

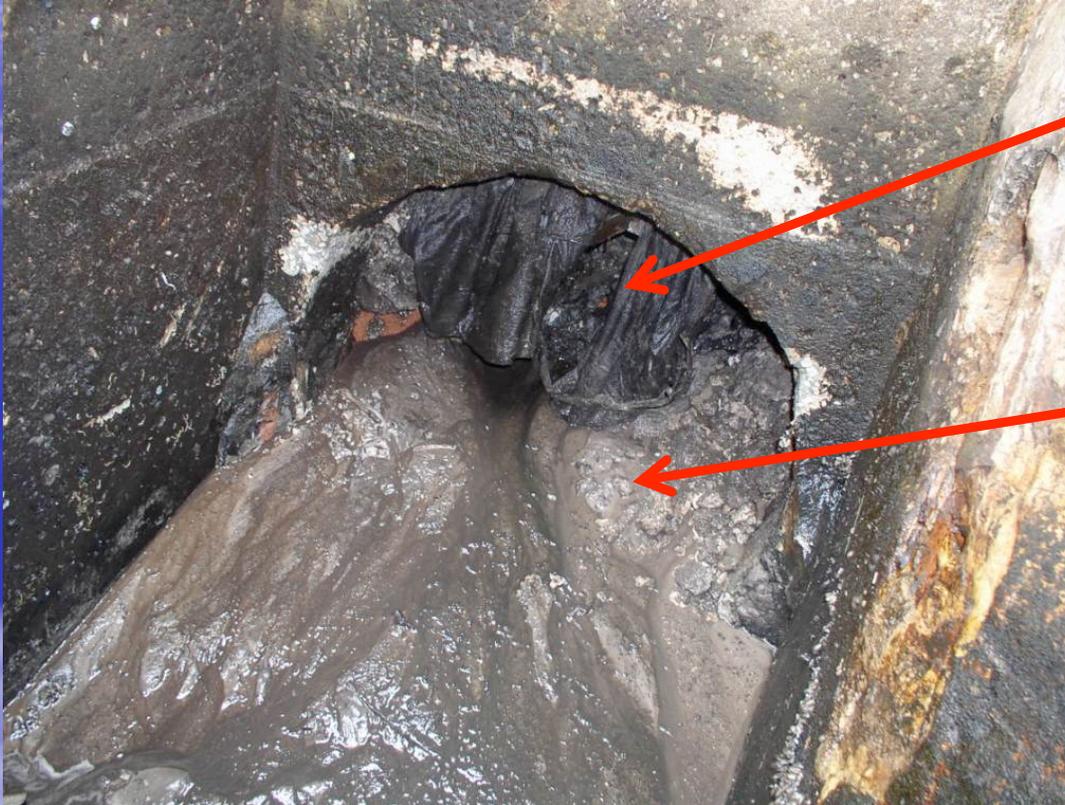
- Evidence of previous repair.

- Collapsed culvert 90%+- blocked by sedimentation.

- Creates possible flooding conditions upstream.

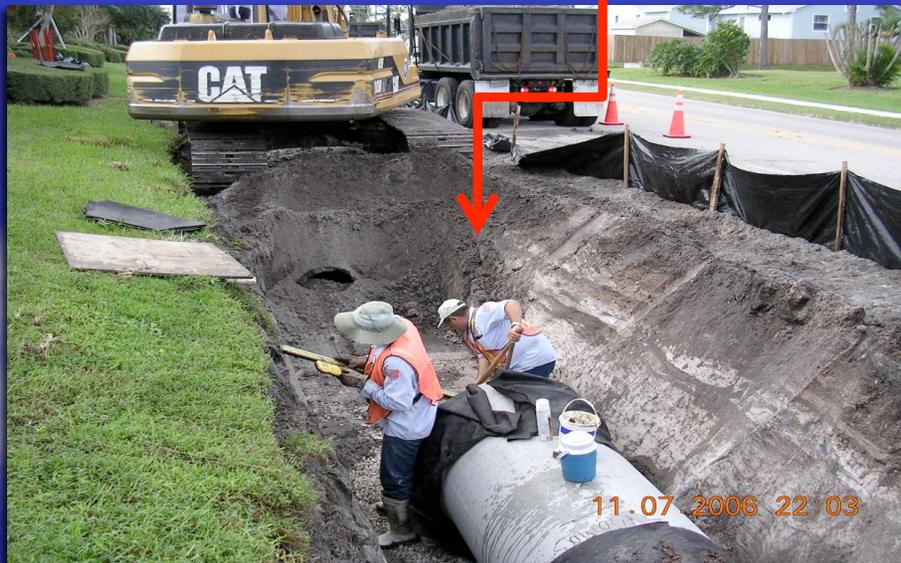
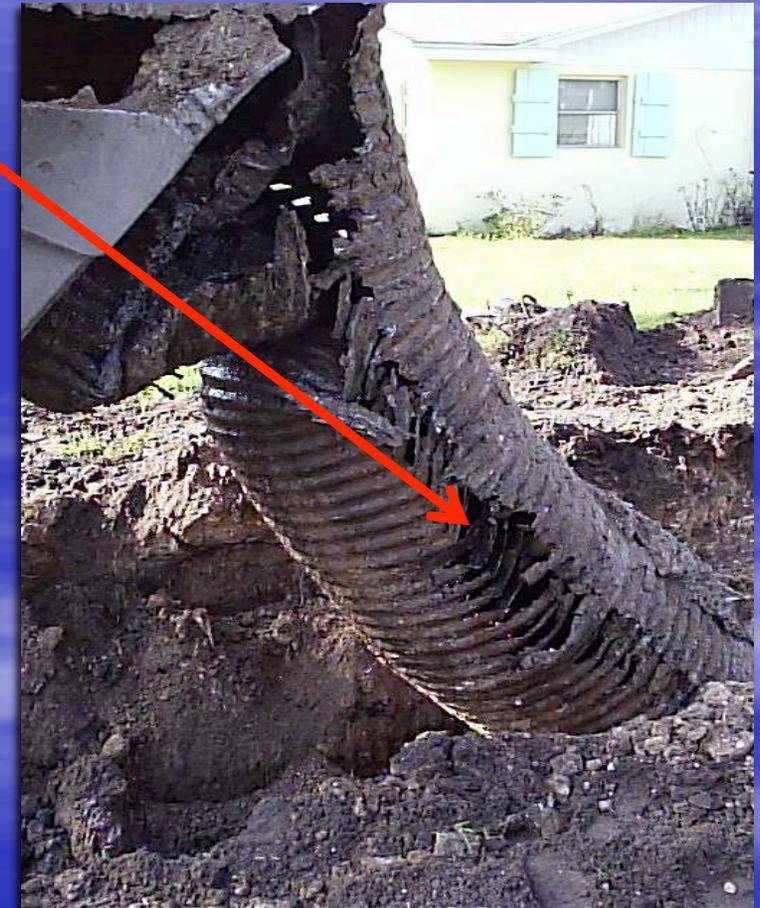
- This culvert exceeded its useful life span and required replacement.
- County staff replacing a failed storm sewer system with material of a greater “design life span”.
